Engineering Failure Analysis 8 (2001) 123–131

Oxygen pitting failure of a bagasse boiler tube

A.M. Heyes

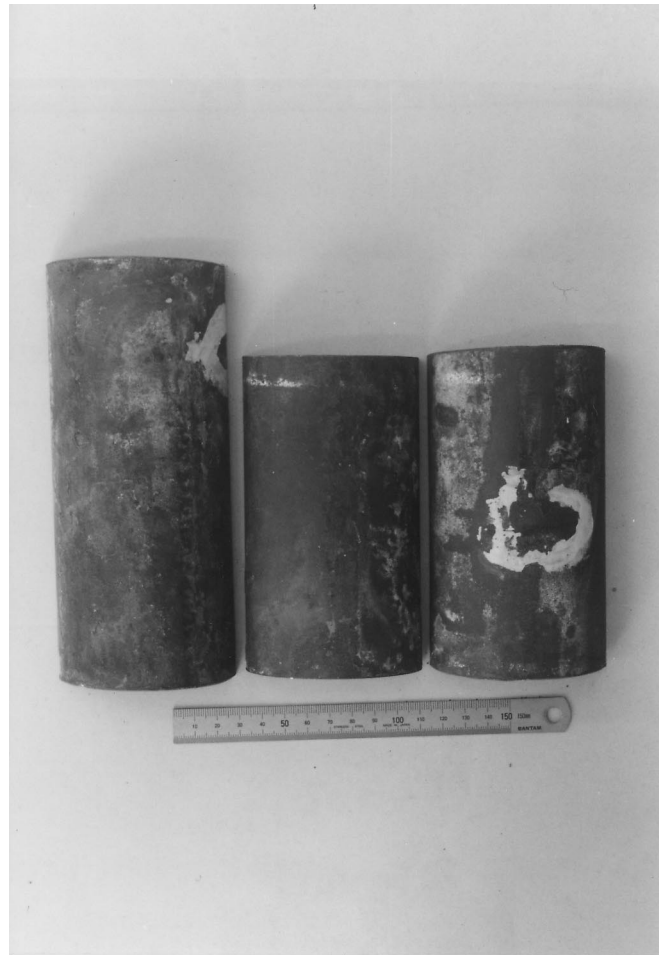
Three samples were received: one comprising the two halves of the tube from the main point of leakage and another half section of the tube, where leakage was only slight. The external (fireside and rearside) and internal surfaces of the samples are shown in Figs. 2 and 3, respectively. Visual examination suggested that there were two through-cracks and that they had originated on the internal surface of the tube, as evidenced by the pitting and transverse cracking shown in Figs. 4 and 5. The internal surface of the tube was covered by an adherent magnetite scale with many of the pitted areas showing red rusting. Fireside deposits were minimal and little deterioration of the external tube surfaces was evident. However, there was a clear difference in the appearance of the fireside and rearside external surfaces, explained by the fact that the roof tubes are recessed into the roof tiles to a depth of half their

diameter. Both of the failures appeared to have occurred on the lower half (fireside) of the tubes and this was confirmed by the operator. On close examination it could be seen that almost all of the pitting and cracking was on the lower half of the tubes.

Fig. 2. External surfaces of the tube samples supplied.

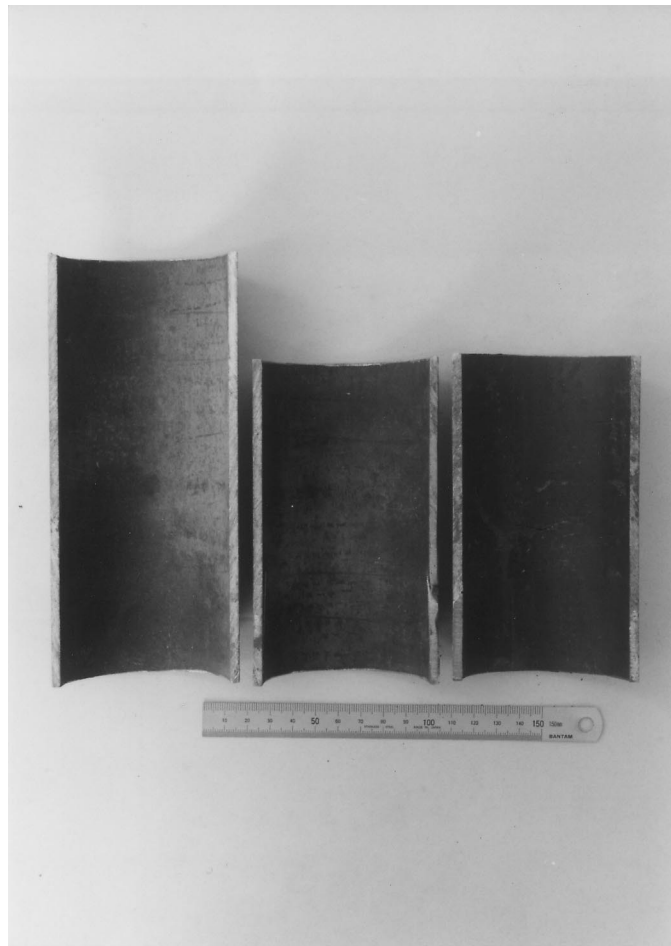
Fig. 3. Internal surfaces of the tube samples.

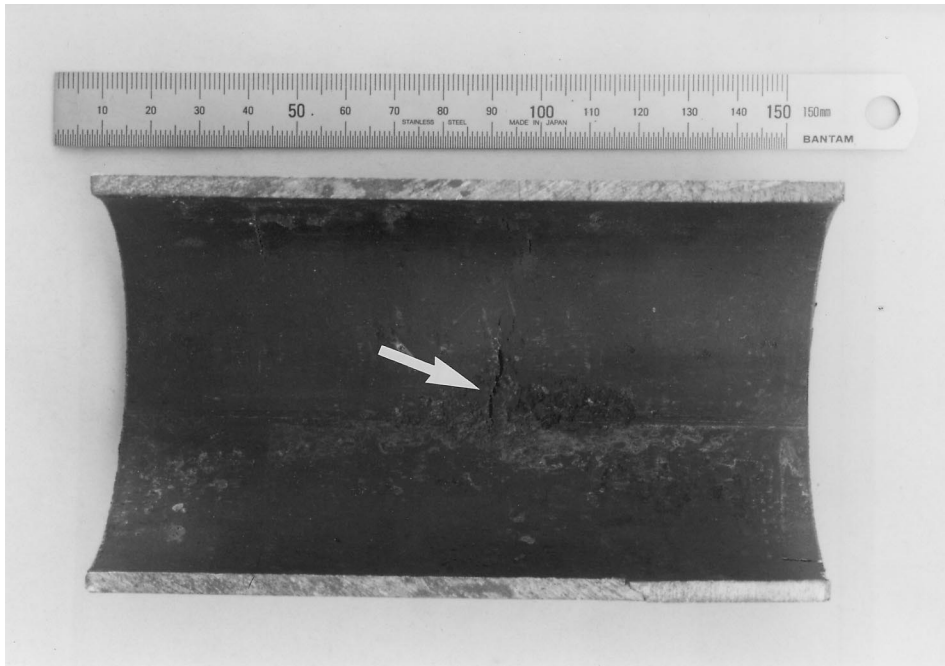
Fig. 4. Pitting and cracking (arrowed) visible in area of major leakage.

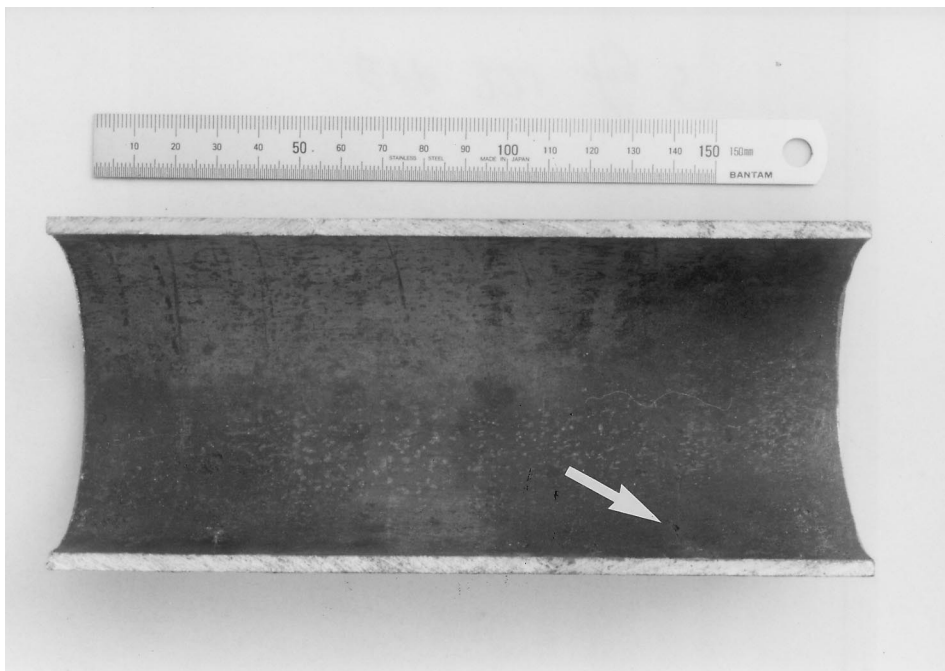
Fig. 5. Pitting and cracking (arrowed) at site of minor leakage.

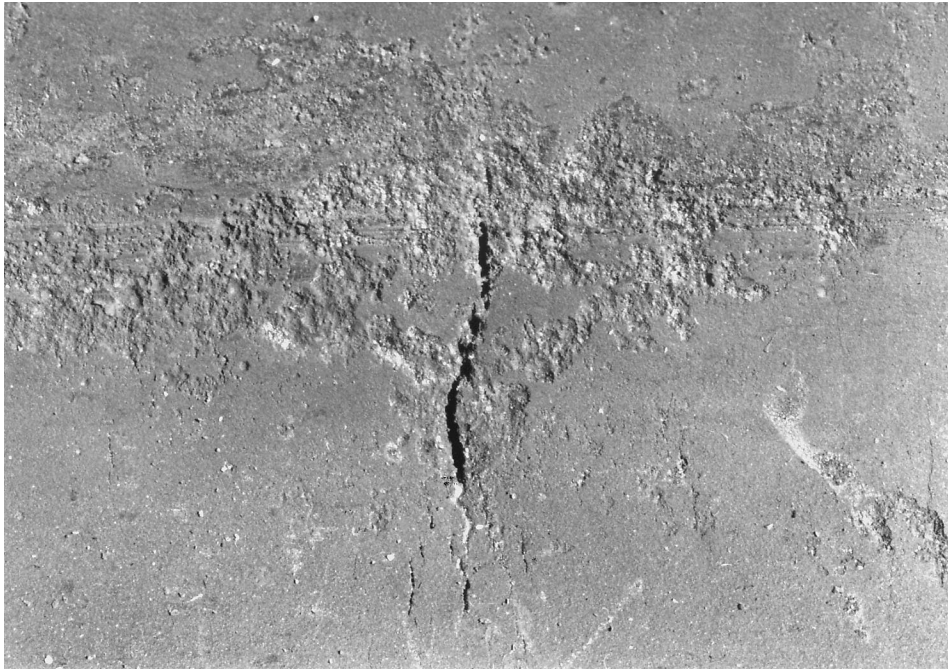
The pitted surfaces were examined under a stereo microscope at magnifications up to 65 \times . Many small pits, with transverse cracks originating from them, were visible. These surfaces are shown in Figs. 6 and 7, where the large through-crack and small through-crack are visible. The morphology of the pitting is consistent with that of oxygen pitting [1–3].

Fig. 6. Close up view of the crack at the point of major leakage.

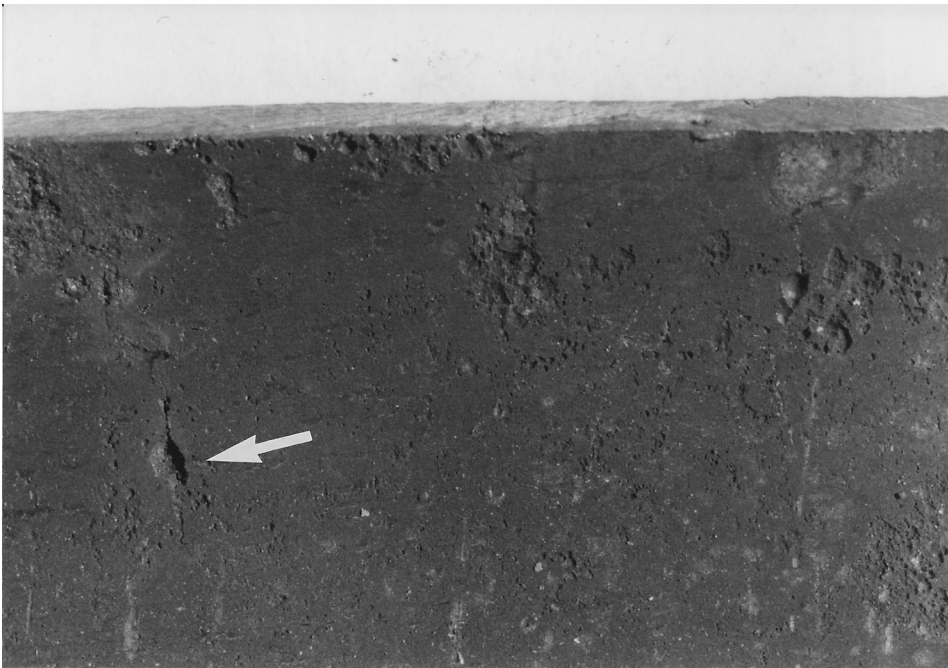
Fig. 7. Close up view of the crack (arrowed) and pitting at the point of minor leakage.

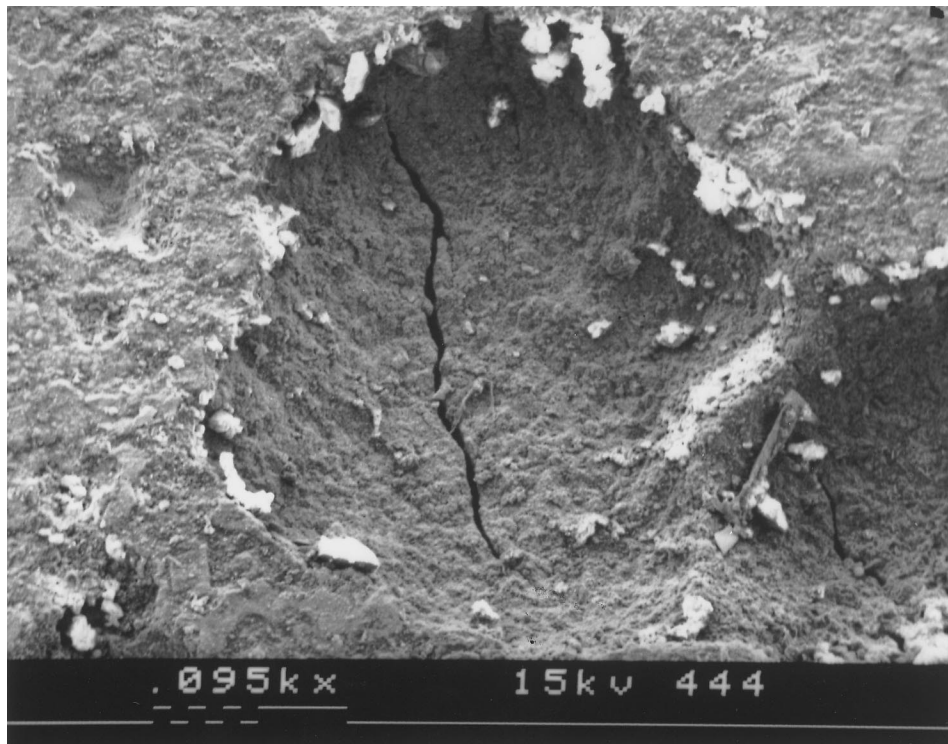
Examination of the pitted areas showed a majority of cracks to have started at pits, this being a result of the stress concentration formed by the pit. A clear example of this is shown in Fig. 8. Small, isolated cracks were found to have initiated in areas where no pits were present, but these were not responsible

Fig. 8. A fatigue crack initiated at the bottom of a pit.

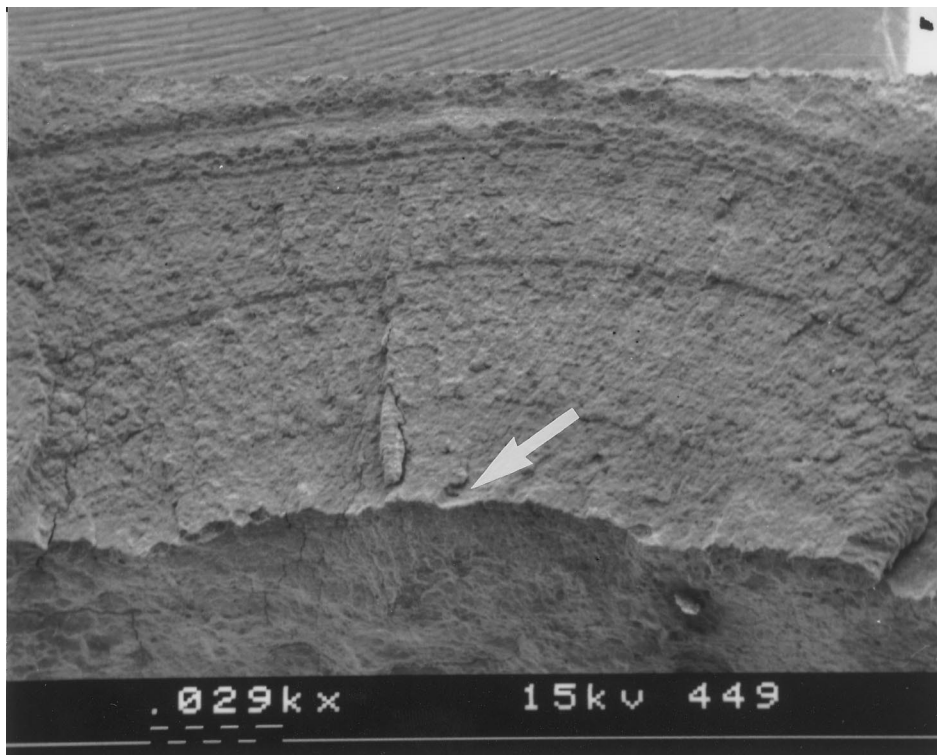
The fracture surface of the main crack was exposed, and an examination under the SEM clearly shows the cracking mechanism to be that of fatigue, as evidenced by the beach markings present on the fracture surface (Fig. 9). It can be seen that the fatigue has, as expected, originated from one of the many pits.

- (v) Vibration of the tubes can cause high cycle fatigue. The cracks were located on the bottom of the tube, the side of the tube which would experience cyclic tensile loads. This is due to the weight of the tube, which would place the bottom of the tube in tension. Vibrations can also explain the cracking at the tube support.

It is therefore most likely that the fatigue was caused by vibration of the tube, usually a result of a harmonic oscillation being set up.

Fig. 9. Fatigue beach marks present on major fracture surface. Note that the origin of the fatigue crack is a pit (arrowed).

The most likely cause of the cracking observed in the tube is vibrations caused by a harmonic oscillation. Obviously, the vibrations must be minimised or eliminated, if possible, either by changes in boiler operation or by changes to the support of the tubes. As it was very likely that other tubes (and possibly the steam drum) would have suffered damage, a thorough NDT examination was recommended.
