Safety in Mines Research Advisory Committee

Final Project Report

Survey and assessment of support for non-standard (anomalous) stope areas in the gold and platinum industry.

Research agency: Itasca Africa (Pty) Ltd

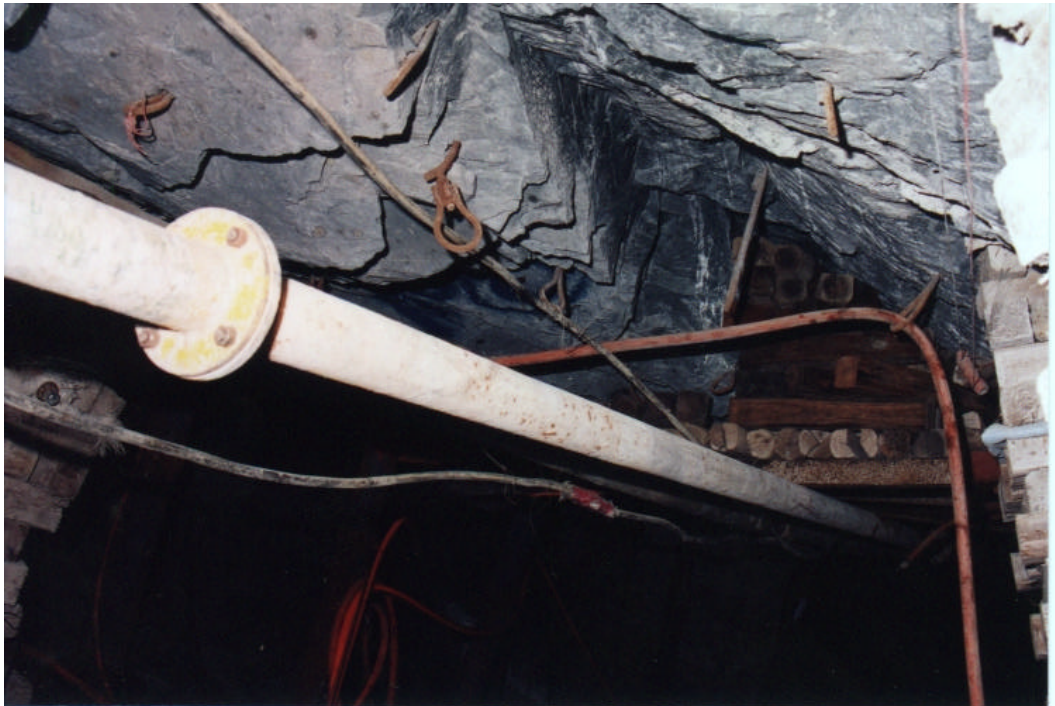
Figure 3.2: Typical joint-bound fall of ground along a reef drive on the VCR.

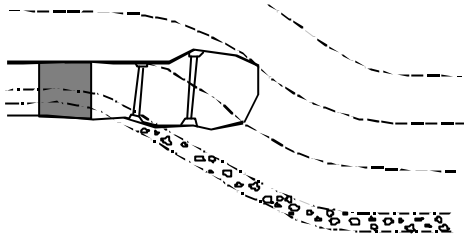
Problems caused by poor mining controls

1. Stopping advanced flat & fails to follow reef roll
2. Cuts through bedding in hangingwall causing loose blocks
3. Need to trench in footwall to follow reef

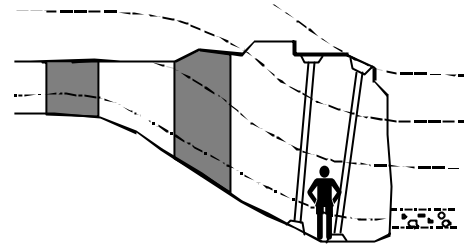
Problems caused by poor mining controls

1. Trenching to follow roll results in increased stope width
2. Now have very high stope face that needs undercutting
3. Due to face height support is less effective, leading to FOG and further increase in face height
4. Safest means of recovery is panel re-establishment by re-raising

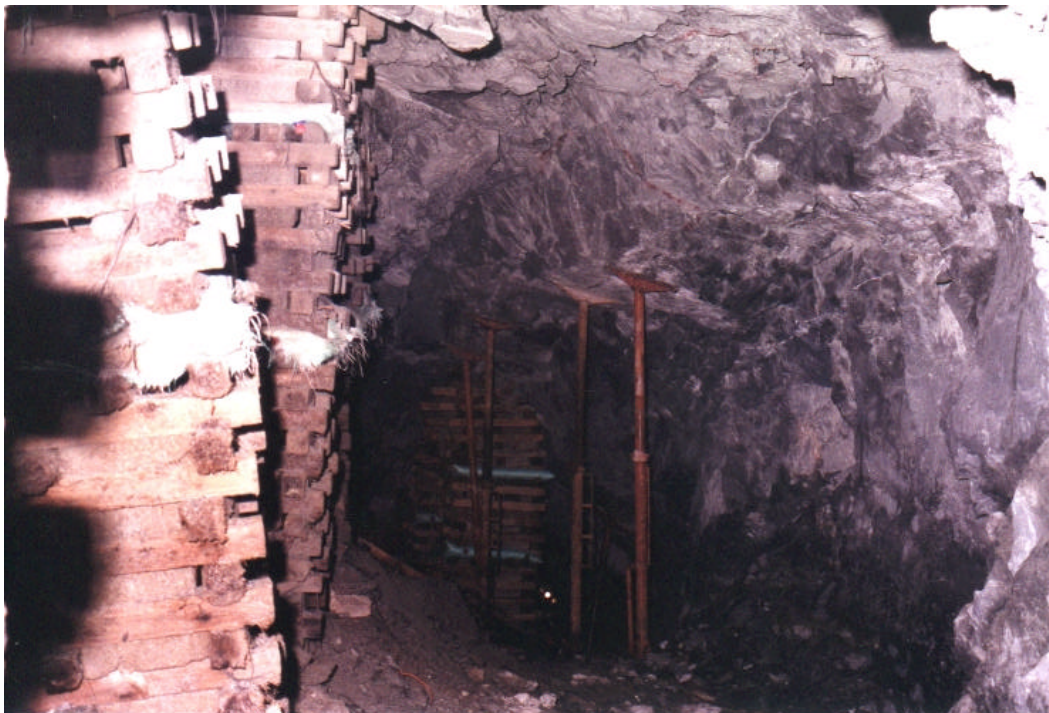
Figure 3.3: Loss of control in a VCR panel after encountering a roll. Reef is approximately 1 m thick at base of face (on the right), and 3 m of lava have fallen out. Tall packs and mechanical props are ineffective as support. The upper sketches explain the cause of the problems that arise with rolls. The high resulting stope face becomes prone to face-bursting in the hard, strong VCR lava.

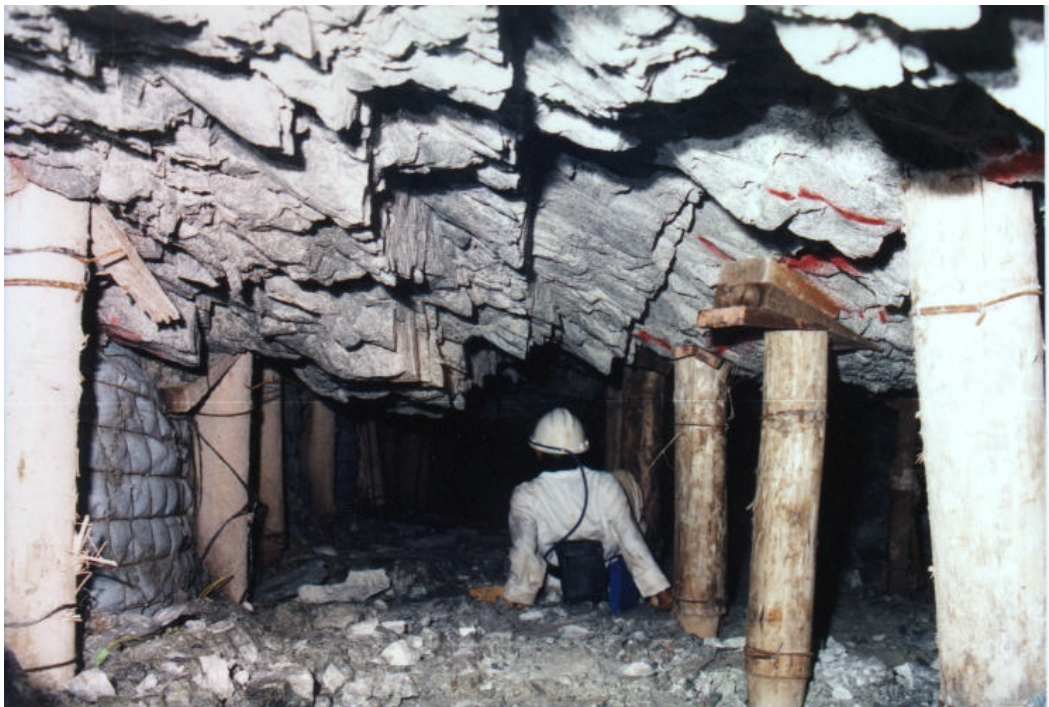
Figure 3.4 - Blocky hangingwall conditions arising from the interaction of jointing and stress induced fracturing when mining West on the Carbon Leader Reef at approximately 3400 m depth. In this instance in-stope ground control of these conditions is good.

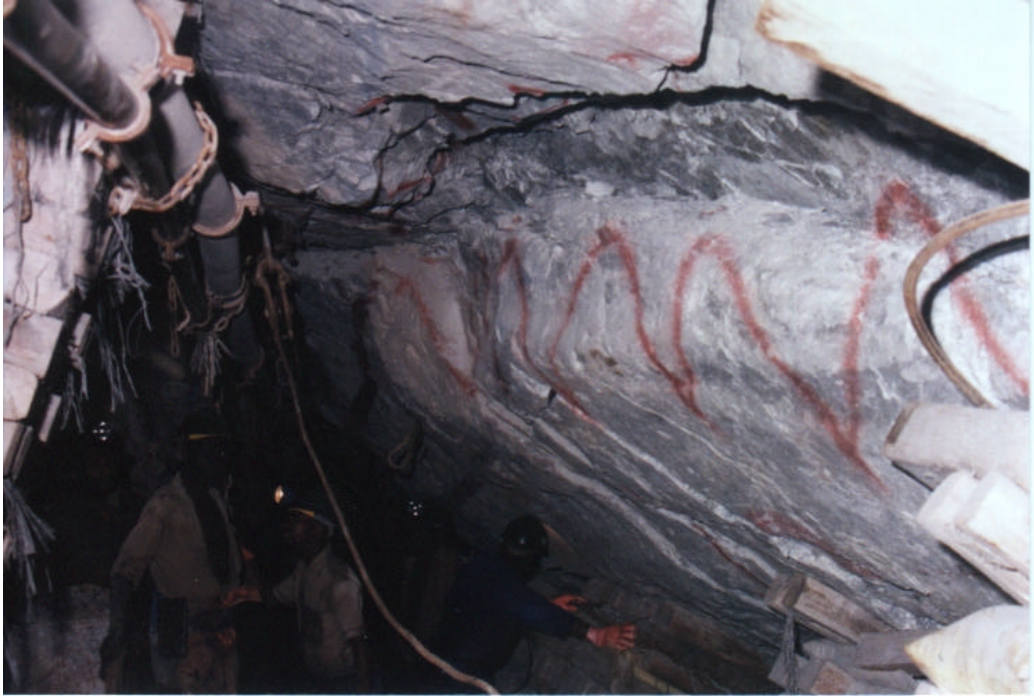
Figure 3.5. - Typical brow on Basal reef where shear parting rolls sharply upwards into the hangingwall. Rock is loose on the up-dip side of the marked brow (to the left), while the brow on the parting is generally stable.

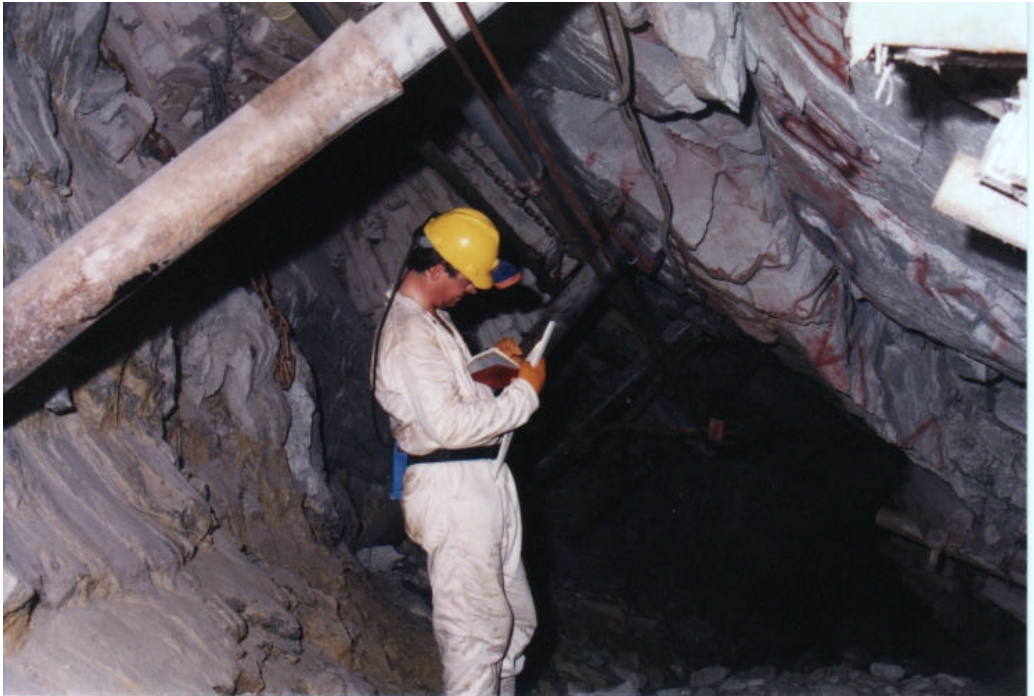
Figure 3.6 - Brows along a gully on Basal reef where bedding-bound blocks have collapsed. Rockprops are being used to control further collapse on the up dip side of the gully.

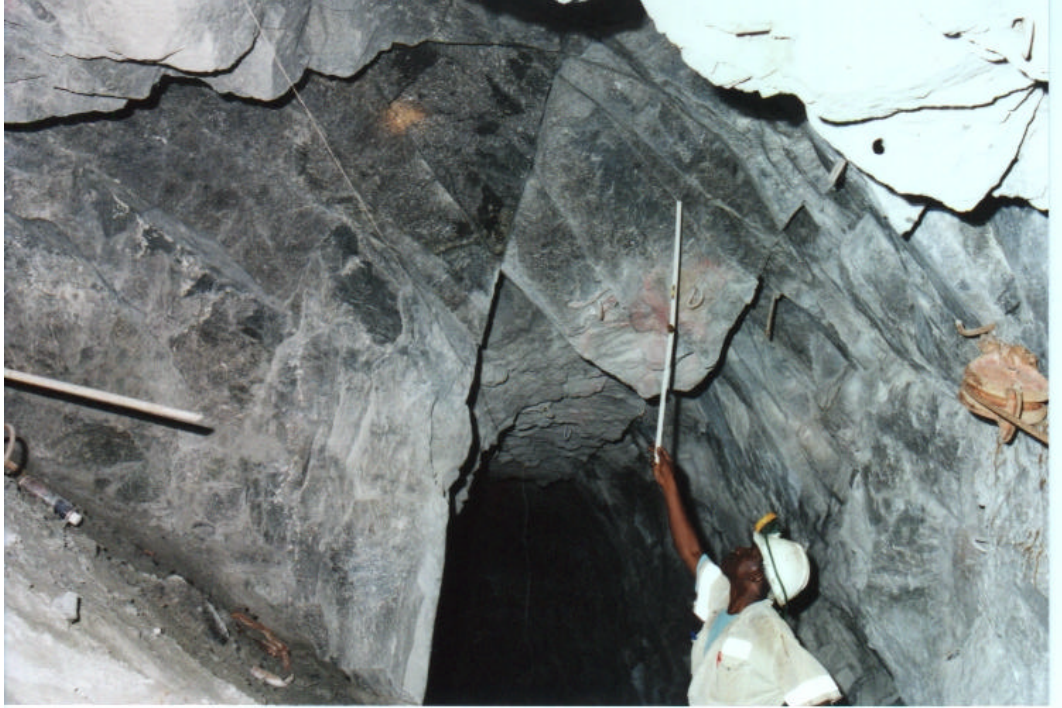
Figure 3.7 - Interaction of joints and a minor fault at shallow depth on the Merensky reef produce typical unstable wedges of ground in the otherwise massive rock mass. Example is at the face of a stope mining along a pre-developed reef drive.

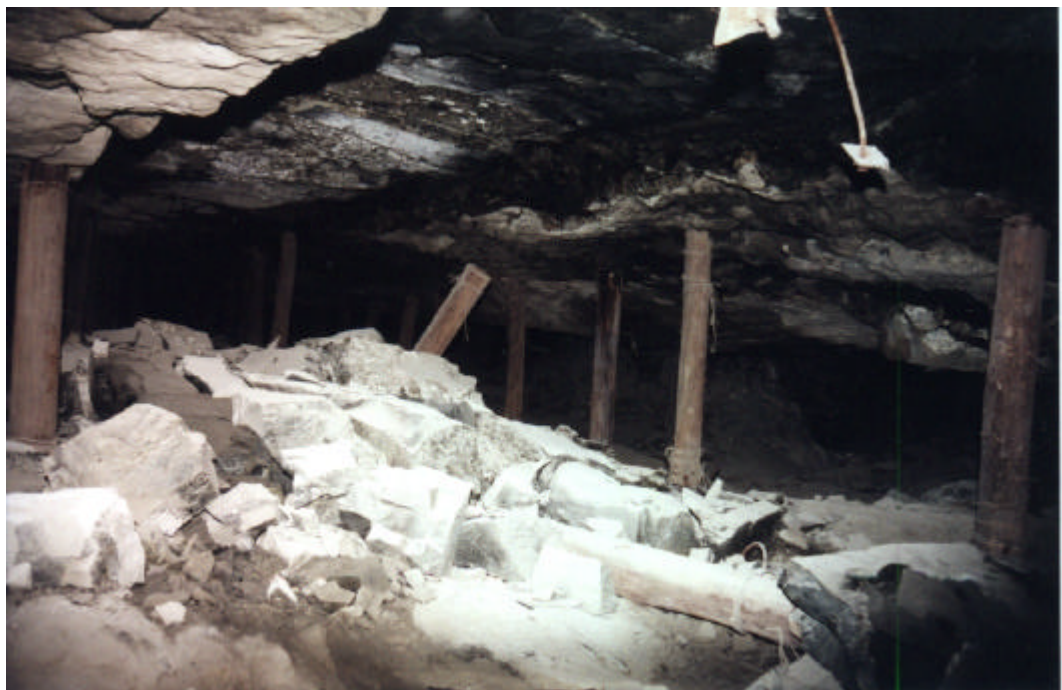
Figure 3.8 - Collapse of 0.5 m to 1 m of hangingwall within a 1.5 m wide dyke in a Merensky reef stope. Additional support is placed along the dyke contacts, but not beneath the dyke.

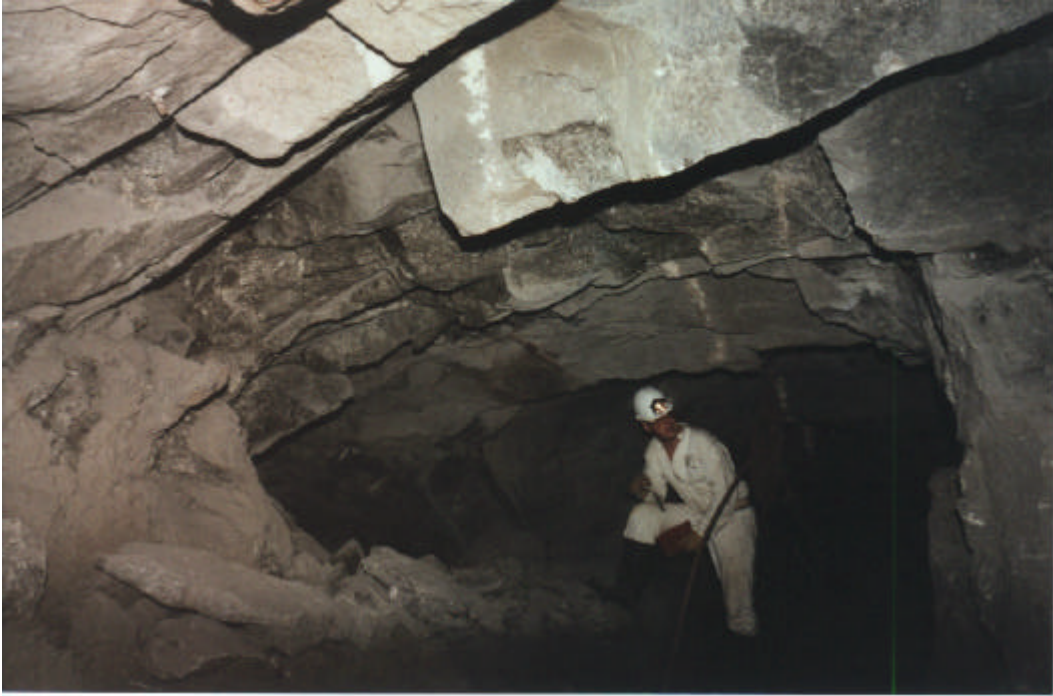
Figure 3.9 - Prominent jointing causing unstable conditions over a Merensky reef stope gully. An additional support pillar has been left on the up dip side of the gully, on the right of the picture.

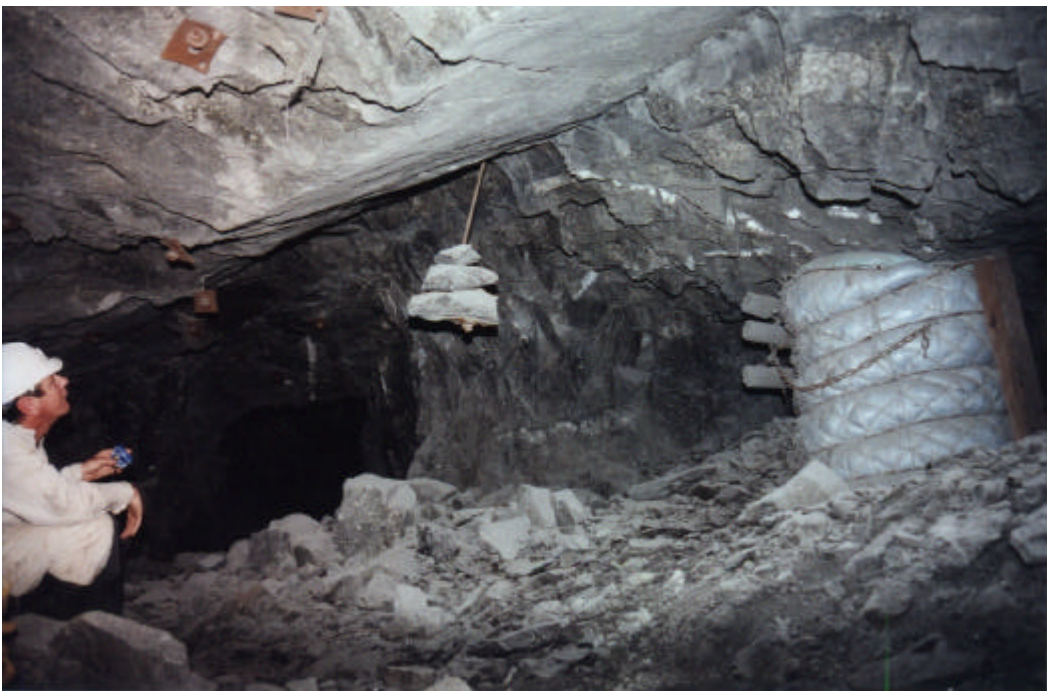
Figure 3.10 - Fall of ground associated with flat dipping sill on Merensky reef at 1800 m depth. Bolting failed to prevent falls in gully; RSS packs captured brow and prevented migration of fall into panel.

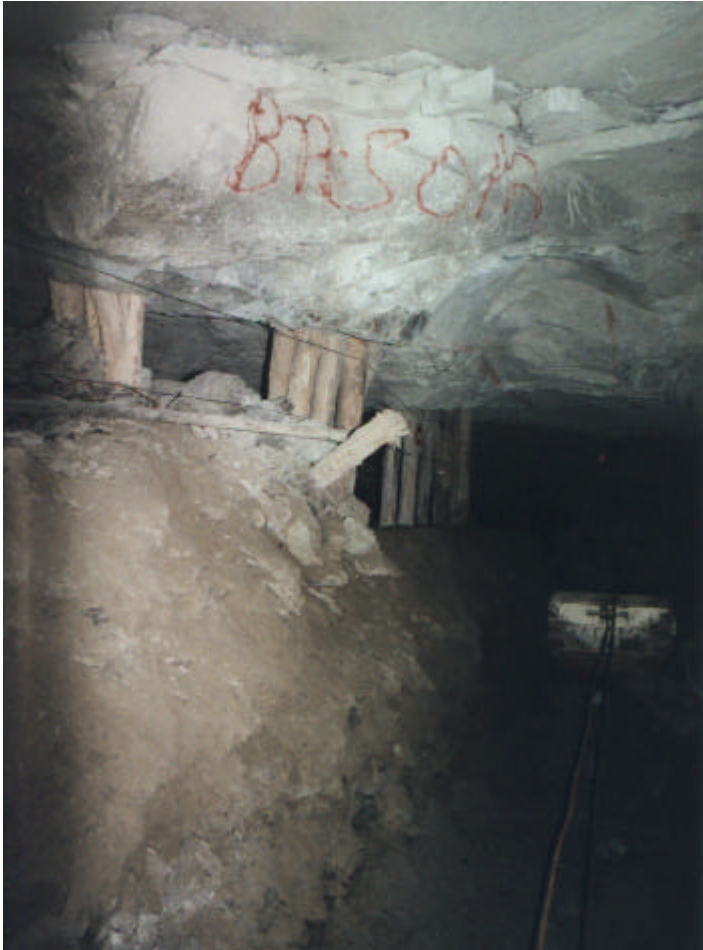
Figure 3.11 - 2.5 m high brow created by partial collapse of a dome on the Merensky reef. Controlled by stiff elongates cluster

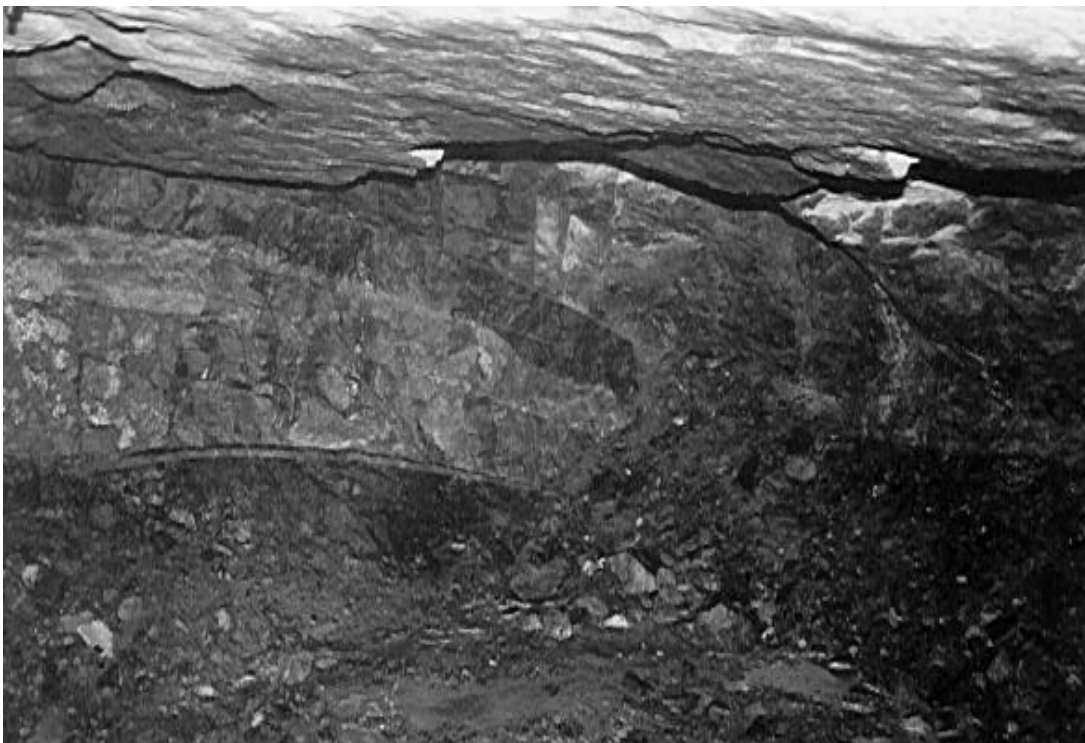
Figure 3.12 - Typical pothole showing rolling of the UG2 reef horizon in a platinum mine. Potholes are generally near circular or oval in plan and vary considerably in size from a few metres to hundreds of metres, with varying degrees of severity of roll. Mining has entered the hangingwall along the roll.

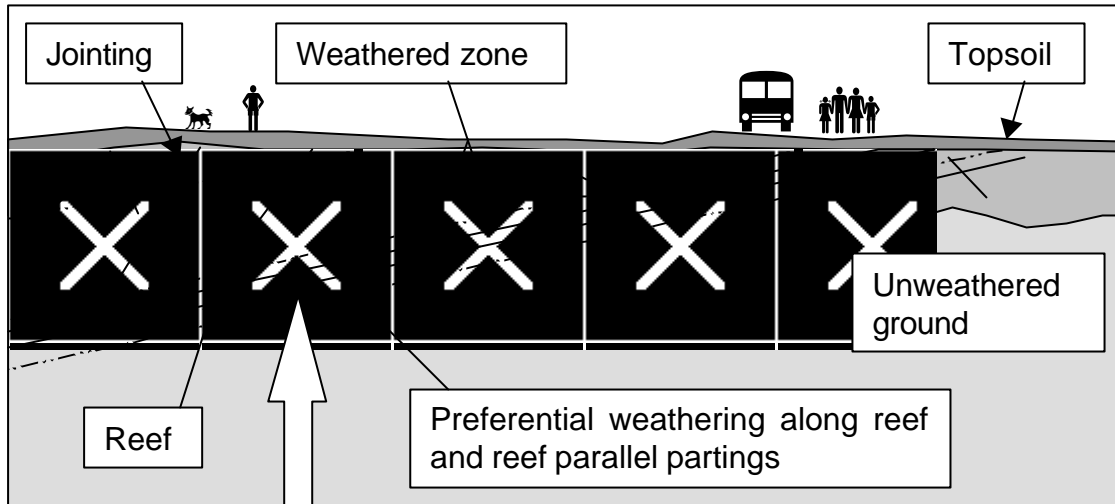
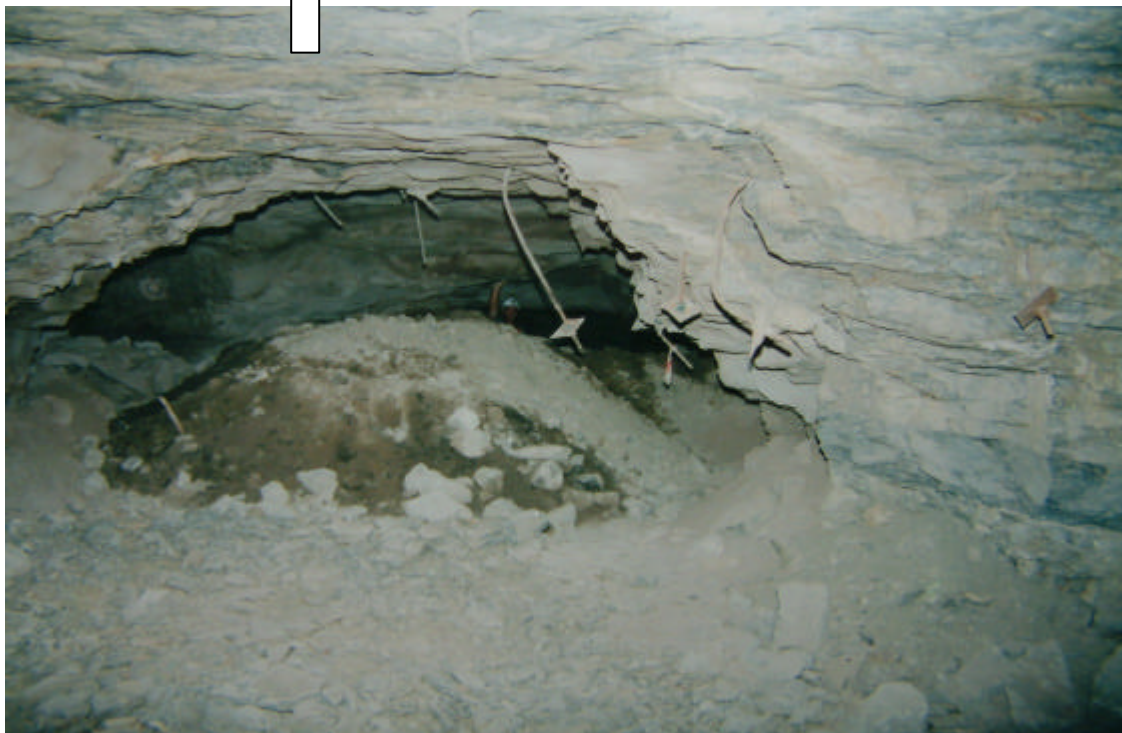
Figure 3.13 – In-stope collapse in a shallow platinum mine in highly weathered pyroxenite ground

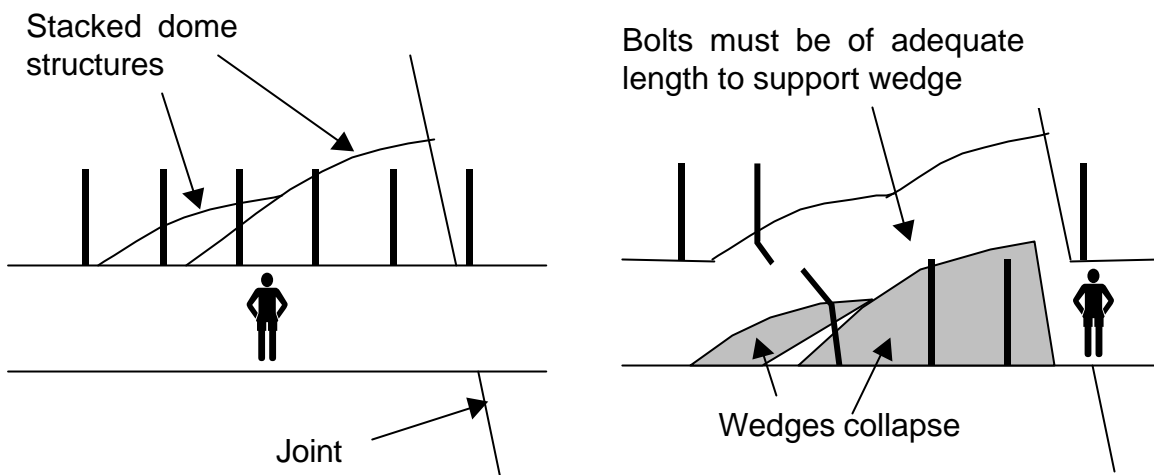
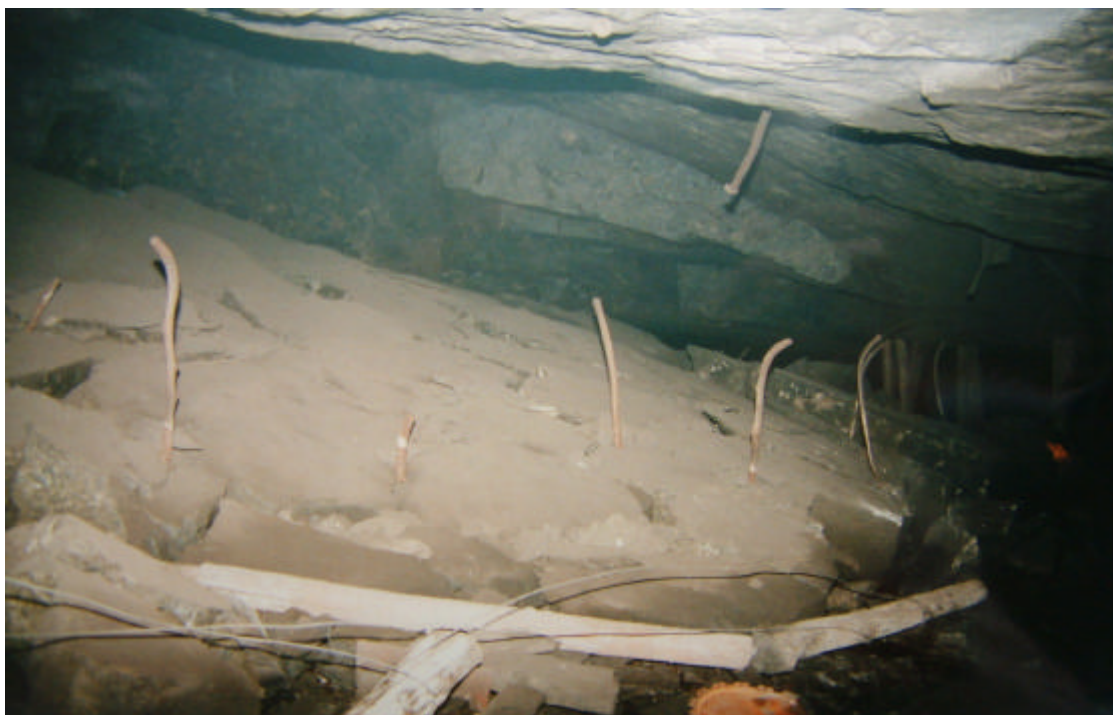
Figure 3.14 - Collapse of a major dome in a platinum mine at shallow depth: installed rebar bolts proved inadequate to support the large wedge of ground. In this example the wedge is approximately 50 m long, 8 m wide and up to 4 m high. The sketch, top, explains the mechanism.

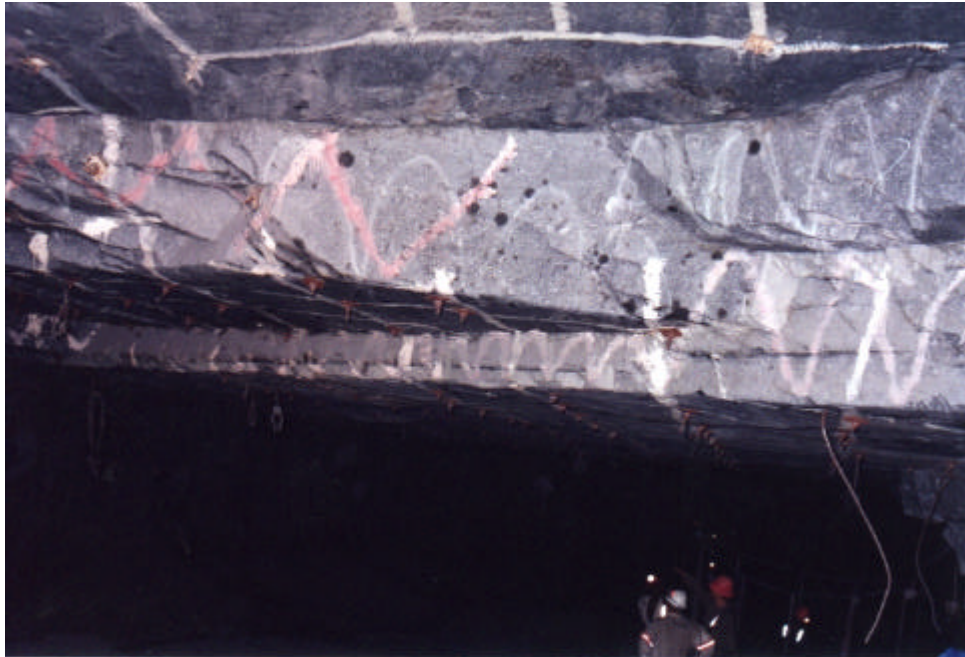
Figure 4.4 - Well identified (paint-marked) brows formed by distinct bedding plane partings, with additional pattern bolting support installed, on the Beatrix reef at approximately 850 m depth. Total height of the multiple brows is approximately one metre
