EVALUATION OF DAMAGE TO A ROAD AND SPORTS COMPLEX ON EXPANSIVE CLAYS

M B Mgangira

P. Paige-Green

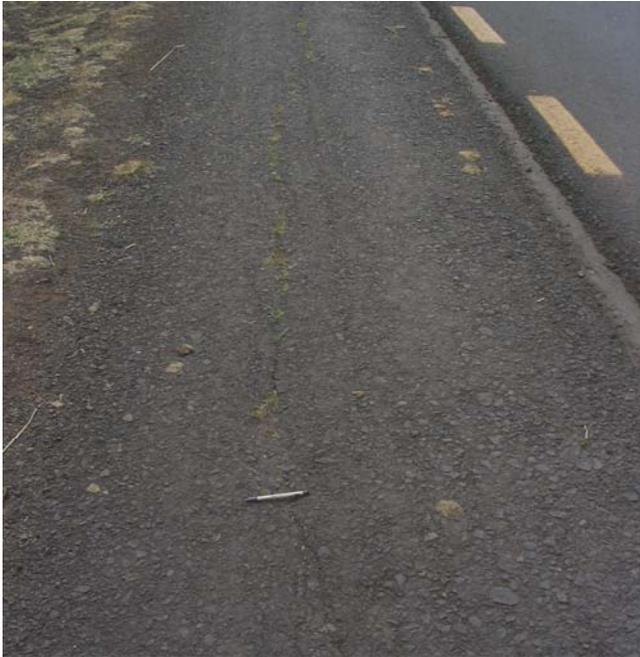
Figure 1 shows an example of the longitudinal cracking in the shoulder. Figure 2 shows a typical longitudinal crack in the asphalt observed along the roadway.

Fig. 1. Longitudinal cracking in the shoulder

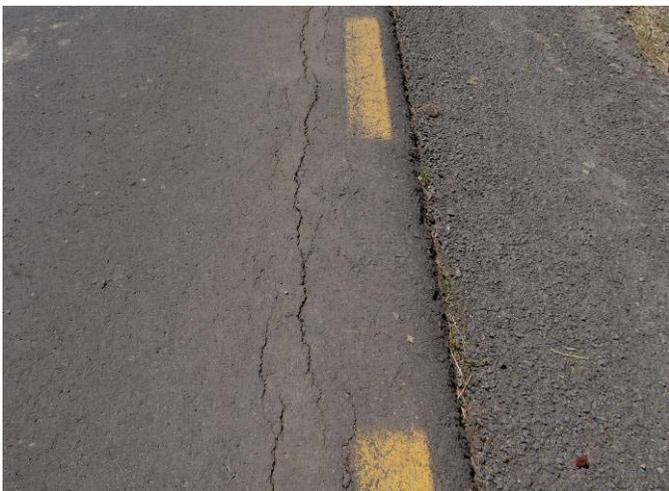
Fig. 2. Illustrative longitudinal crack in asphalt carriageway

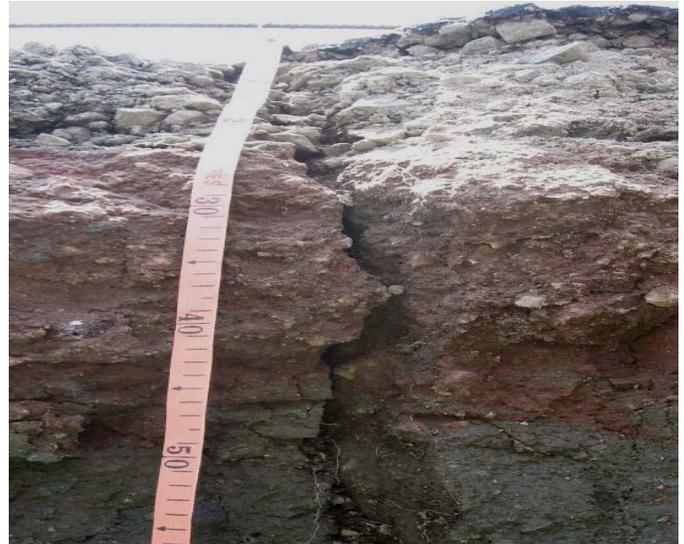
Test pit observations. Figures 3 and 4 show the crack propagation with depth as observed in two of the test pits. Figure 3 shows the crack at a shoulder location while Fig. 4 shows the crack propagation underneath the carriageway near the outer wheel track. The cracks pass through all of the pavement layers. While the cracks could not easily be discerned in the roadbed itself, the highly slickensided structure was indicative of the seasonal movement taking place within the clay.

Fig. 3. Crack propagation in shoulder

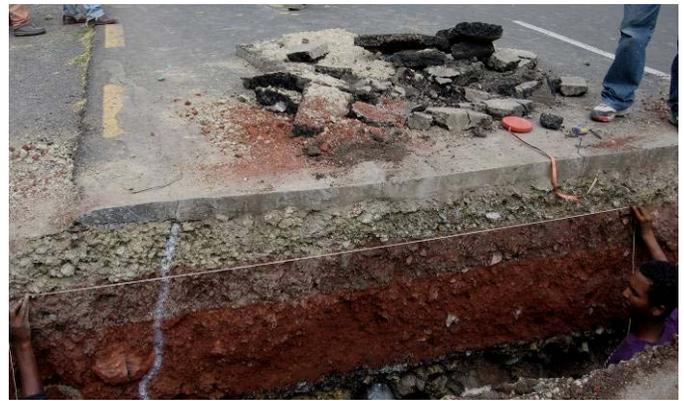
Fig. 4. Crack propagation in outer wheel track

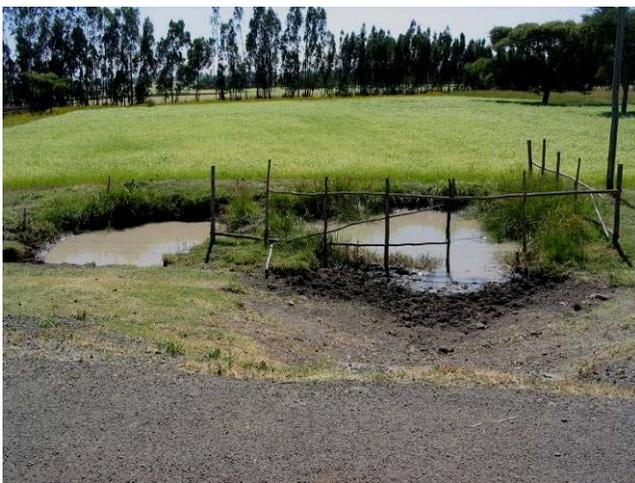
Drainage control. The generally flat topography of the area under investigation required that particular attention be paid to drainage to ensure that the surface rainfall does not accumulate near the roadway. However there were sections along the route where there was water ponding alongside the road (Fig. 6). This photo was taken during the last month of the rainy season and no rain had fallen for a week.

Fig. 6. Ponding of water adjacent to road

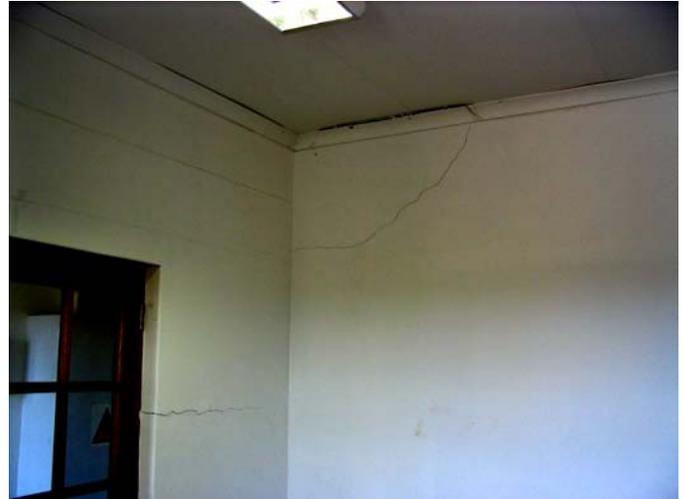
It is evident that the precautionary measures had an impact although the extent of differential movement of the foundations has a significant impact on many of the buildings. The installation of the concrete ring beams reduced the tendency for corner cracking but led to cracking parallel to them (Fig. 7) and between the groundbeam and window-level ringbeams. Corner cracking and movement of the ceilings, however, affected internal walls (Fig. 7), window frames and many of the floors were cracked.

Fig 7. Cracking parallel to ring beam (above window) and on internal wall

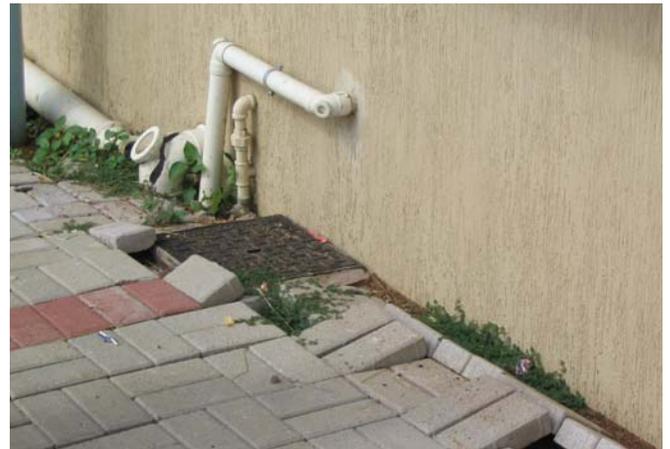
Although the wet services made use of flexible joints, the placement of concrete slabs and block paving against them “locked” them in and resulted in failures and subsequent leakage (Fig. 8).

Fig 8. Damage to wet services as a result of leaking paving

Aspects such as the placement of the block paving and/or concrete slabs adjacent to the wet services, the location of irrigation systems and drainage of water from air conditioning units need to be carefully considered. These measures are usually implemented at the end of the project under subcontract by people without a full understanding of the consequences of the actions.

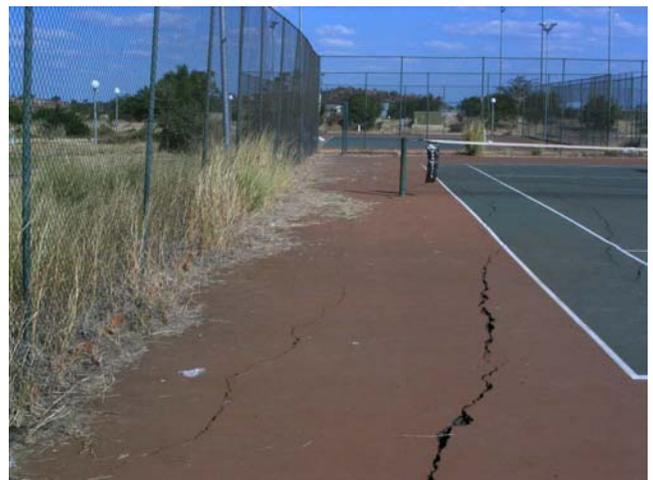
Other facilities such as tennis courts were placed on soil rafts. Despite this, the edges of the courts were subject to movement and cracking (Fig. 9).

Fig 9. Damage to tennis court – note distortion of fencing supports
