Characterization of Pavement Distress from Test Pit Observation

Martin B Mgangira, M. SAICE, Pr. Eng.

Senior Researcher, CSIR Built Environment, Mering Naude, Pretoria, South Africa:
mmgangira@csir.co.za

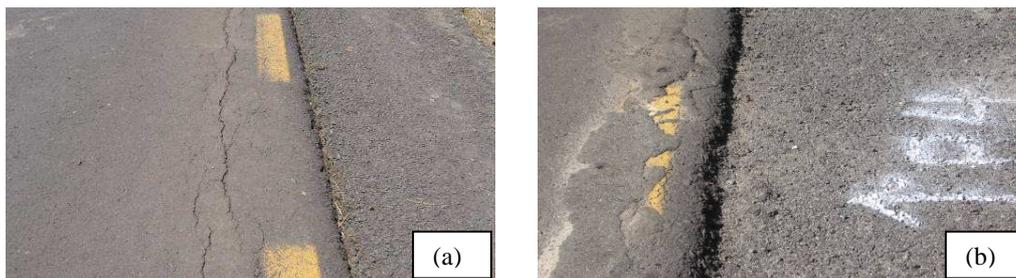
This section presents the observed form of distress within the pavement along the road as determined from the test pits. While pavement surface deformations were also observed, the most prevalent distress observed was longitudinal cracking near the edge of the pavement and along the shoulders Fig. 1 shows the typical conditions with respect to longitudinal cracking observed on the road. Fig. 1b shows a sealed crack.

FIG. 1. Typical unsealed and sealed longitudinal crack. Fig. 1a from Mgangira & Paige-Green (2008)

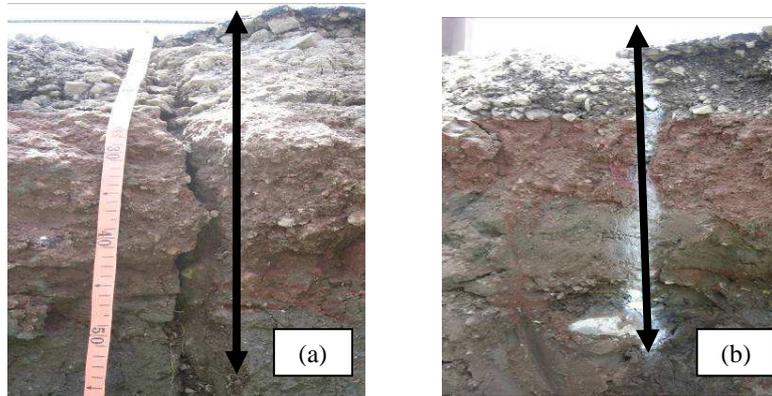
Cracks were also observed on the shoulders with very little or no differential elevations. Fig. 2 shows the crack propagation on the shoulders from two different test pits.

FIG. 2. Observed crack propagation on shoulders. Fig. 2a Modified from Mgangira and Paige-Green (2008)

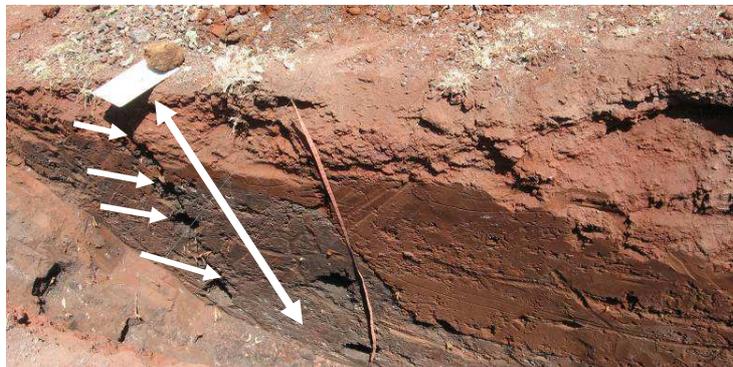
Fig. 3 shows the propagation of a crack in the in-situ material under the embankment. The reddish soil is the selected fill. The crack in this case is not vertical

FIG. 3. Crack propagation within the embankment

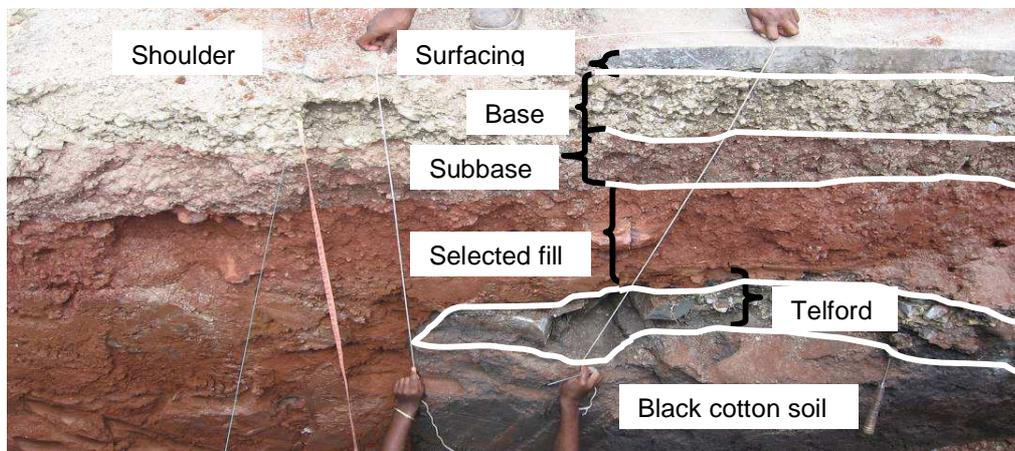
Fig. 4 shows the typical pavement structure. It also shows the general orientation of the crack at this test pit, which is again not vertical.

FIG. 4. Typical pavement structure

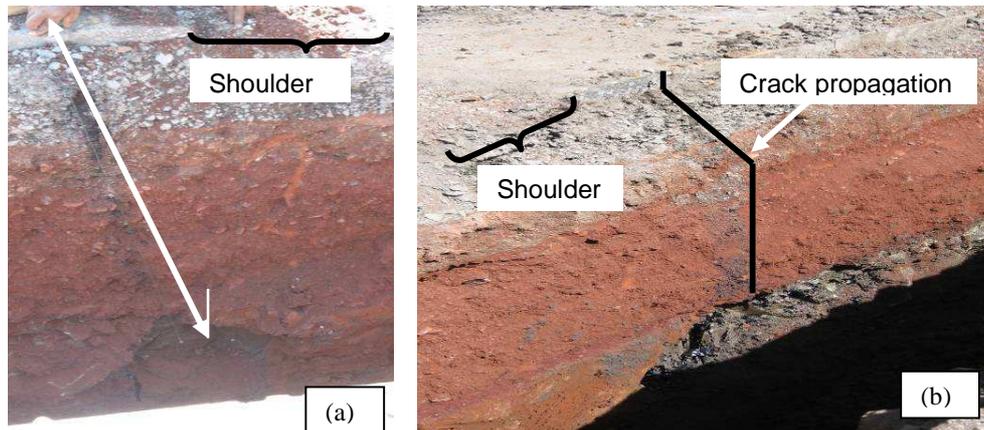
that the orientation of the crack is again not vertical and that it can also change direction within the pavement, Fig. 5b. Note the binder flowing out of the Telford which came from the crack sealing. What it means is that only the upper portion of the crack was actually sealed. Fig. 6 shows the crushing experienced by the subbase under the area with surface depression within the outer wheel path.

FIG. 5. Observed different crack propagation

Based on test pit observations it has been possible to elucidate the nature of distress within a pavement that failed prematurely as a result of the highly expansive roadbed on which it was built with inadequate measures taken into account during the design for minimizing the effects of moisture changes and the associated volumetric changes. In addition test pit observations have shown that the longitudinal cracks are not always in a vertical plane with depth, they may vary in orientation within the pavement. This observation has practical implication when performing crack sealing maintenance work. When deciding on a crack sealing exercise determination of crack orientation is essential otherwise crack sealing is only effective within a limited depth.

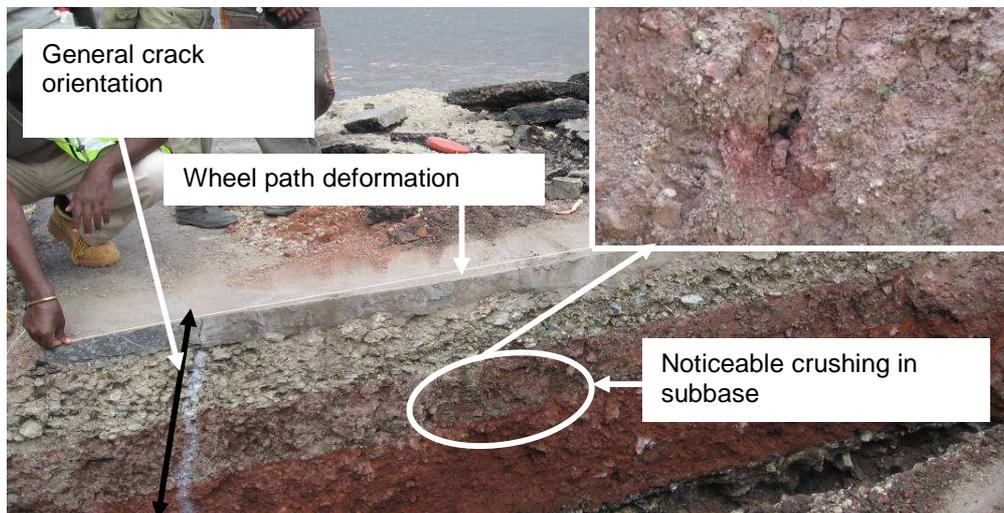
FIG. 6. Observed form of distress

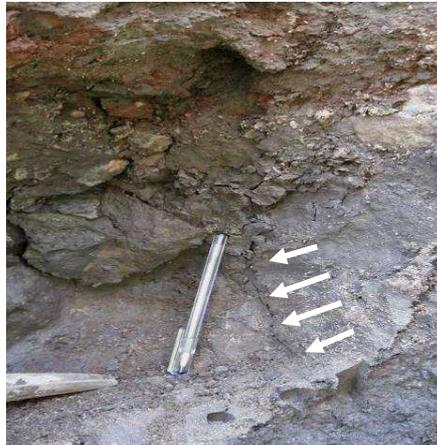
highly slickensided structure was indicative of the seasonal movement taking place within the clay. Fig. 7 shows one of the rare situations where it was possible to discern the crack propagation within the black cotton soil subgrade. It shows for all practical reasons a vertical crack.

FIG. 7. Crack propagation within the black cotton soil subgrade
