String Fault Finding on the Single Axis Tracker Photovoltaic Plant

Mudau Unarine ¹, Pratt Lawrence², Duma Talent ³ and Nithin Isaac⁴

This paper will describe the diagnostics and repairs done at the single axis tracker solar PV plant after the lightning strike in April 2019. The results before, during and after fault finding will be discussed as well as the overall lesson learned during the fault finding process.

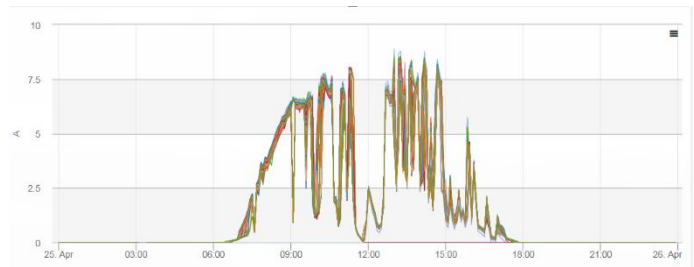
Figure 2 String level DC current on 25 April 2019

Figure 2 below shows the DC current of 11 strings from combiner box GD800 on the 25th of April 2019. At 11:45 the DC current of all strings started rapidly dropping to zero due to a large storm system that caused the global horizontal irradiance to drop from 110.43 W/m² to 12.71 W/m² in a matter of 15 minutes. Lightning and thunder was reported by observers in the area. After the heavy storm clouds passed, the DC current from all the strings except for one returned to expected output given the variable clouds. The current from “GD800 left I5” producing 0 current, is shown on figure 2.

The output current remained 0 until the following afternoon when troubleshooting began.

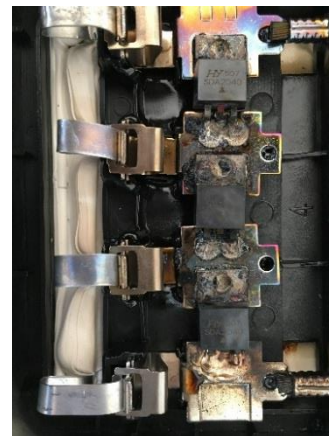
Figure 3 Charring inside the junction box of a damaged module

Figure 3 shows the inside of the junction from one of the damaged modules. Three bypass diodes are still intact, but interconnection bridge shows signs of charring.

After the initial inspection was completed, two PV modules were replaced with remaining spare parts and three were bypassed because of a shortage of spares. The string was left with 17 modules in series until more spares could be acquired. This will result with the string producing less voltage than the other strings, but the current should remain the same as the other strings in parallel. The GD800 left I5 string power will be low compared to other strings of the same rating on the same combiner box.

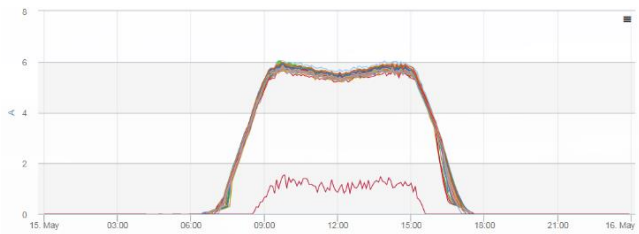
Figure 4 GD800 left I5 string current after two modules were replaced

The monitoring system continued to indicate low current of the faulty string, as shown in Figure 4. The string DC current measured only 25-30% of the other strings in the box. A clamp on DC amp meter also measured low current when the string was connected to the combiner box despite the short circuit current of each module measuring fine when measured individually.

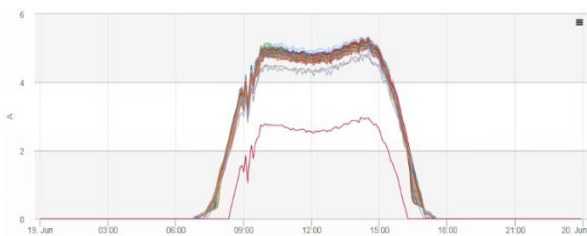
Figure 5 GD800 left I5 string current after all modules were replaced on faulty string

Figure 5 below shows the DC string current after the remaining damaged modules were replaced on 18 June 2019. Even after the remaining modules were replaced, the DC string current output continued to measure low.

The string current increased to roughly 50% of expected, but still below the DC current produced by the other strings in the same combiner box. Further testing was done on the 21st of June to test the maximum current (I_{mpp}), maximum voltage (V_{mpp}), short circuit current (I_{sc}) and open circuit voltage (V_{oc}) per module using the IC Curve tracer and the results are stipulated on figure 6 below. The results indicate each module was performing as expected.

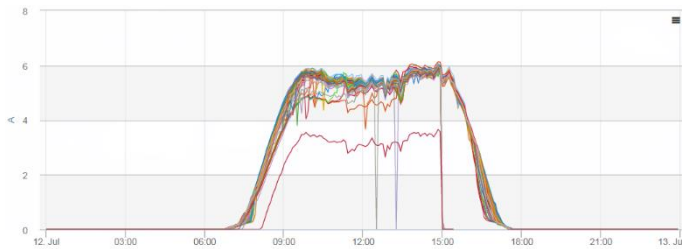
Figure 9 D800 left I5 DC string current (red colour) on the day the monitoring circuit board was replaced.

After testing the combiner box, we realised that all the measurements are fine. There is nothing showing that there's a fault on the combiner box. When we checked on the monitoring software we realised that there's still a low current on the GD800 left I5 DC string. A further testing was done to check if the fault is in the string monitor inside the combiner box. The string monitor board was replaced with a new string monitor board and all the DC string currents finally matched. Figure 9 shows the GD800 DC power before the string monitor board was replaced, the figures show that the GD800 I5 during fault it was producing less current and the Figure 10 shows the results as displayed on the web portal.

After replacing the 5 PV modules and burnt fuses, a major fault was the monitoring system circuit board which was giving us false signals, causing delays in determining the root cause of the fault. Further investigation on the monitoring system circuit board still needs to be done. As much as there was no supporting evidence that the lightning caused all the damage, there is a high possibility that it was lightning that damaged the PV modules, burnt fuses and damaged the monitoring circuit board and the surge protection device (SPD) did not protect the monitoring system circuit board because it is connected before the SPD.
