Safety In Mines Research Advisory Committee

Causes of Falls of Roof in South African Collieries

**J.N. van der Merwe
J.J. van Vuuren
R. Butcher
I. Canbulat**

**March 2001
Revised August 2001**

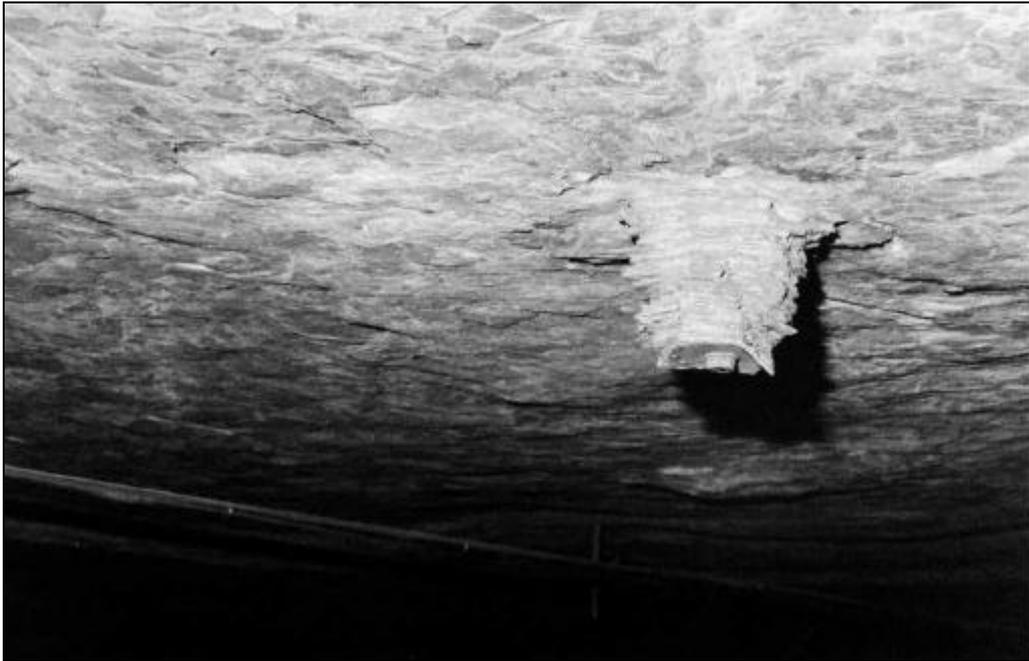
Figure 9. Illustration of a roof fall with island bolts, indicating excessive bolt spacing.

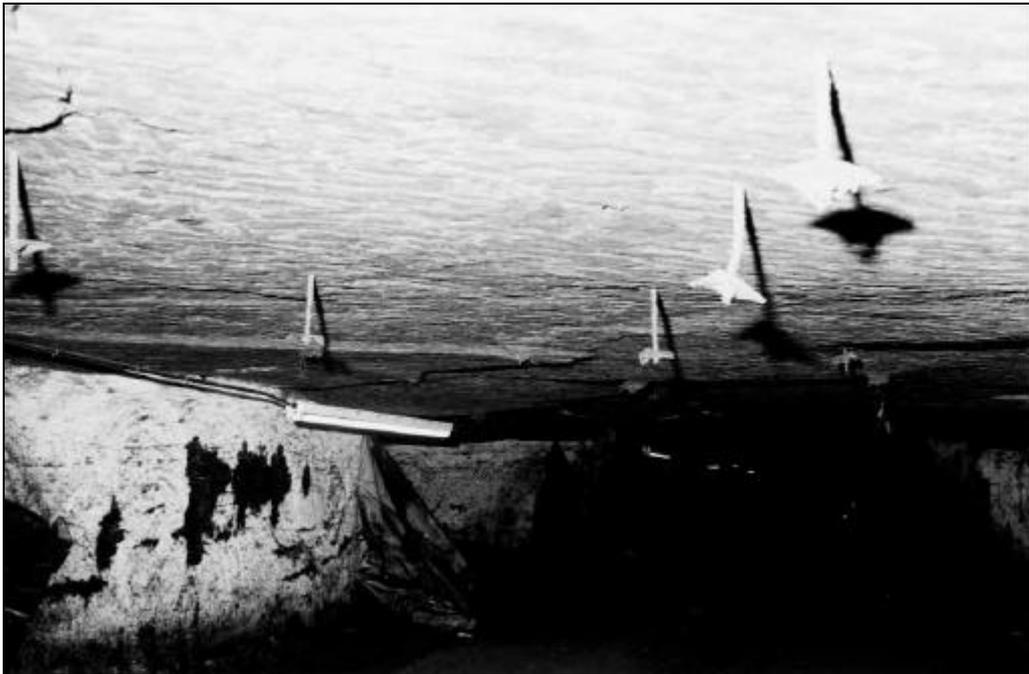
Figure 10. Illustration of a fall with free hanging bolts, indicating insufficient tension or excessive bolt spacing. This roof is now unsupported.

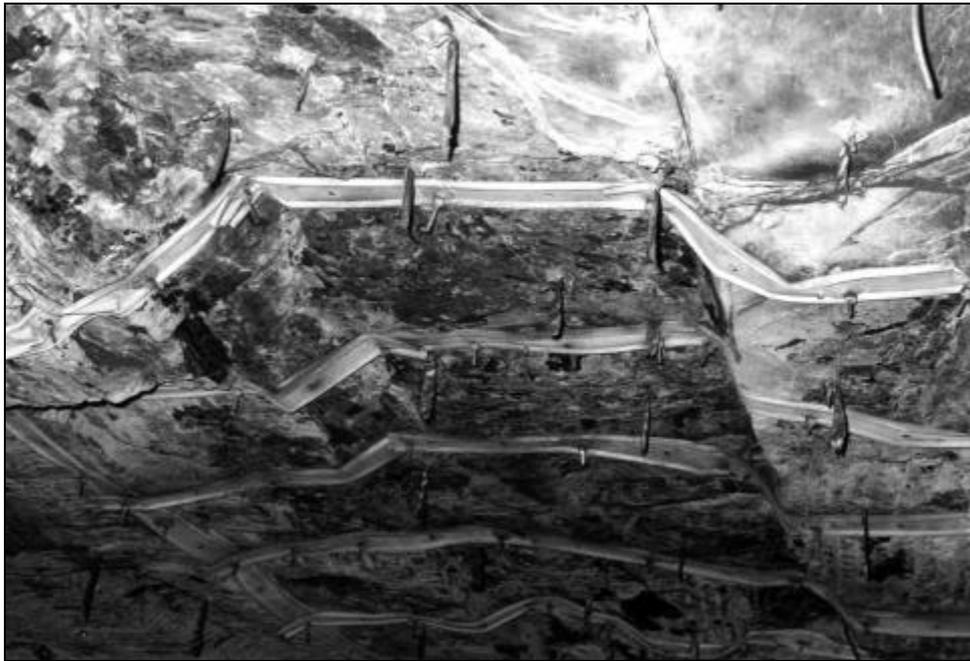
Figure 12. Example of a roof fall that was caused by insufficient joint support. The W-straps in the photo were installed after the roof fall had occurred.

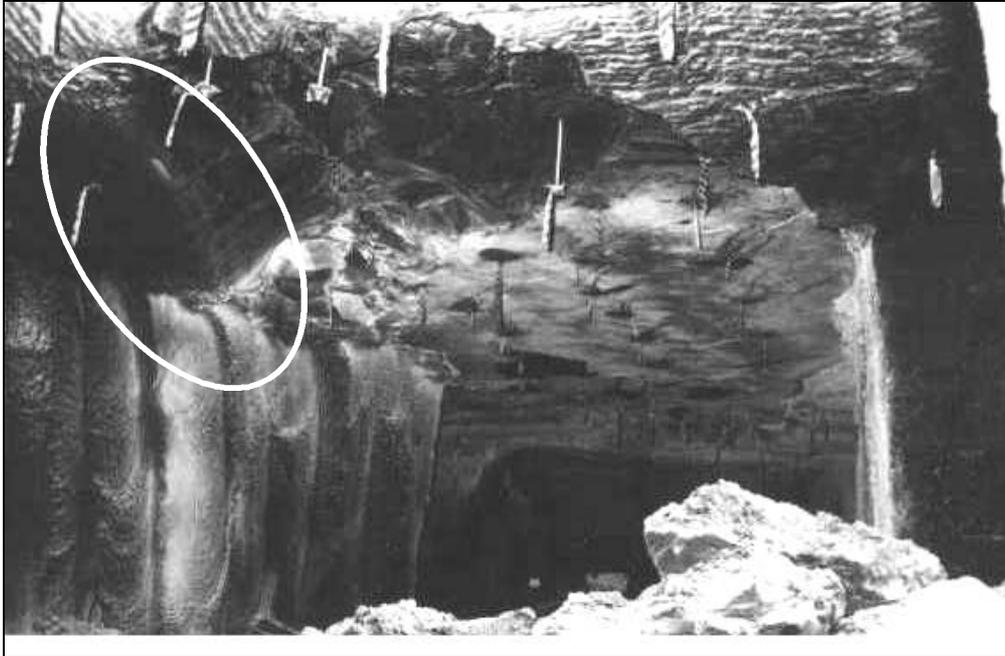
Figure 16. Example of a Large Fall that occurred after the installation of support caused by insufficient joint support. The ellipse indicates the joint plane without support.

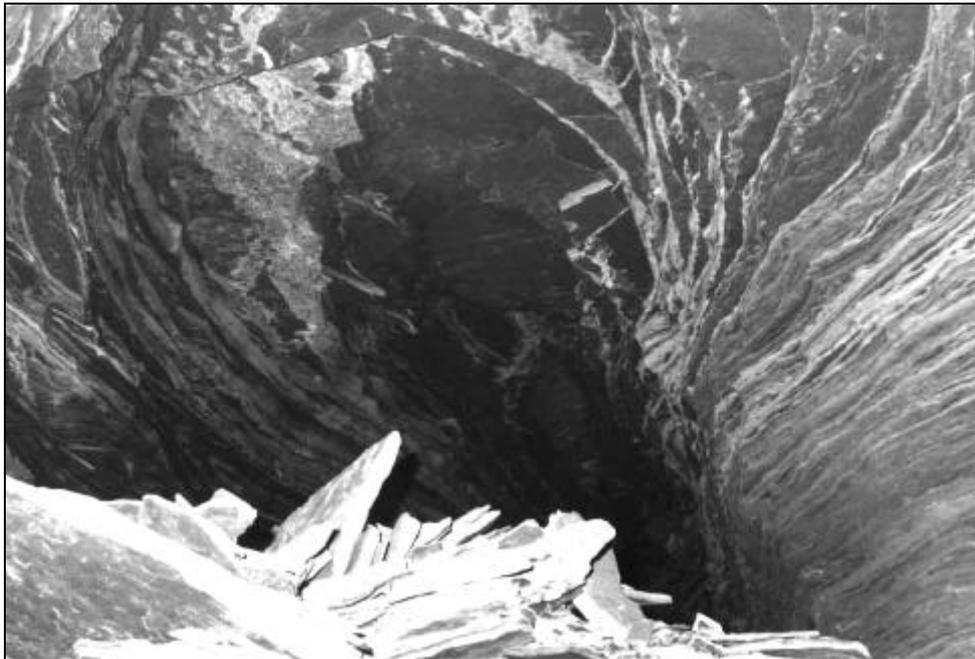
Figure 20. This fall was classified as Major. It occurred after support had been installed and was classified as being caused by horizontal stress. It occurred in the vicinity of a dyke.

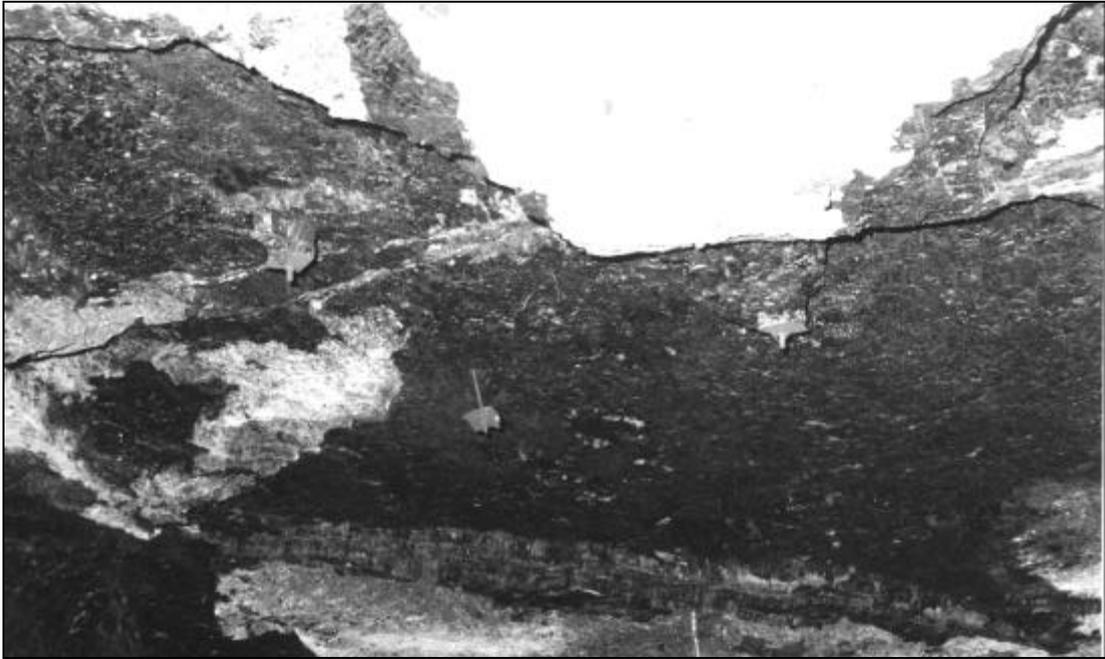
Figure 35. Skin fall caused by failure between bolts that were spaced too widely.

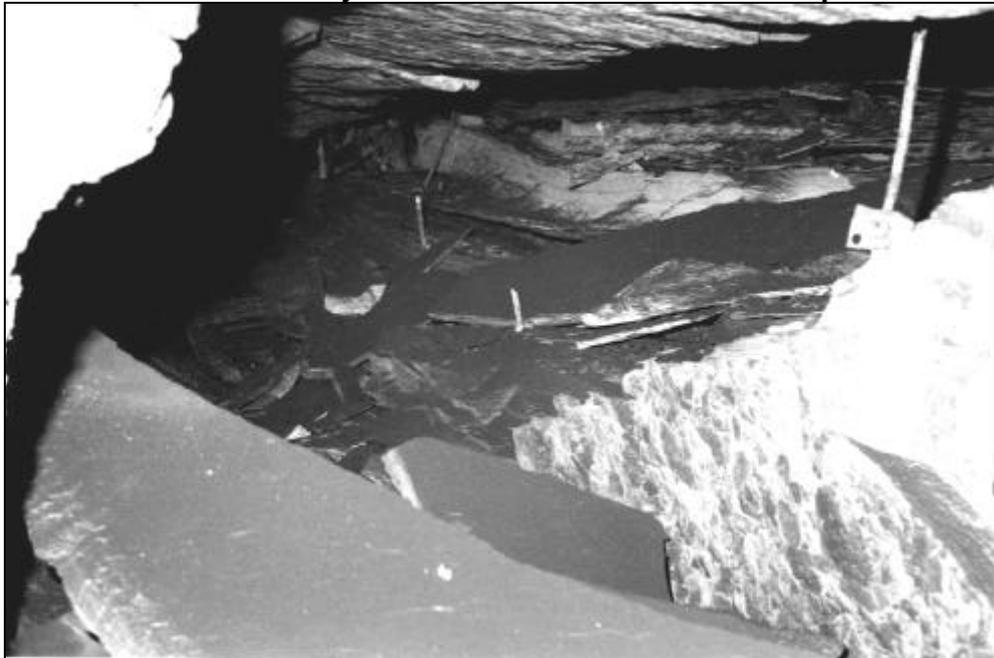
Figure 36. Major fall that was caused by a bolt system failing at the weakest link, the resin contact. A denser bolt spacing would have prevented this fall.

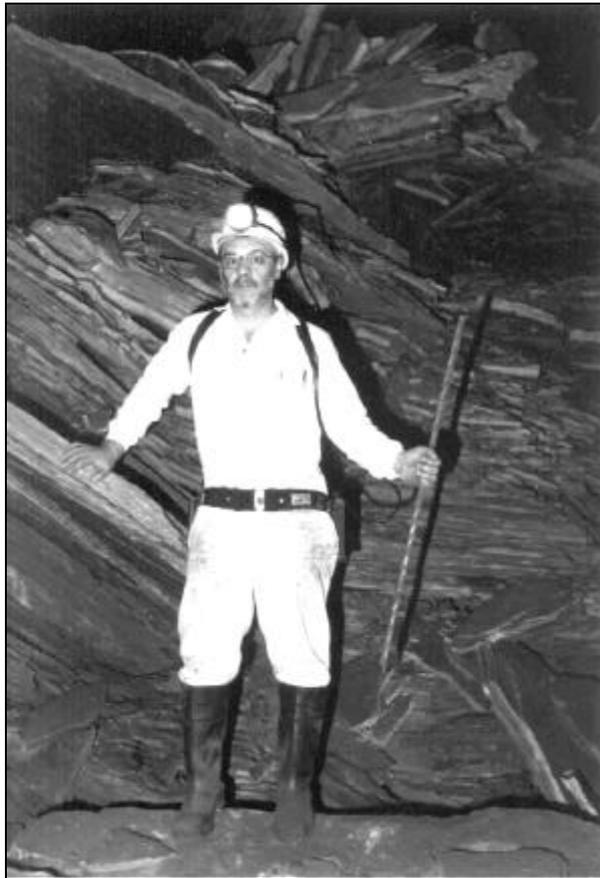
In two other cases, suspicious lengths of cut-off cable were found in places where cable anchors had been installed by outside contractors. The lengths of the cables to be installed are usually specified by contract and are delivered in the correct length. There is no reason to cut cable to the required length underground. However, it was not possible to retrieve full lengths of installed cables from the fall debris to check the installed length of the cables.

Figure 37. Was the fall in the background caused by cutting lengths off cable anchors like the one shown in the photograph?

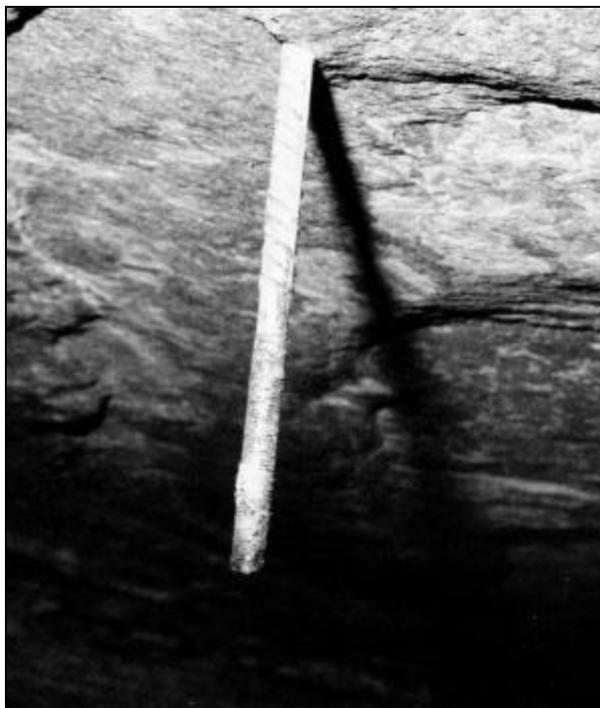
In one fall, it was found that the nuts had stripped off the bolts, shown in Figure 38, resulting in a major fall of roof. The thread should not be the weakest part of the bolt assembly. It is suspected that in this case, either the diameter of the thread was too small or the diameters of the nuts were too wide.

Figure 38. The smooth appearance of the thread on this bolt was due to the nut having stripped off on it.

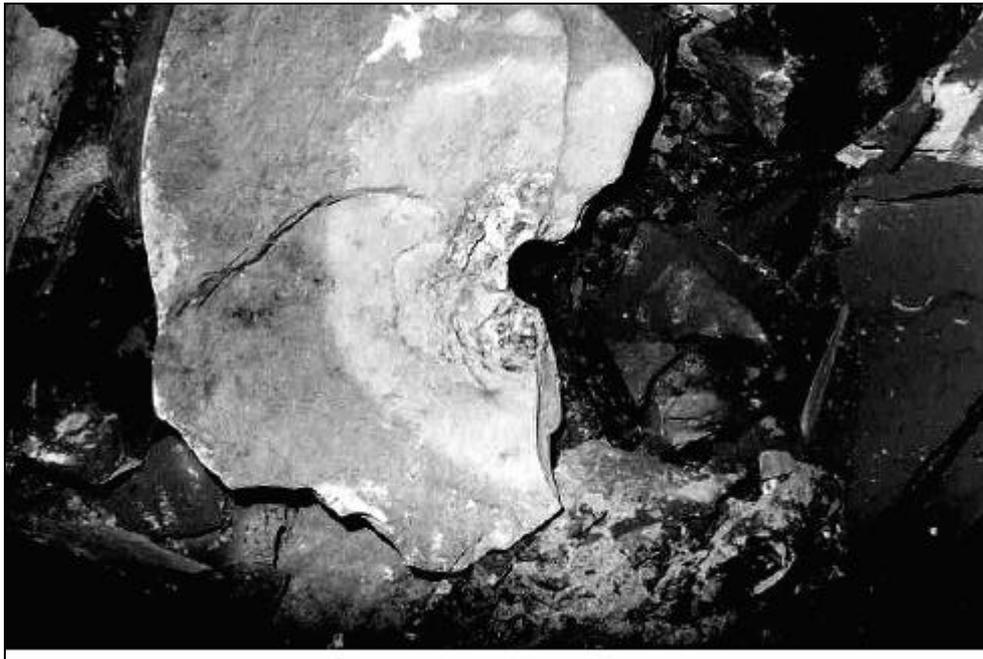
Figure 5. View of the stress damage around a roof bolthole.

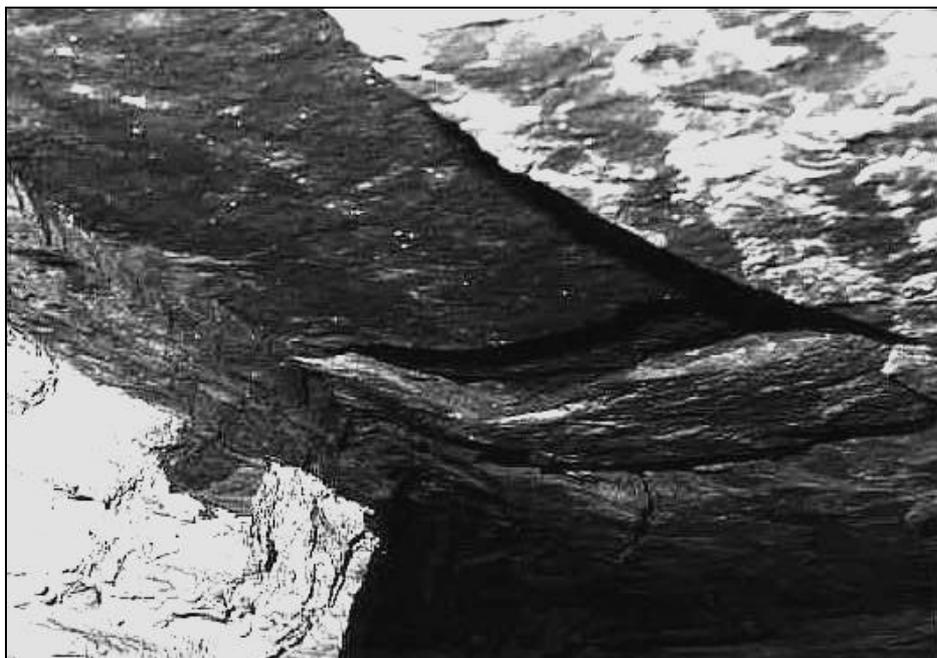
Figure 2. *Buckling of the nether roof layer*

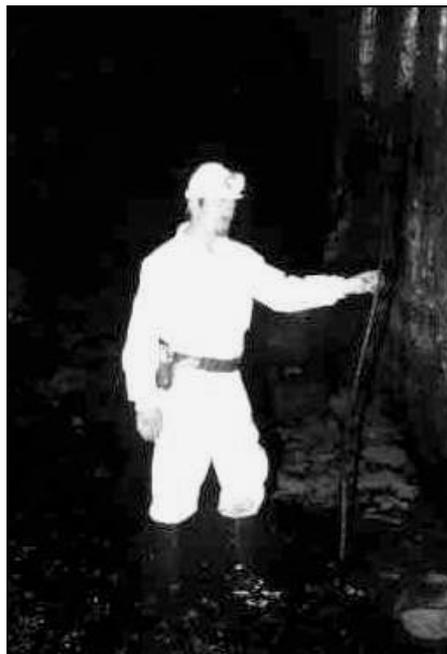
Figure 2. *Worker holding the cable cut-off that was found in the section.*

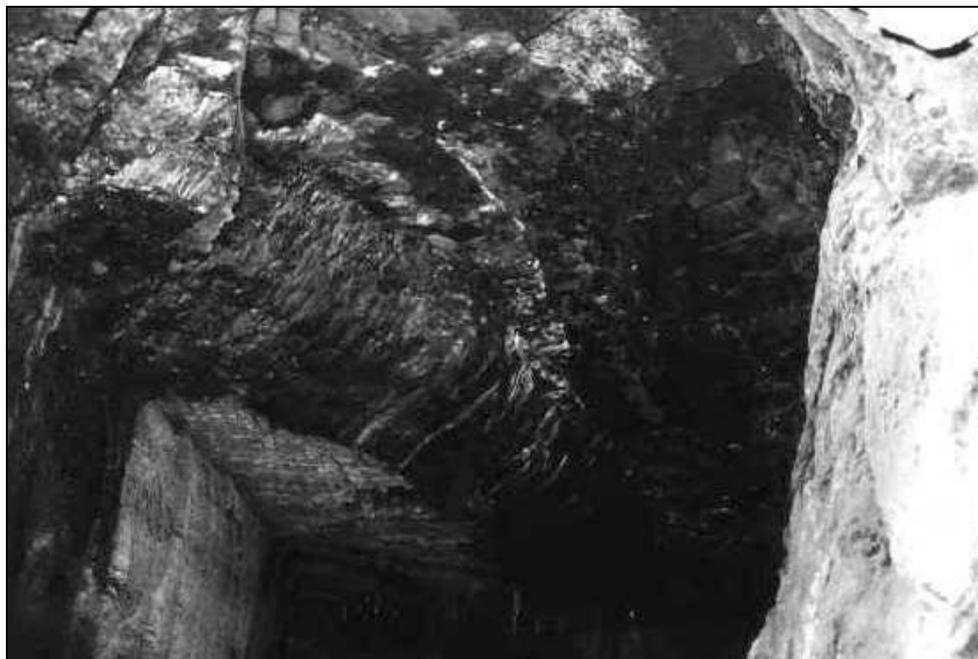
Figure 4. View of the slickensided joint forming the one end of the wedge.

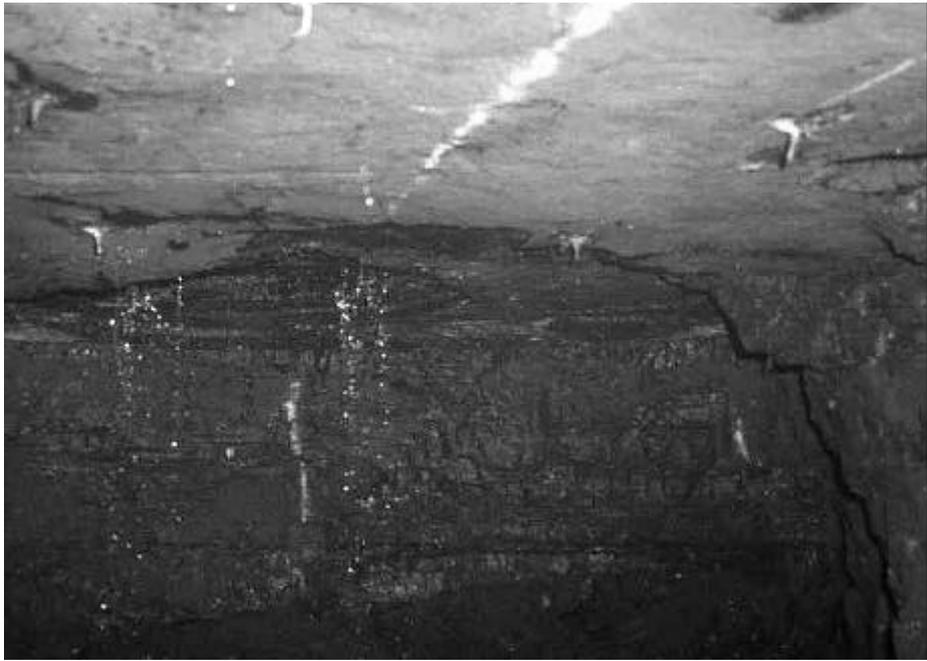
Figure 2.4. General view of Fall 4, showing water flowing from the borehole.

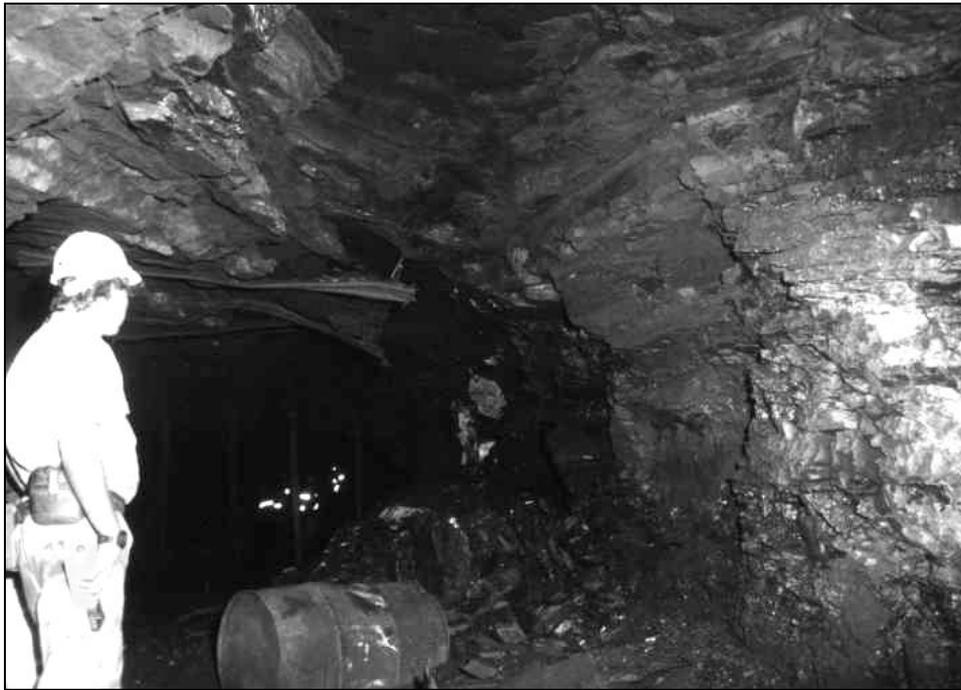
Figure 3.3. *General view of one of the burnt coal falls. The channel shape of the fall was caused by parallel joints, forming a wedge that fell.*

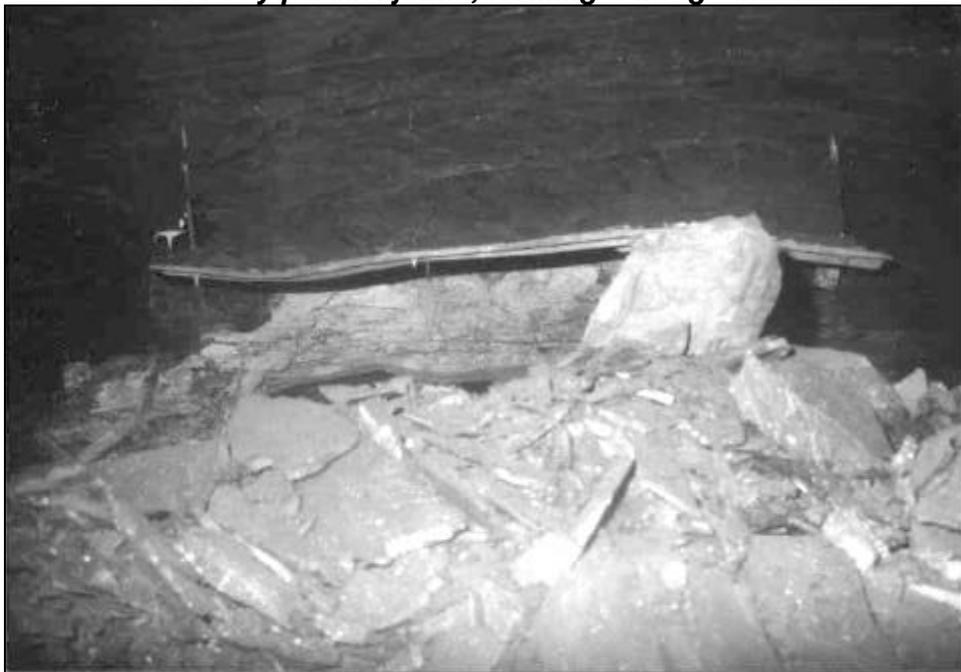
Figure 3.4. *Note the rock on top of the W-strap in the background, indicative of the roof's inability to support itself over short distances.*

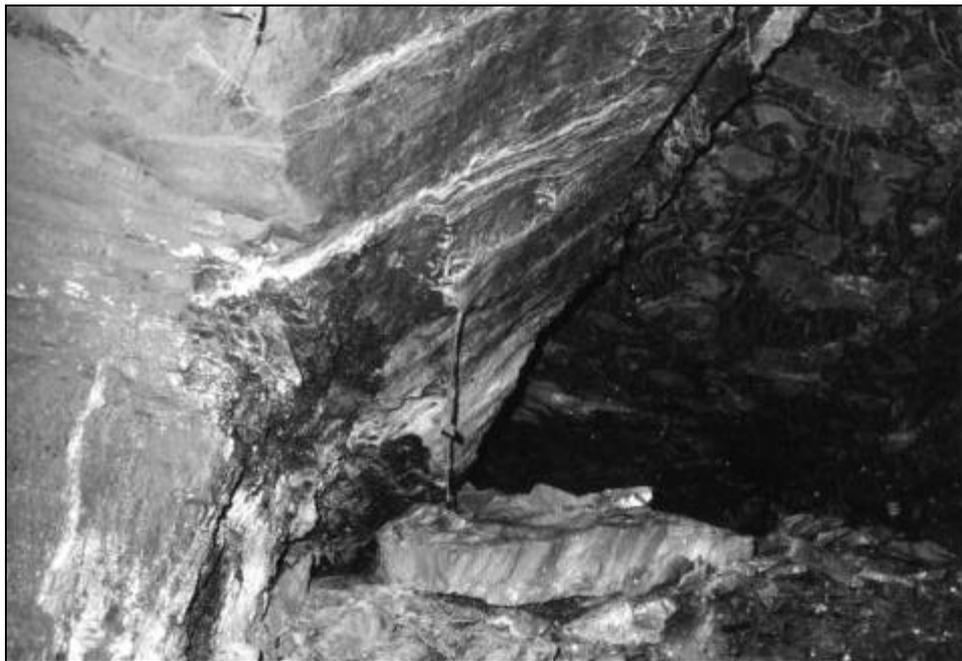
Figure 4.2. *One side of the wedge formed by intersecting joints.*

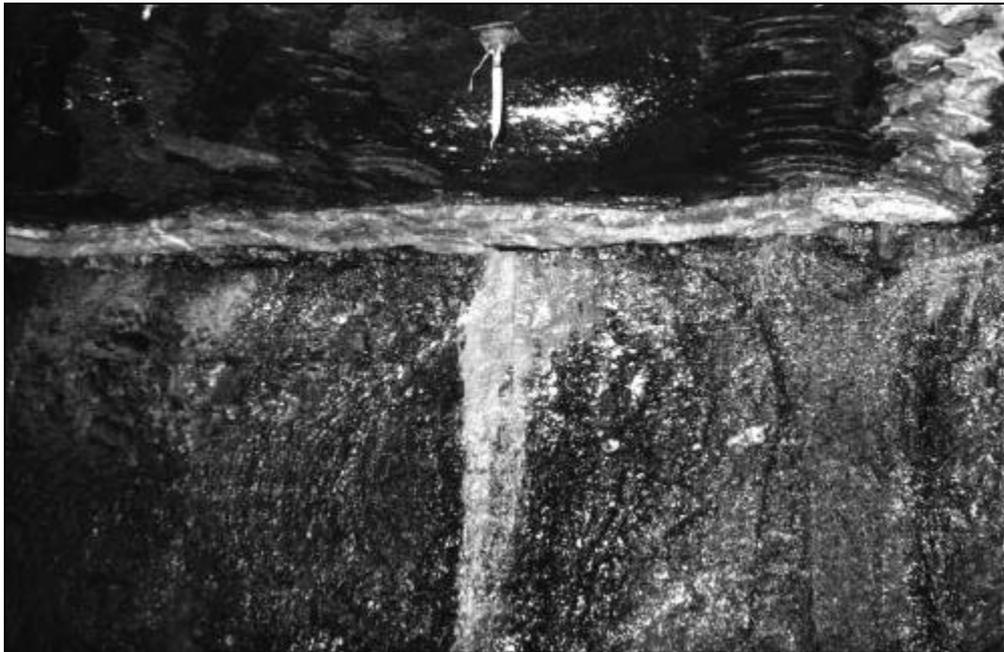
Figure 8. *Position where water was coming out at the contact between the roof and the ribside.*

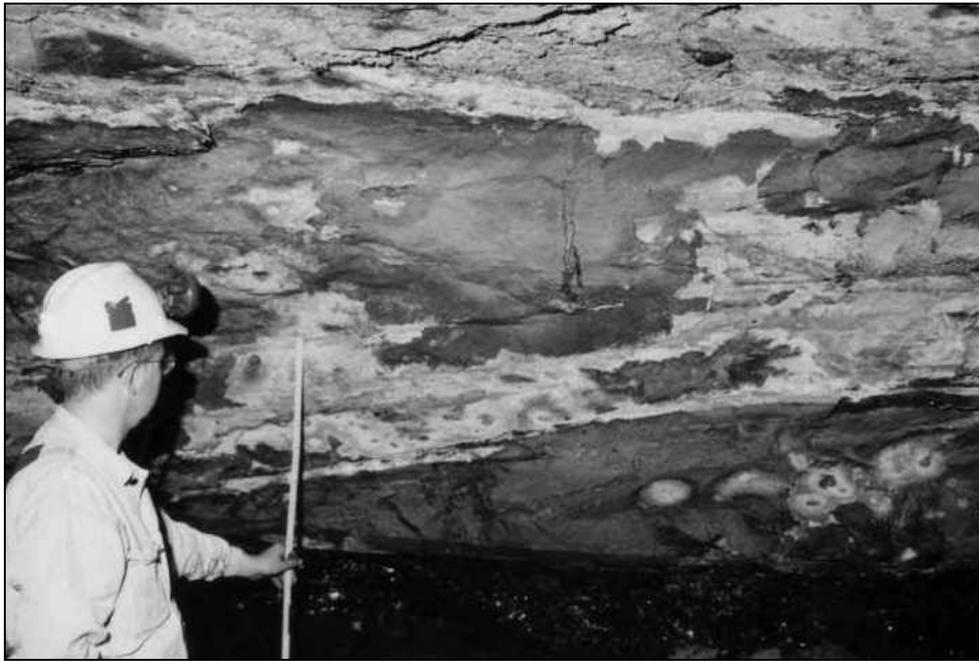
Figure 3. *Discoloration caused by acid mine drainage from the overlying Gus seam workings.*

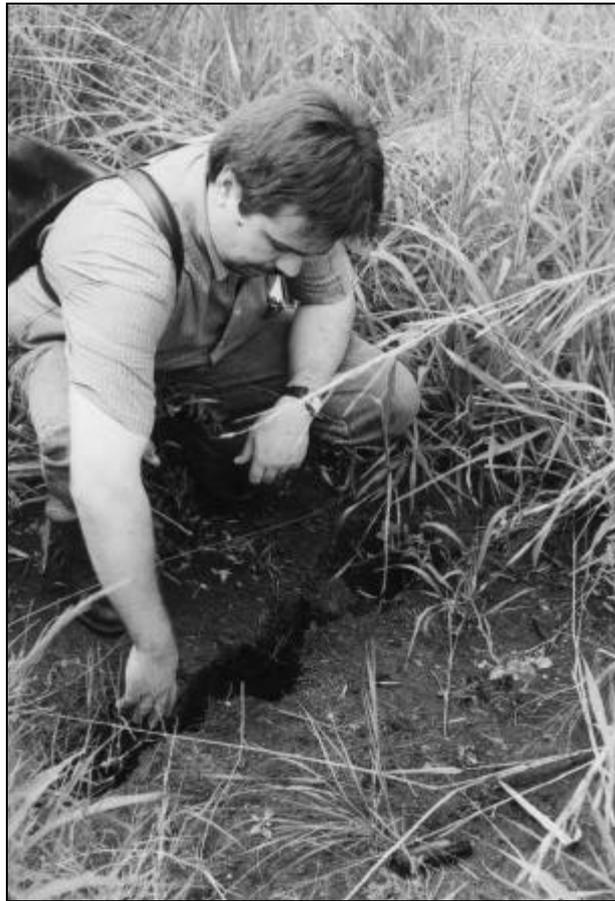
Figure 4. Example of a surface crack.

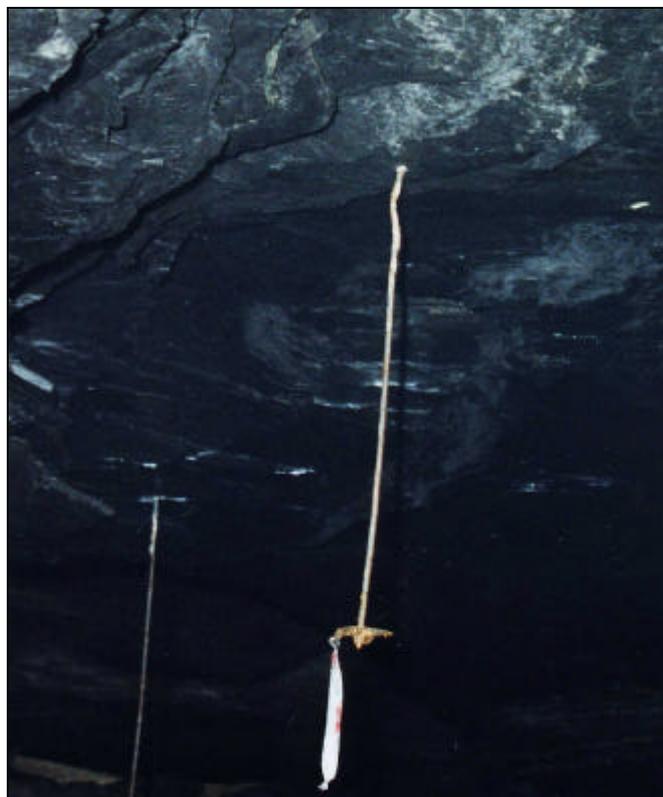
Figure 2. Crank handled roof bolt seen in the fall

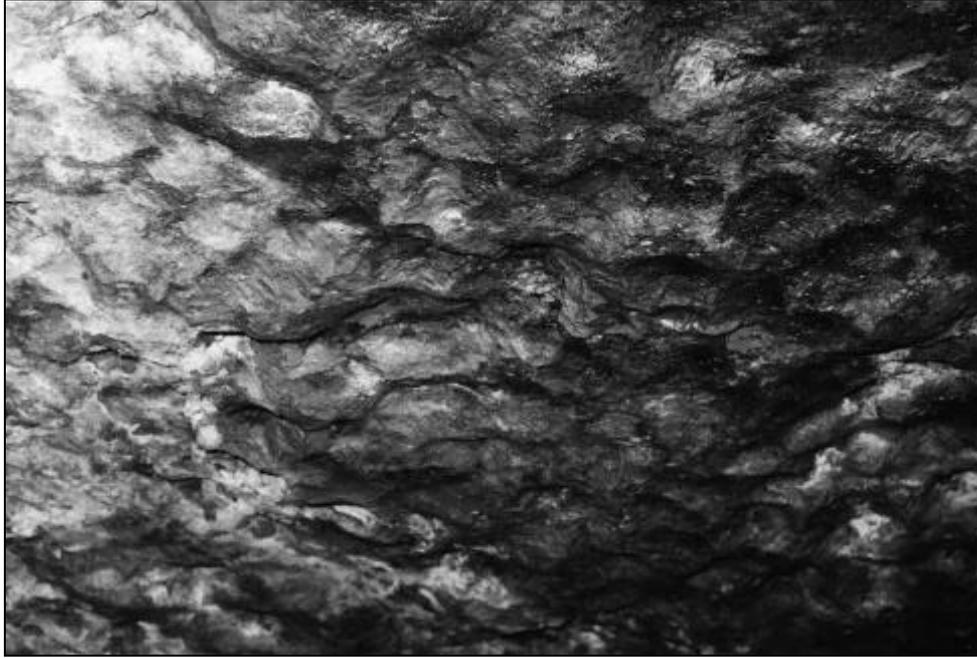
Figure 3. Ripple marks on the sandstone roof of the fall. Note the discoloration caused by water.

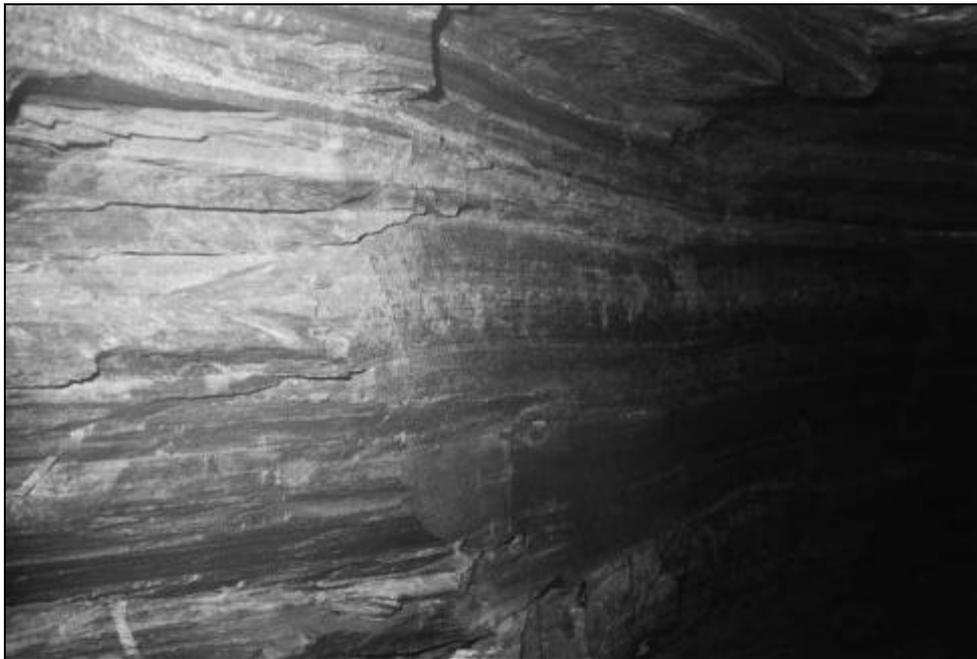
Figure 4. Discoloured joint plane bounding the fall.
