## ADVANTAGES OF FLUORIDE ION CLEANING AT SUB-ATMOSPHERIC PRESSURE

WARREN MIGLIETTI\* and FRITZ BLUM

**Abstract**—The fluoride ion cleaning (FIC) process is used to assist in the successful braze repair of nickel-based superalloy components. This process is especially effective in removing deeply embedded oxides in wide and narrow cracks typically found in aircraft parts such as in combustors and turbine blades and vanes. Where Al and Ti are present in the base metal, the FIC process depletes these elements from the surface, thereby improving the braze flow and repair of the cracked components. The objective of this paper is to highlight the benefits of using the FIC process at sub-atmospheric pressure. To achieve this, firstly entailed designing and producing specimens suitable to study the fatigue crack behaviour of brazed repaired cracks/joints under mechanical and thermal loading. The cracks/joints prior to brazing were either in an unclean form, i.e. had an oxide layer on, or were fluoride ion cleaned at sub-atmospheric pressure. Fatigue crack propagation tests under constant load as well as under constant stress intensity factor range were conducted in order to study fatigu

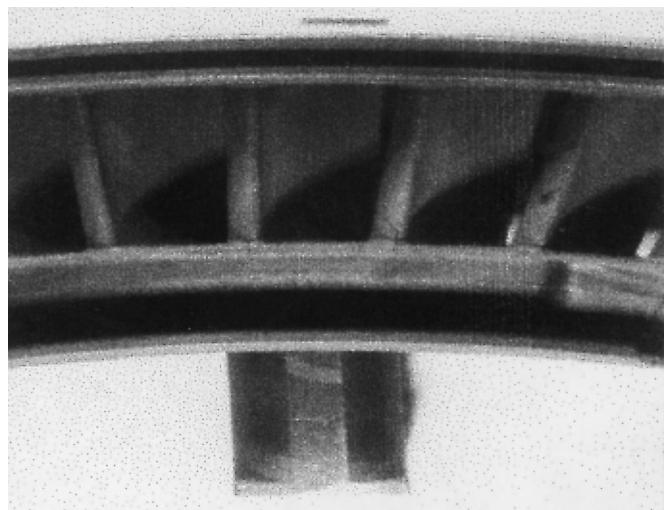
Fig. 1. Severely oxidised narrow, deep cracks on an IN-738 T56, 2nd stage vane.

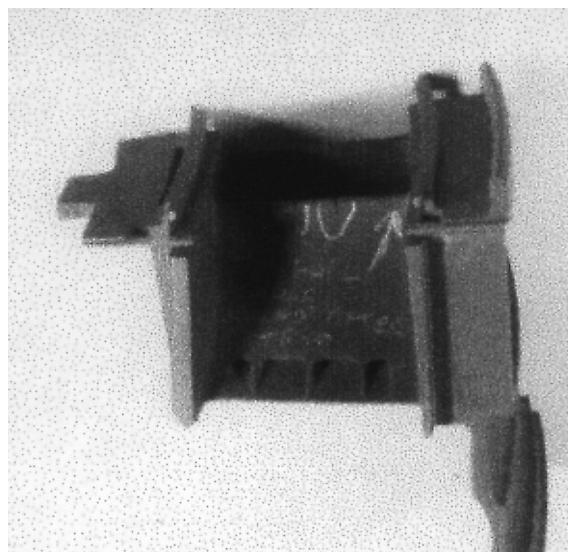
Fig. 2. Severely oxidised wide cracks on an IN-713 T56, 1st stage vane.

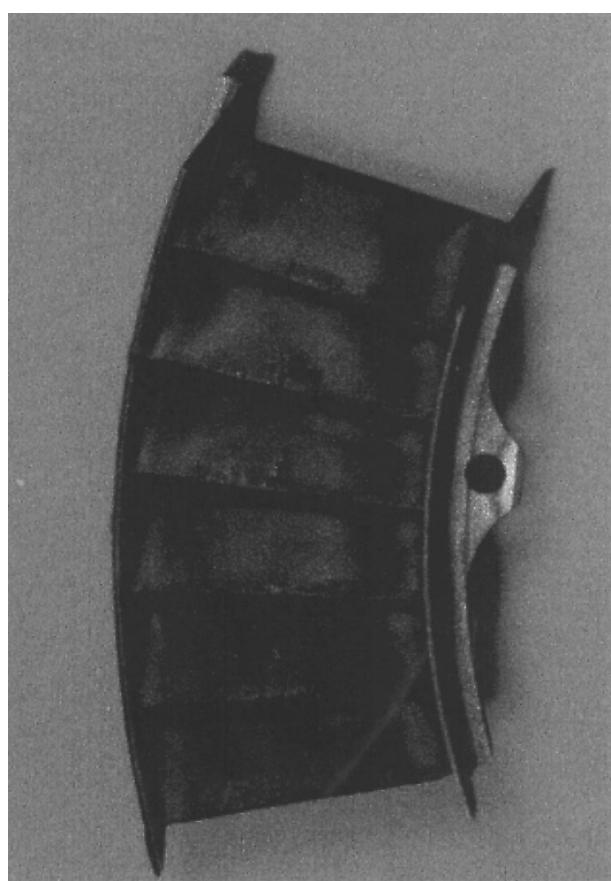
Fig. 3. Severely oxidised cracks on a X-40 Viper, 1st stage vane.

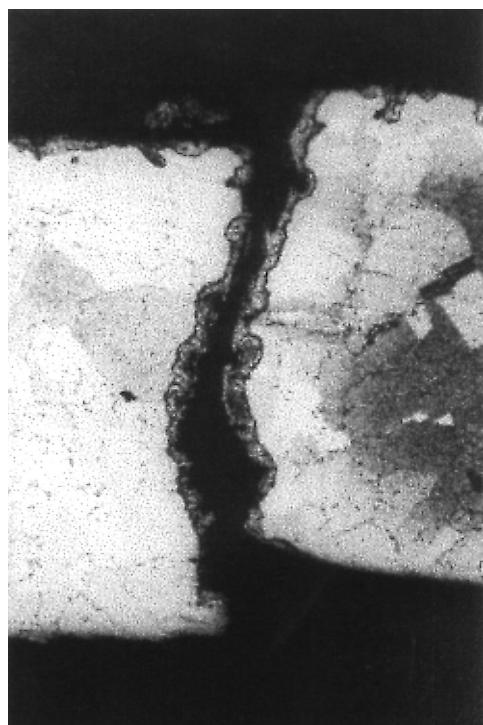
Figure 6 shows the typical oxide layer on a leading edge crack of a T56, 1st stage vane. The greyish oxide layer can clearly be observed in Fig. 7.

Fig. 6. Oxide layer in the crack of a T56, 1st stage vane, Magnification 100 $\times$ .

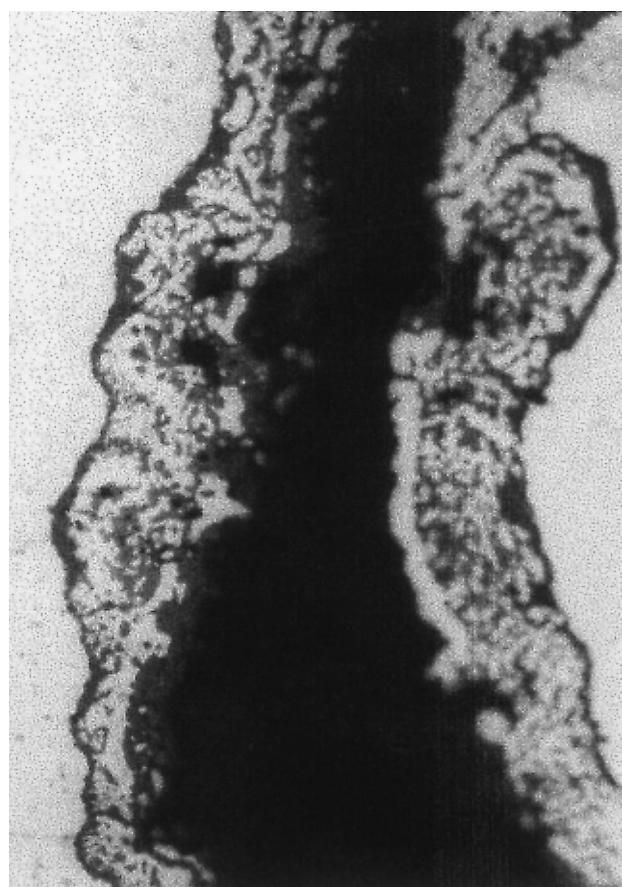
Fig. 7. Greyish oxide layer on side walls of a crack on a T56 vane, Magnification 500 $\times$ .

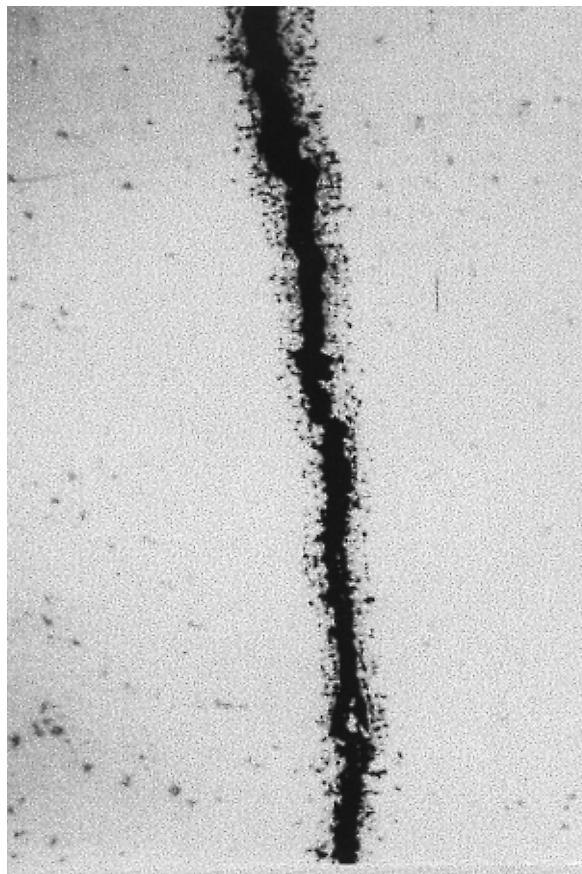
Figure 8 shows the oxide layer on a leading edge crack of a 2nd stage, T56 vane after atmospheric FIC. The greyish oxide layer can be clearly seen towards the middle to the bottom of the crack. This shows that for deep cracks ( $> 7$  mm) the atmospheric FIC technique utilised does not consistently clean the bottom of the crack completely.

Fig. 8. Oxide layer, still present after atmospheric FIC, on a 2nd stage T56 vane, Magnification 50 $\times$ .

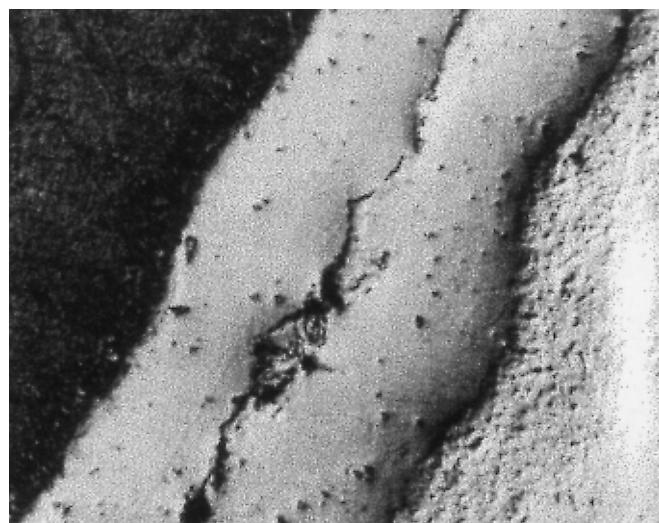
Using a sub-atmospheric FIC cycle and vacuum brazing, a crack on the IN-738 vane results in excellent wetting of the braze to the side walls of the crack, as seen in Fig. 9. The centerline phase is the brittle boride phase that results because the gap was wide, and there was insufficient diffusion time for B to diffuse from the braze joint into the parent metal.

Fig. 9. Sub-atmospheric FIC and vacuum brazing of a crack on a 2nd stage T56 vane, Magnification 500 $\times$ .

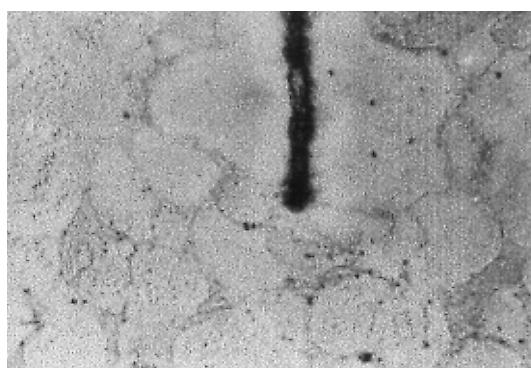
Compared with Fig. 6, there is very little oxide layer present in the cracks of the Viper vane as seen in Fig. 10. This is partially attributed to the low amount of Al + Ti content in the substrate material.

Fig. 10. Little oxide present in the cracks of the Viper vane, Magnification 200 $\times$ .

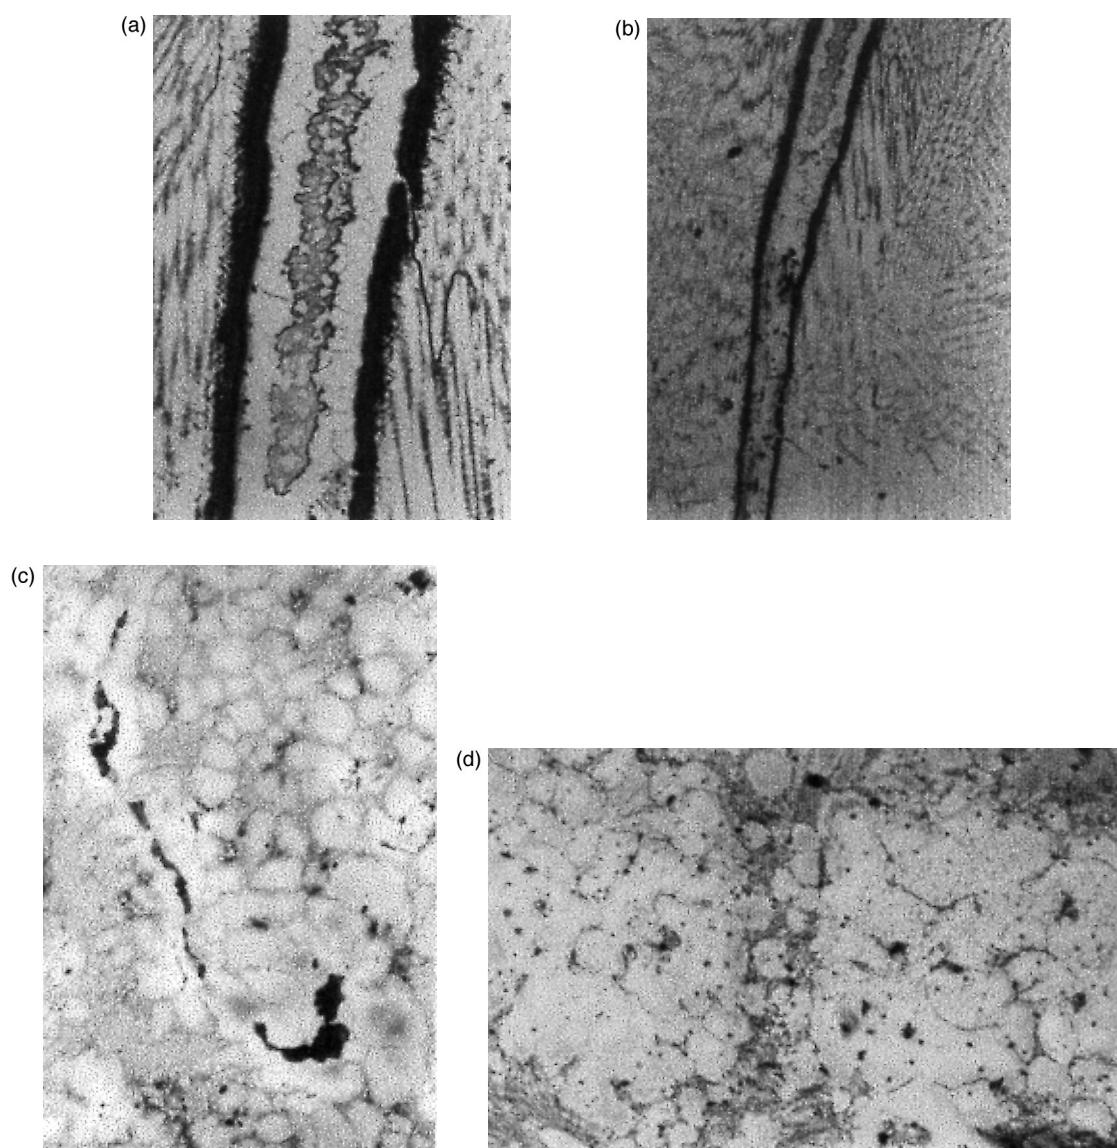
The cracks on the Viper vane were also fluoride ion cleaned under sub-atmospheric conditions and thereafter vacuum brazed. Figure 11(a), (b), (c) and (d) show in all cases the excellent wetting and bonding of the braze to the walls of the crack. Unfortunately, the micrographs also show evidence of brittle boride phases which resulted from inadequate diffusion of the B into the braze.

Fig. 11. Various cracks on the Viper vane segment which were fluoride ion cleaned under sub-atmospheric conditions and thereafter vacuum brazed. (a) Magnification 200 $\times$ ; (b) magnification 100 $\times$ ; (c) magnification 100 $\times$ ; (d) magnification 100 $\times$ .

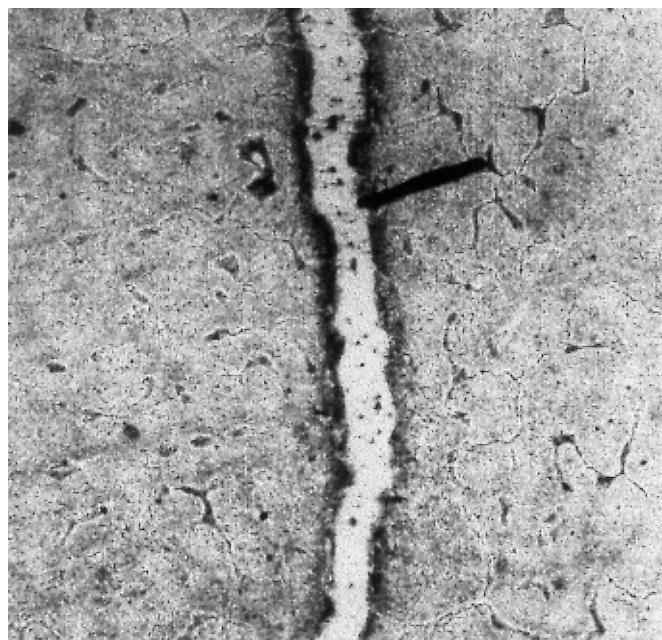
Figure 12 shows a crack which was brazed repaired, after sub-atmospheric FIC. Although there is porosity in the joint, there is no brittle boride centre line phases and there is once again good wetting and bonding of the braze to the walls of the crack. The crack was only  $40 \mu\text{m}$  wide and thus a long diffusion time was not needed to diffuse the B away from the joint.

Fig. 12. A crack which was brazed repaired. No centre-line boride phases are present and there is good bonding, Magnification 200 $\times$ .

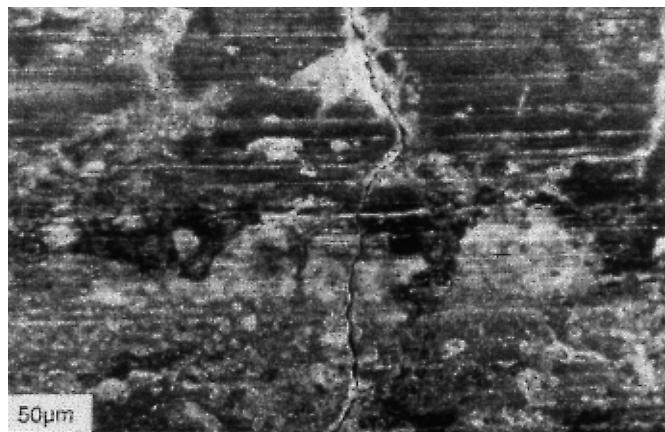
Fig. 14. Thermal fatigue cracking close to initiation site in the N-braze after 500 thermal cycles.

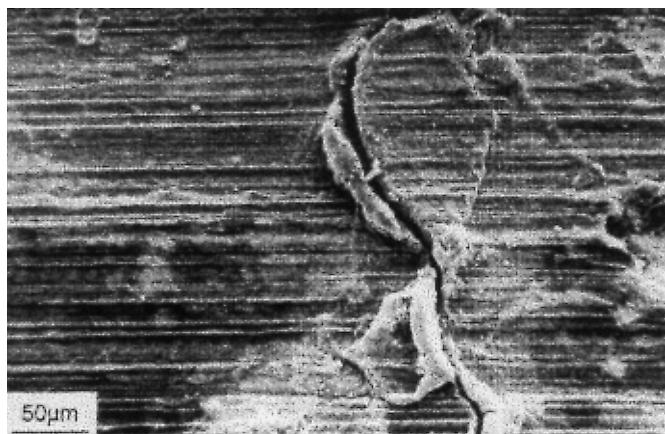
Fig. 15. Thermal fatigue cracking close to initiation site in O-braze after 500 thermal cycles.

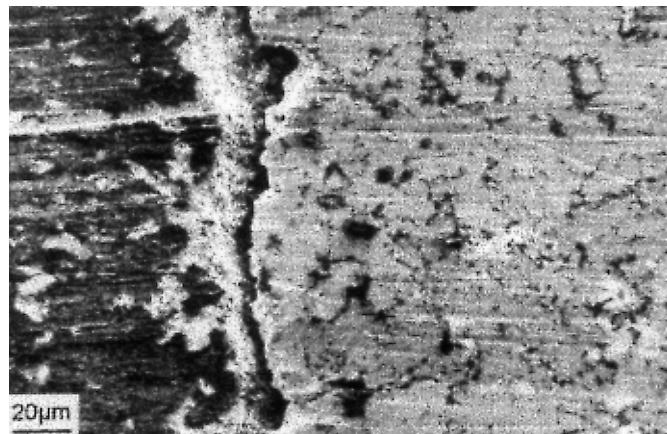
much earlier than in the N-braze. Optical and scanning electron microscope studies show that the initiation and subsequent growth of the TF crack occurred at the braze-parent metal interface for the O-braze. This is not too surprising as this sample was not given a fluoride ion clean cycle and it was expected that there would be a bonding problem, especially at the interface between the braze and the slot. In contrast, cracking was found in the middle of the N-braze. Typical TF cracks close to initiation sites (specimen edge) after 500 thermal cycles are shown in Figs 14 and 15. Figure 16 shows the TF crack propagating at the braze/parent metal interface, whereas Fig. 17 shows the crack through the centre of the braze.

Fig. 16. Scanning electron micrograph showing TF cracking at the parent material/braze material interface.

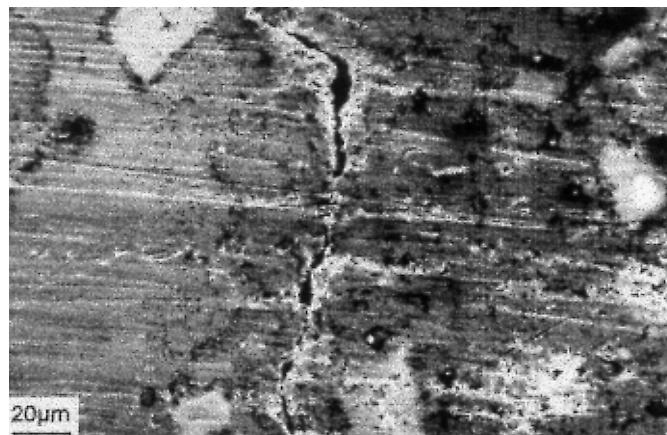
Fig. 17. Scanning electron micrograph showing TF crack propagation through the middle of the N-braze.

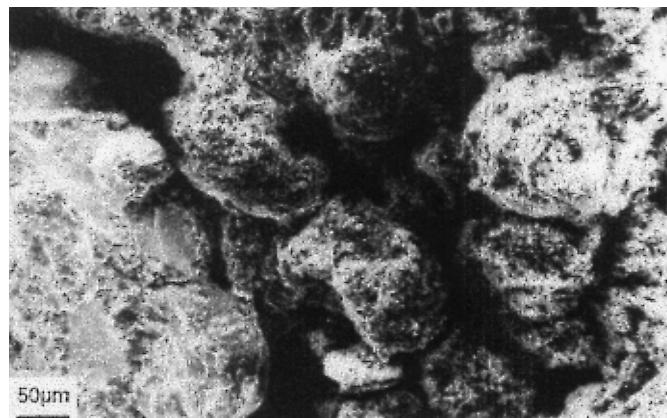
Fig. 33. Scanning electron micrograph showing evidence of inadequate braze processing.

Some areas showed a high density of ‘pores’ which was probably the result of either inadequate cleaning or incorrect braze processing, as can be seen in Fig. 33.
