HEAVY VEHICLE SIMULATOR TESTING ON PRE-CAST CONCRETE PANELS

This paper focuses on results obtained from recent accelerated loading testing in California with a Heavy Vehicle Simulator (HVS) on a particular system of pre-cast slabs, referred to as SuperSlab®.

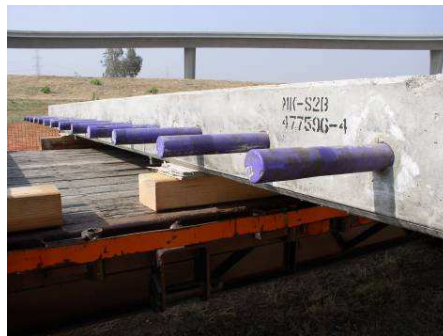
Standard load transfer dowels are cast at one end of each slab at locations that match the location of dovetail-shaped slots cast in the bottom of each adjacent slab as seen in [Figure 1](#). Similarly, standard tie bars (or the female half of a standard tie bar) are cast at one side of each slab matching the location of slots cast in the adjacent slab.

Figure 1. Precast Dowels and slots showing slot/dowel bar connection

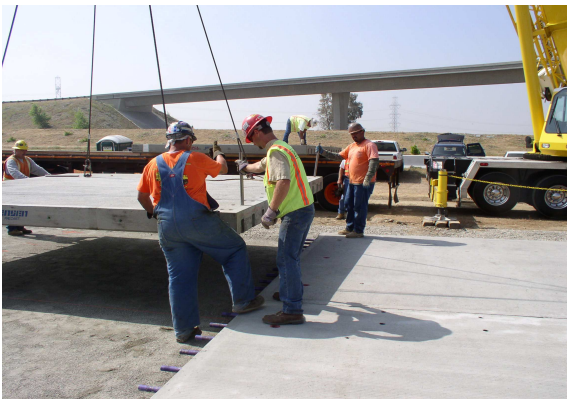
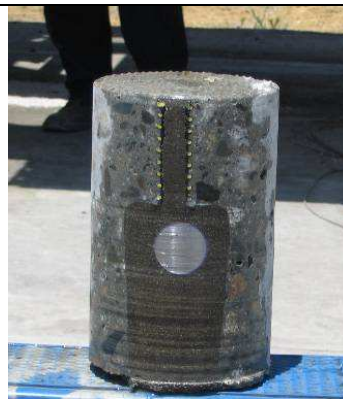
Two grout ports are cast in the top of each slot to make it accessible for grouting after the slab has been placed. Grout is pumped into one port until it exudes from the other, completing the structural load transfer connection from slab to slab. Fully grouted slabs are essentially the equivalent of cast in place pavement slabs and perform in the same way. Dowel slots cast on the bottom of the slabs provide two benefits. First, they keep dowel grout on the bottom, protecting it from de-icing chemicals and degradation from freeze/thaw activity. Secondly, they keep the dowel grout out of sight, thus maintaining a uniform-looking, high-performance pavement surface. Figure 2 shows the positioning of the slabs and a core taken from a dovetail slot/dowel bar connection.

Figure 2: Slab positioning and core showing dovetail slot/dowel bar connection

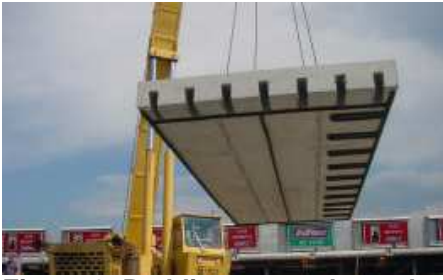
The bedding grout distribution system, visible on the bottom of the slab in [Figure 3](#), comprises a series of half-round channels cast in the bottom of the slab that extend across the slab to distribute bedding grout to the entire slab contact area. They are accessed from the top of the slab through grout ports cast in at each end of each channel (red dots in [Figure 1](#)). Also visible in [Figure 3](#) are black foam gaskets glued to the bottom edges (and in between half-round channels) of each slab to create discrete, sealed grout chambers.

Figure 3. Bedding grout channels and gaskets

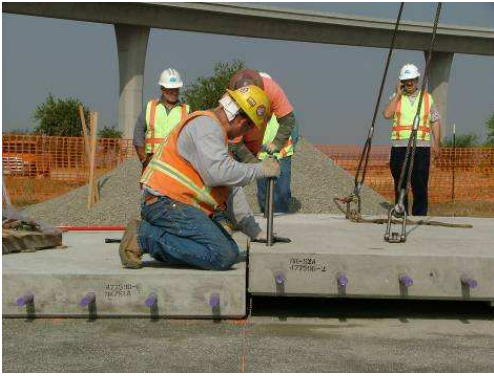
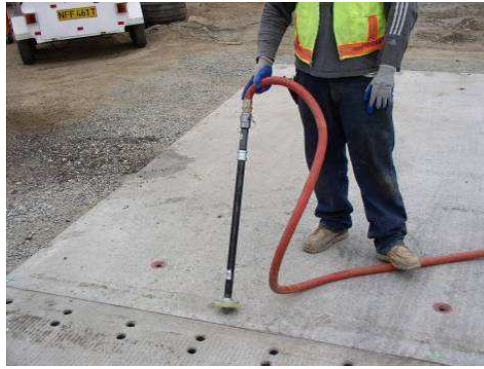
- The construction of a 100mm cement treated base course;
- A thin (8mm) layer of fine bedding material (stone sand) placed on top of the base;
- Pre-cast Super-Slabs®, 225mm thick, placed upon the precisely graded sub-base and grouted as described in the foregoing and shown in Figure 4; and
- Diamond grinding of the top surface of the slab to meet the smoothness requirements of the project.

Figure 4. Precise placement of the slab on the sand bedding layer and hose with fitting for injecting grout

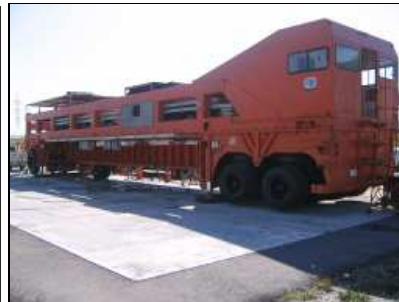
Two test sections were evaluated between June 2005 and August 2006 using a Heavy Vehicle Simulator (HVS), as shown in [Figure 5](#). In the evaluation of the SuperSlab® System the main test objectives were:

Figure 5. Layout of test sections and HVS during load testing

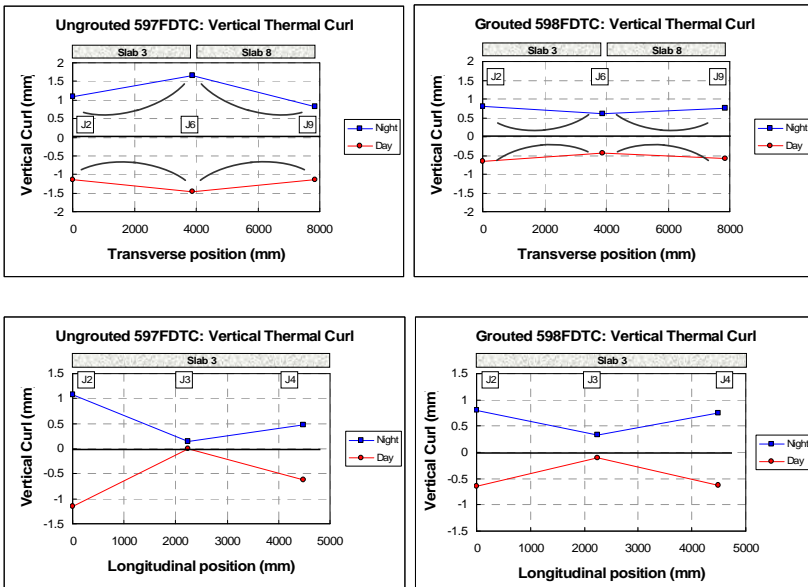
The thermal deformations (with no traffic loads) were compared before and after grouting. The vertical displacement at an interior corner after grouting reduced from ± 1.5 to ± 0.5 mm as shown in [Figure 7](#). In the un-grouted condition each slab curled separately, while after grouting the presence of tie-bars and grout in the joint (coming from the tie-bar grout slots) restrained the movement. This in turn should reduce self-weight stresses and ensure better support conditions. Along the longitudinal direction, on the exterior corners (on what would be adjacent to the shoulder) the effect of grouting was minimal (see [Figure 7](#)).

Figure 7. Comparison of the vertical deformations caused by thermal curl of the slabs before and after grouting, in the transverse and longitudinal directions

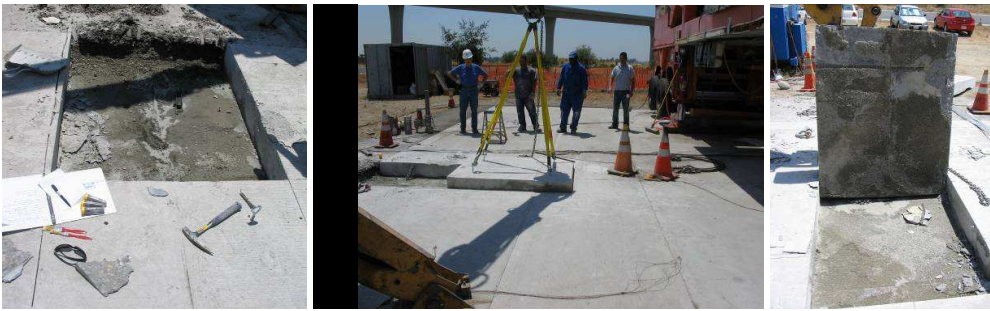
Apart from this, no other forms of distress were observed, despite the fact that considerable pumping of material from under the slab occurred during wet trafficking. An investigation was carried out to evaluate the extent of the suspected voids under the slab caused by pumping (See Figure 9). It revealed that the pumped material consisted of the finer particles from the sand bedding layer and of disintegrated bedding grout. There was no clearly noticeable void in the wheelpath under the joint, but there were rather widespread marks of washed fines.

Figure 9. Investigation of void under the slab in Section 2

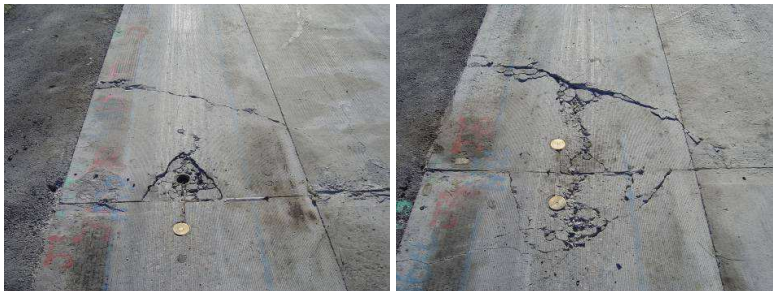
Failure of the section was reached in the form of a localized collapse in one of the joints and a more extended corner crack on the other joint. Forensic investigation revealed that

the localized failure happened in between the dowel bars, exactly where the channelized wheel traffic loaded the pavement. Even though the failure happened at the location of one of the multi-depth deflectometer sensors, it was concluded that this had no effect. The combined observations point toward concrete fatigue under channelized traffic and the loss of support caused by pumping. The other joint presented a failure that can be considered typical of cast-in-place slabs, with large concrete cracks. Both failed joints are shown in Figure 11 (as an indication of their size, the brass sensor caps are 75mm in diameter).

Figure 11. End of life at the two joints of section 1, loaded to failure
