Evaluation of a nano-silane-modified emulsion stabilised base and subbase under HVS traffic

Synopsis-This paper describes the findings of a Heavy Vehicle Simulator (HVS) test on road D1884 in the Gauteng province of South Africa. The pavement structure was rehabilitated using an anionic nano-silane modified bitumen emulsion stabilising agent in the base and sub-base. The rehabilitation design traffic loading (20 year design period) is based on 3 million Equivalent Standard 80kN Axle Loads (ESALs). The 50 year old pre-rehabilitated road exhibited severe distress with in-situ materials in the upper pavement layers that have weathered to a tested G8 quality – materials usually considered unsuitable for use in base/sub-base layers of a pavement structure. The HVS test subjected the pavement structure to an equivalent of at least 3.5 million ESALs (using calculated damage factors). Using the standard damage factor of 4,2, 7.5 million ESALs were applied. Although the dual wheel load was increased to 80 kN and water introduced (in depth as well as on the surface), no structural failure could be induced during the test (a final rut of only 8 mm was measured). The in-situ stabilisation of

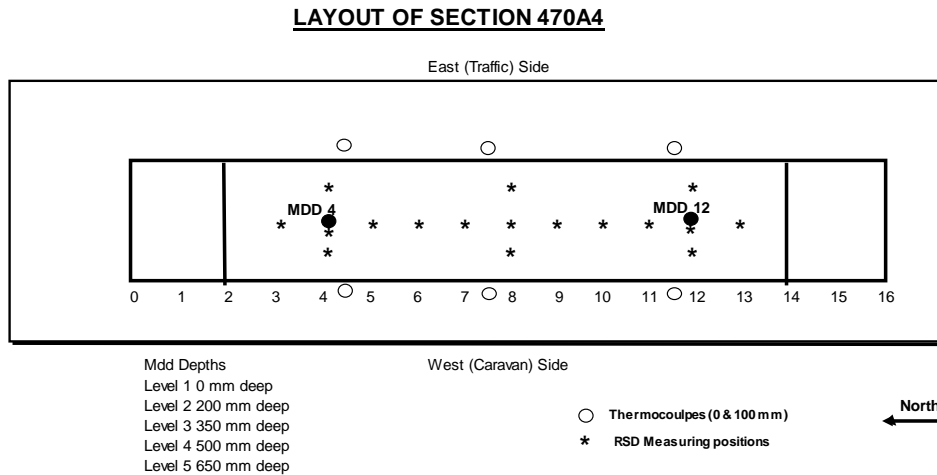
The total number of repetitions applied was 946,481. Water was applied both in depth through holes drilled at depths of up to 400 mm as well as on the surface while applying an 80 kN wheel load. The test section layout is shown in Figure 2.

Fig. 2. Layout of the HVS test section

From Figure 2 it can be noted that the following measurements were taken during HVS testing:

- Profilometer measurements to determine the surface deformation across the test section;
- Road surface deflectometer (RSD) readings to determine the surface deflection characteristics;
- Multi-depth deflectometer (MDD) readings at two points, and
- Temperature readings using thermocouples on the test section as well as a control section.

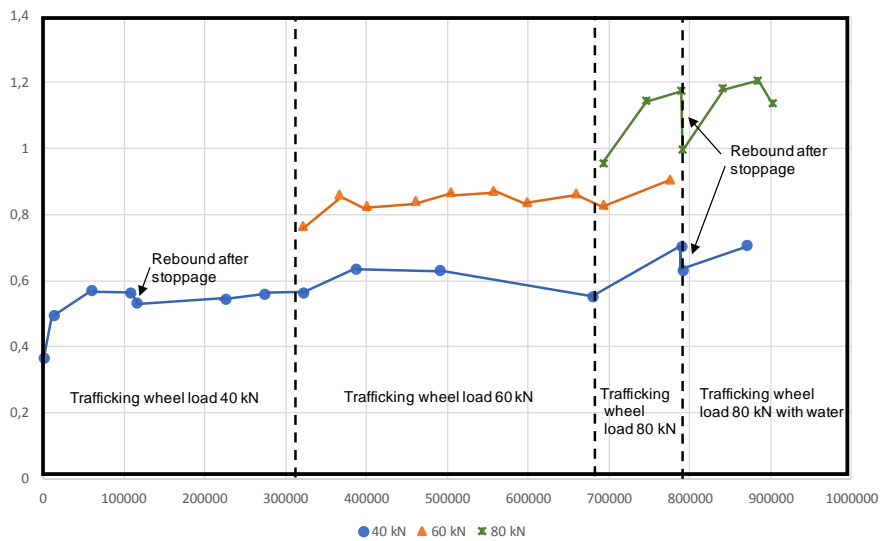
The surface deflections as measured with the RSD under 40 kN, 60 kN and 80 kN test wheel load through the test are given in Figure 6.

Fig. 6. Average surface RSD deflections (40 kN wheel load, tyre pressure 800 kPa)

From Figure 6, it can be noted that the average deflection increased from an initial value of 0.36 mm to 0.71 mm under a 40 kN wheel load (tyre pressure 800 kPa). The deflections under 40 kN did not vary significantly across the test section (see Figure 7). The maximum deflection measured during the test under 40 kN was 0.89 mm. Detailed deflection measurements at 60 kN and 80 kN were reported by Rust *et al.* [3]

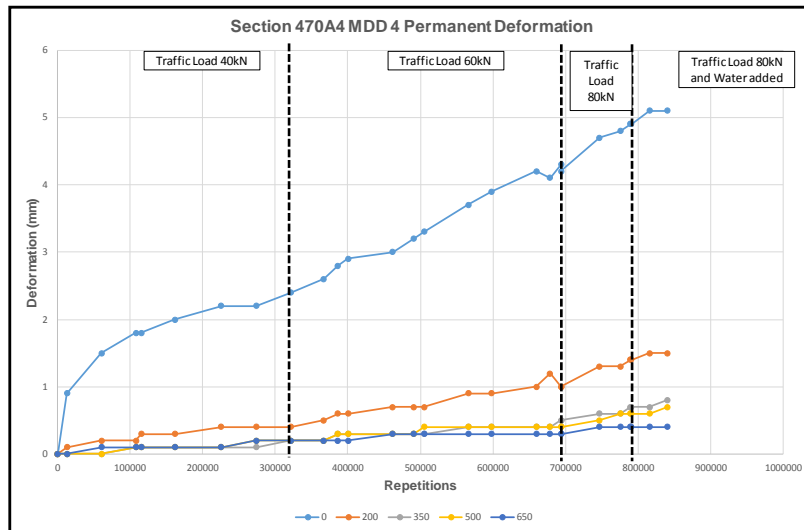
The multi-depth deflectometer (MDD) measurements at Point 4 are depicted in Figure 8 (permanent deformation measurements in depth) and Figure 9 (elastic deflections in depth).

Fig. 8. Permanent deformation (PD) measurements at MDD 4

From the graphs in Figures 8 and 9 it can be noted that, although most of the permanent deformation came from the base layer, this deformation is still very low in terms of pavement design standards and is measured at about 3.6 mm within the base as it consolidated under traffic. The total deflection under the 40 kN wheel load is 0.59 mm, of which, at 490,000 repetitions, 0.11 mm came from the silane-modified base-layer and 0.18 mm came from the silane-modified subbase layer.

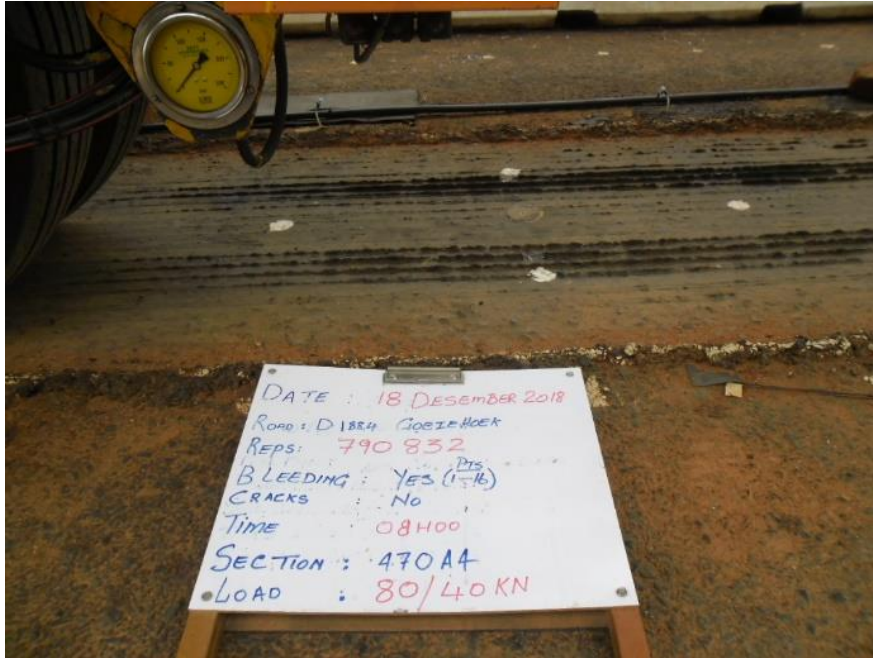
As mentioned above the surfacing failed probably due to a combination of high temperatures, the high wheel load applied, and some oil spillage from the HVS hydraulic system. However, in spite of the problems with the surfacing and the surface and in-depth water added, the base and subbase performed exceptionally well (which was the main objective of the test). Figure 13 shows the failure of the surfacing. Figure 14 shows the blocks of the modified G8 material that were taken from the test pit inside the test section after the HVS test. The strength and cohesion in the base material is evident and is in line with the laboratory test results discussed above. It is noteworthy that these blocks contained only 1,5% of the modified emulsion and **no cement**. It must also be noted that no cracking was observed at the surface. The detrimental effect of cracks in cemented layers that are active and cause crack reflection through surface treatments have been well-documented [18], [19].

Fig. 13. Surfacing failure

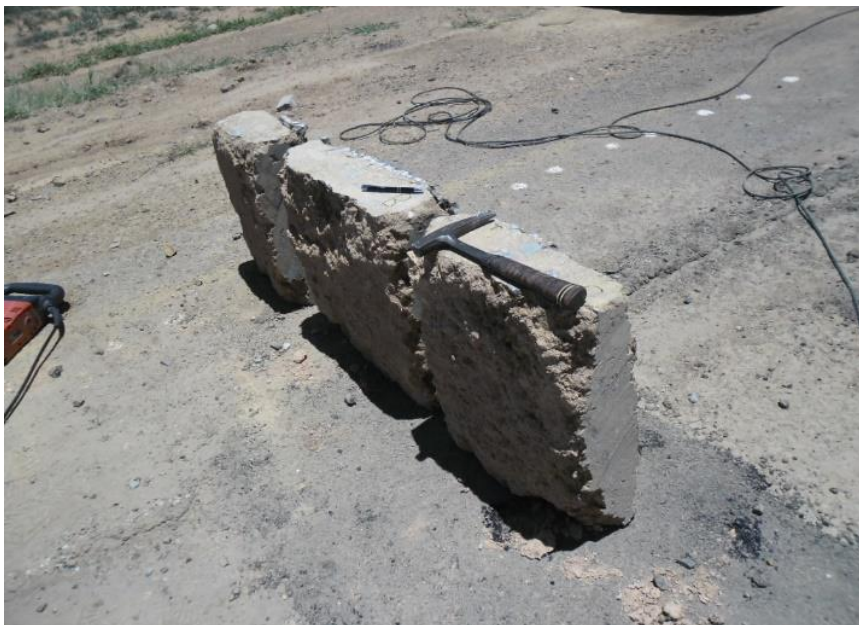
Fig. 14. Blocks of material taken from the modified base

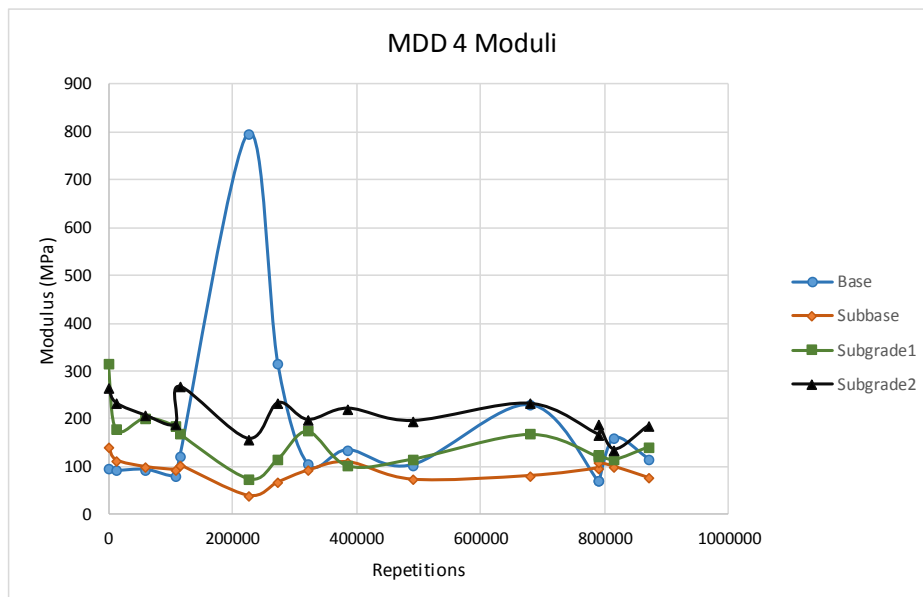
The progression of change in the MDD back-calculated moduli is shown in Figures 15 and 16.

Fig. 15. MDD4: Back-calculated moduli

- Apart from one or two outliers, the moduli of the layers did not change significantly over the test period;
- However, the base layer seemed to stiffen initially as the base compacted under traffic and then weaken slightly as the base started to fatigue under the heavy 80 kN wheel load;
- As observed from the test pit, there was a stiff, dry clay layer present in the subgrade, which may have influenced the back-calculation of the base and subbase moduli, seeing that it is well-known that linear-elastic theory has shortcomings when a stiff layer is present lower in the pavement structure. These moduli should therefore be viewed with discretion.
