Rail Track Monitoring using Ultrasonic Guided Waves

Philip W. Loveday*, Craig S. Long and Dineo A. Ramatlo
CSIR Manufacturing, South Africa
*Email: PLoveday@csir.co.za

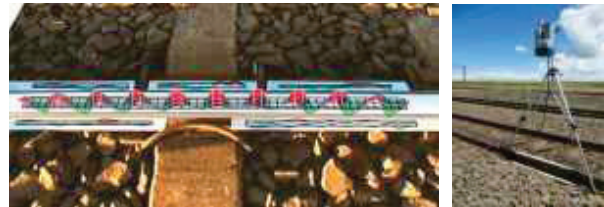
Figure 4. Scanning laser vibrometer measurement of ultrasonic guided waves.

A technique was developed to measure the excitation and propagation of the guided wave mode in operational rail track [9]. This confirmed numerical predictions and identified modes that are suitable for long range propagation. Figure 4 shows a measurement performed with a scanning laser vibrometer at a distance of 500 m from a transducer on an operational rail track.

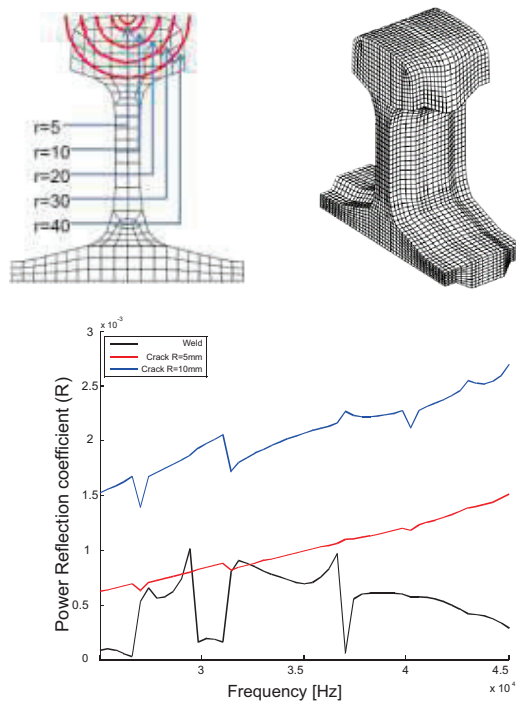
Figure 5. Numerical modelling to predict and compare scattering by cracks and welds.

Suitable defects are not available for measurement but aluminothermic welds are readily available. The predicted reflections from aluminothermic welds and transverse defects in the head of the rail were compared as shown in figure 5. It was found that even a relatively small vertical crack in the rail head will reflect the selected mode of propagation in a fashion similar to that of a weld cap. Therefore if we can detect the aluminothermic welds we expect to be able to detect relatively small cracks.

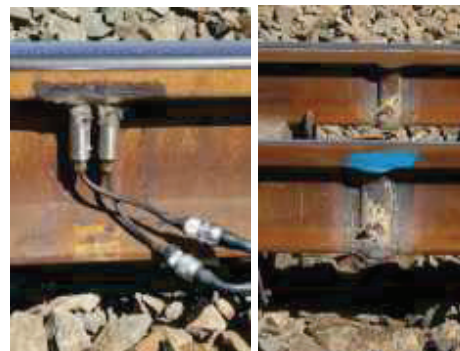
Figure 6. Experiments performed to detect reflections from aluminothermic.

Measurements were performed to investigate the feasibility of this idea for detecting defects in the head of the rail using the transducers developed for the UBRD V5 system. Initially an array of four transducers were used with two transducers on the inside and two transducers on the outside of the rail. Later an array of only two transducers was used as shown in figure 6. Also shown in Figure 6 are a pair of typical aluminothermic welds and a graph of reflections versus distance showing large reflections from the aluminothermic welds. Note that the signals from the two transducers have been processed to determine the direction of the welds from the transducers.

The experiments revealed that it was possible to detect aluminothermic welds that are 1000m away from the transducers. It is therefore expected that cracks will be detected at this range well before they result in rail breaks. The measurement shown in figure 6 is similar to a once-off inspection. When the system is permanently installed a large amount of data can be gathered and then analysed to detect the growth of defects. This approach is being used in pipelines where permanently installed guided wave systems have been shown to detect corrosion at a size that would not be possible with a once off inspection [14]. If the only change occurring in a system was the growth of a defect it would be possible to detect very small defects by subtracting an earlier baseline signal
