JONES, D. 2006. The use of ultralight aircraft for material location and road surveys in remote rural areas. **Proceedings 22<sup>nd</sup> ARRB Conference: Research into Practice.** Canberra, Australia: Australian Road Research Board. (ISBN 1-876592-49-4).

## THE USE OF ULTRALIGHT AIRCRAFT FOR MATERIAL LOCATION AND ROAD SURVEYS IN REMOTE RURAL AREAS

**D JONES**

Transportek, CSIR.

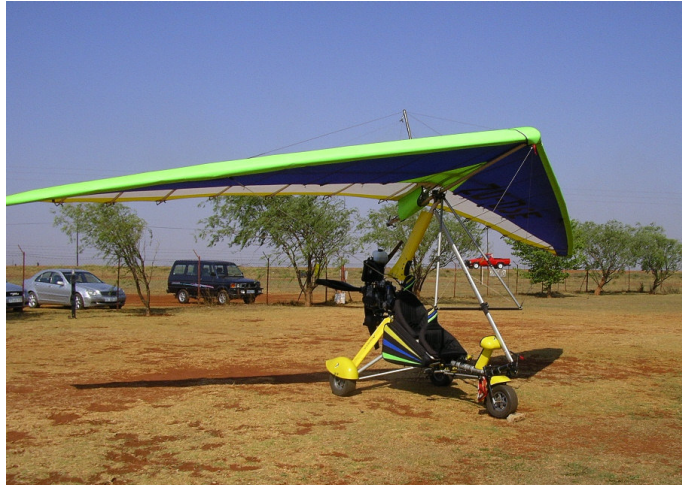
**Figure 1: Weight shift ultralight aircraft**

Two popular ultralight configurations are typically used - weight shift ultralights (**Figure 1**) which have evolved from hang gliders and three axis ultralights which have evolved from conventional aircraft and are flown in a similar manner (ie controlled by joystick and rudder).

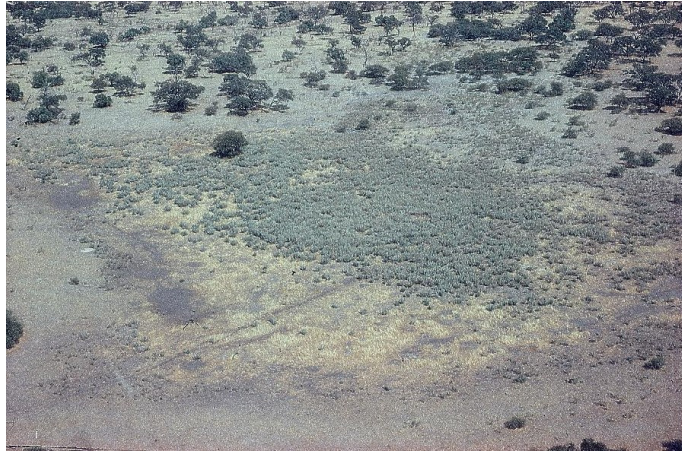
**Figure 2: *Catophractes alexandri* on calcrete pan**

Pedogenic materials are probably the most easily identified using botanical indicators. Calcrete (caliche) and silcrete have high calcium contents and are thus indicated by calcium tolerant plants. Examples from southern Africa include *Catophractes alexandrii*, *Combretum imberbe*, *Dichrostachys cinera*, *Erioccephalus ericoides*, *Grewia bicolor*, *G flava*, *G flavescens*, *Maytenus senegalensis* and *Pechuel-loeschea leubnitziae*. These materials generally occur in shallow pans, which are difficult to spot in flat featureless terrain.

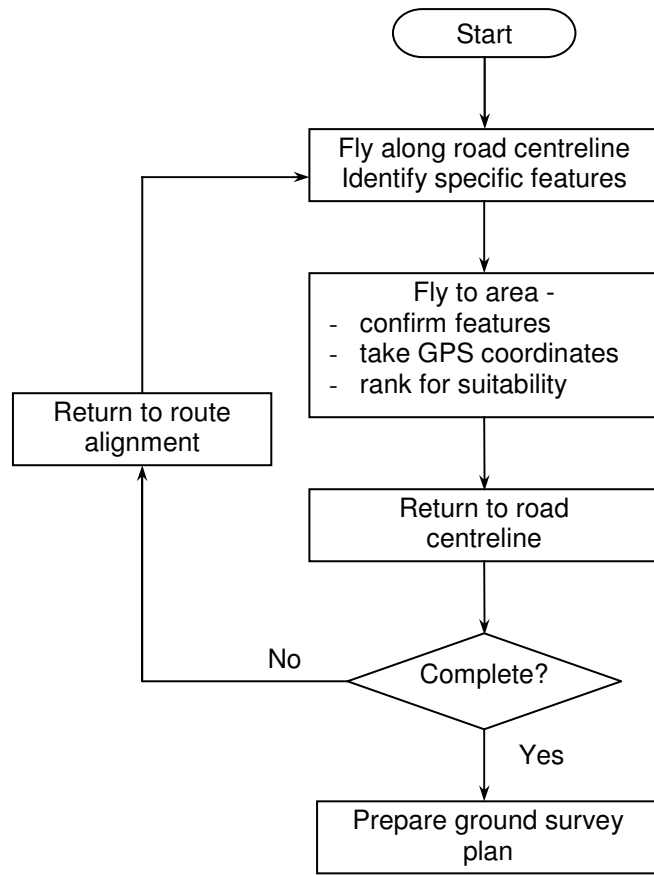
**Figure 3: Flowchart for material location from the air**

In material location projects, desk top studies should first be undertaken for the pilot and/or investigator to familiarize themselves with the geomorphology and vegetation. When flying the following procedure is generally used (**Figure 3**):

- i) The aircraft is flown approximately 200 - 500 m above the ground along the proposed alignment.

- ii) Any abnormalities in micro-topography (eg pan rims), vegetation (distinct change of species, dense thicket of one or two species, change in plant morphology (e.g. stunted or multi-stemmed)) or soil colour are sought on both sides of the route alignment. Where feasible, specific species are sought.

- iii) Once observed, the aircraft is flown to these areas and a closer inspection made from the air while circling the area. If the presence of known plant indicators are noted, GPS co-ordinates are taken and a rating given to facilitate and prioritise later site visits. Observations are usually recorded on a tape recorder through the aircrafts intercom system as writing is usually difficult, especially if the pilot is doing the survey. An example of the output from a survey is provided in **Table 1**.

- iv) After inspection, the aircraft is flown back to the alignment and the flight along the route continued until a new potential site is observed.
- v) Once the aerial survey is completed, the identified sites are visited and exploratory excavations made to confirm the presence of material, collect samples for testing and to delineate the extent of the source.

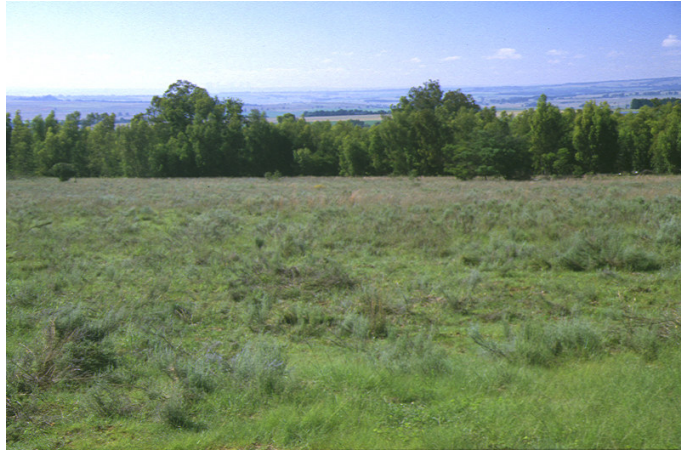
**Figure 4: *Stoebe vulgaris* on ferricrete/laterite source**

Ferricrete or laterite is often identified by plants that tolerate impeded drainage. In southern Africa, the occurrence of a particular species (*Stoebe vulgaris*) invariably signifies that lateritic material is present (**Figure 4**).

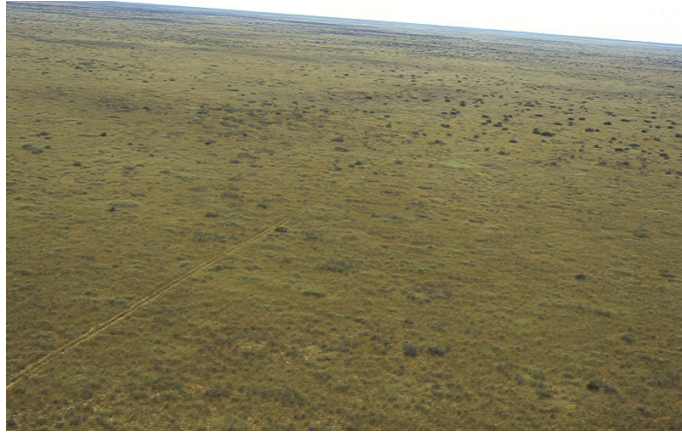
**Figure 5: View of area to be crossed by the Trans-Kalahari highway**

Economic developments in southern Africa and future plans for growth dictated the need for a corridor linking the port of Maputo in Mozambique on the east coast of Africa with Walvis Bay, a Namibian port city on the west coast. The 2,750 km corridor would ultimately traverse Mozambique, South Africa, Botswana and Namibia. Much of the Botswana and Namibian sections of the road traversed very sparsely populated, dry arid areas with only very basic infrastructure or vehicle tracks. The area is flat, featureless and covered with thick layers of mostly wind-blown sand (**Figure 5**). The vegetation is mostly scrub savannah and the only road construction materials are the sand and isolated deposits of calcrete (caliche) and arkose.
