Tectonophysics 289 (1998) 105–116

## Violent failure of a remnant in a deep South African gold mine

The violent failure of a peninsular remnant at a depth of 2300 m below surface occurred in a mine in the Carletonville Goldfield of South Africa, severely damaging a stope mining the Ventersdorp Contact Reef (VCR). At the rockburst site the VCR is 1–2 m thick with a lava hangingwall and quartzite/conglomerate footwall. The remnant had been formed as the result of a fault and ‘roll’ encountered during mining. Observations at the rockburst site led us to conclude that the seismic event, with local magnitude of 2.1, resulted from failure of the remnant with attendant movement into the workings. The event could not be explained by a single shear slip. Two different damage mechanisms were identified. Firstly, the face and footwall on the east side of the remnant were violently ejected into the void between the original face and first line of timber packs following failure and dilation of the remnant and its foundation. Secondly, the hangingwall on the south side of the remnant fragmented and collapsed when subjected to intense seismic shaking. This response was due to the presence of a

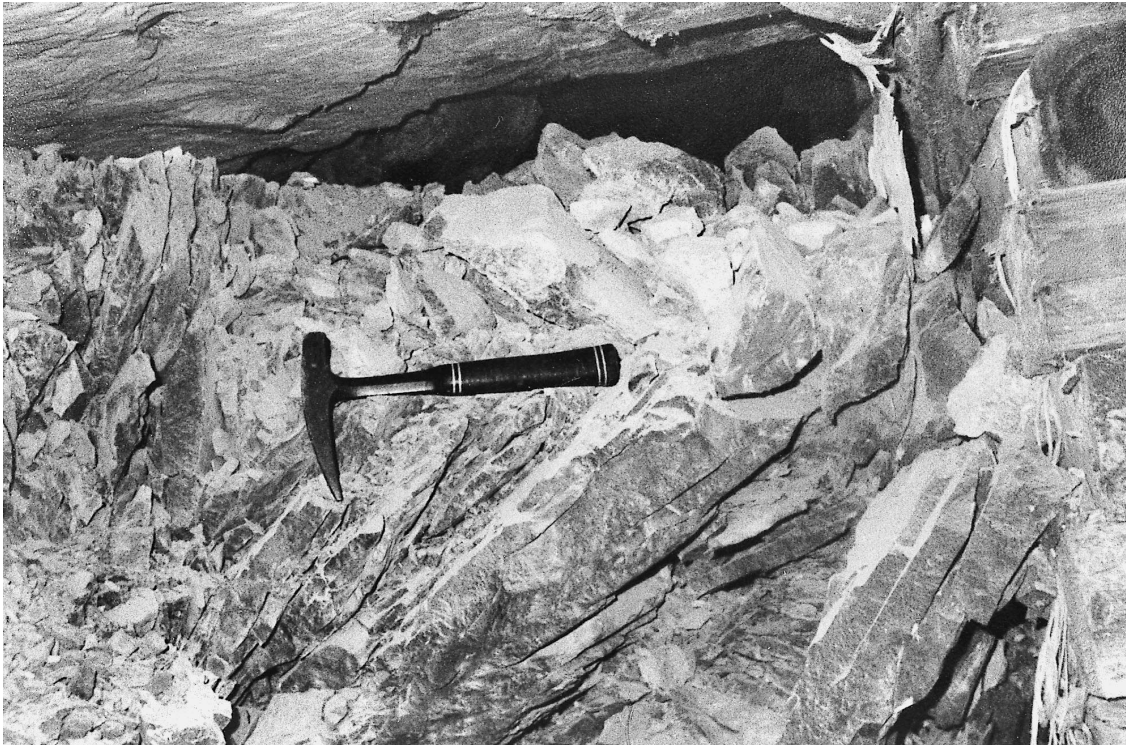
from F to G. At the top of the panel (position F) reef was exposed at the base of the face, but over the remainder of the panel only lava was exposed. Between F and G rock had been ejected into the void between the original face position and the first dip line of packs. Typical of a face burst, no hangingwall had fallen. Bulked face and footwall rock had been ejected into the void between the (original) face position and the dip line of packs (Fig. 7). Fresh splitting on packs in this area indicated dynamic convergence of 10–15 cm, and smears of timber on the hangingwall provided evidence that packs were forced laterally by the ejection of the face.

Fig. 7. Rock ejected from the footwall and face between F and G (Fig. 6) into the space between the original face position and the first dip line of packs. The photograph is taken looking updip with the face to the left. Note the intact hangingwall.

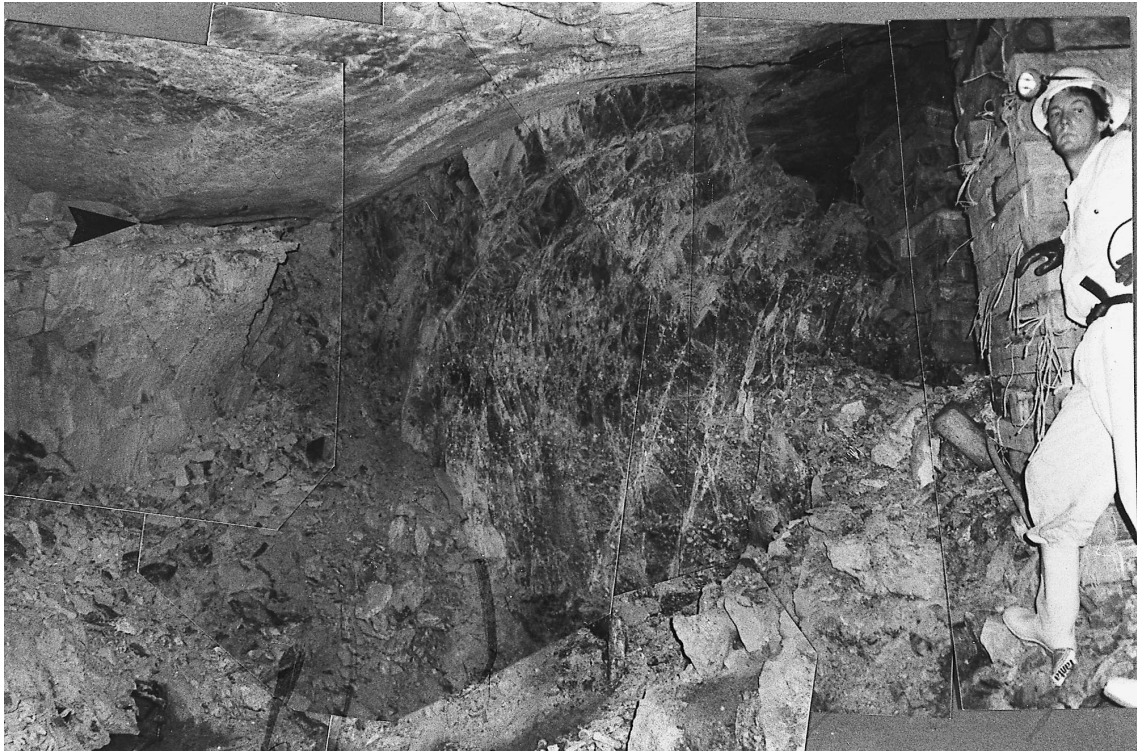
Severe damage occurred at the updip face (H, Fig. 6). The hangingwall of the updip stope was shattered into small fragments. The support that had been installed (1.1 × 1.1 m timber packs and hydraulic props at the face) was ineffective in supporting this hangingwall. The strata in this area were structurally disturbed by the reef roll and an undulating, bedding-parallel fault. To the east of the roll the fault plane was located close to the VCR–lava contact. To the west of the roll the fault plane is found within the hangingwall lava about 2 m above the VCR–lava contact (Fig. 5). This phenomenon has been observed at VCR rolls at other mines, where the bedding-parallel fault does not follow the VCR–lava contact when straddling rolls. Towards the west of the roll the undulating fault plane marks the top of the fall of ground area (Figs. 5 and 8). The bedding-parallel fault and minor fault planes associated with the major fault are coated by calcite. Minor faults and randomly oriented joints, associated with secondary calcite, are most prominent in the vicinity of the roll and appear to decrease in abundance with increasing distance away from the roll. The presence of the calcite-coated joints and minor faults weakens the hangingwall.

Fig. 8. Photo mosaic showing the up-dip face where the fatalities occurred, viewed from position H (Fig. 6) and looking up-dip. The timber packs on the right are situated to the east of the roll. The hangingwall fragmented during the rockburst. Most of the fallen rock was subsequently removed. Note the numerous fractures and joints in the face, and the smooth surface marking the parting above the collapsed brow.

the rockburst, examination of the remaining props showed clearly that the props had been ineffective in preventing falls of ground. This is ascribed to the fragmentation of the hangingwall. The timber pack underneath the brow at H (Fig. 6) was well installed, but did not hold the brow up. From Fig. 5 it is clear that no horizontal confinement is provided, without which a brow is prone to disintegrate. The rockbolts installed in the vicinity of the crosscut-reef intersection (position I) were also ineffective in preventing shake out of the fractured hangingwall by the rockburst.

The stope support system (timber packs and hydraulic props) was ineffective in preventing falls of ground due to the fragmentation of the hangingwall. Larger headboards should be fitted to hydraulic props in areas where the hangingwall is prone to fragmentation. The lack of support providing horizontal confinement to the brow probably increased its susceptibility to fragmentation.
