Safety in Mines Research Advisory Committee

Final Project Report

**Performance of various types of
containment support under quasi-static
and dynamic loading conditions**

Project number: GAP 810

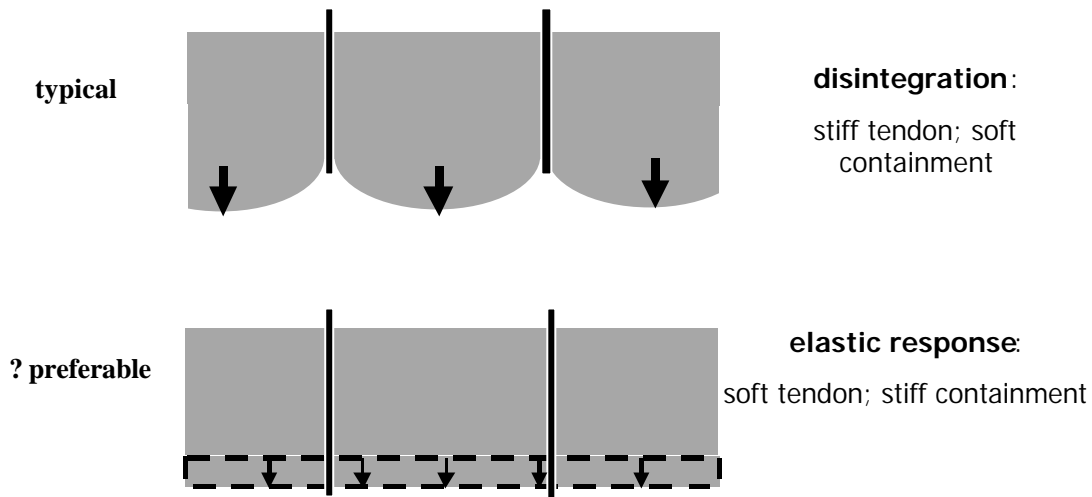
Energy can be absorbed in various ways. In the context of tunnel (and stope) support systems, energy absorption is often associated with yielding tendons (and props). However, this mode of energy absorption is only relevant in a relatively competent rock mass. As soon as relatively large rock mass deformations between the support units can take place, energy is absorbed locally by the fabric support and within the unraveling rock mass. In such cases, a stiff fabric support attracts large impact forces and small deformations, while a softer fabric will be subject to large deformations and smaller forces. The stiff fabric is therefore more prone to failure, but is able to prevent rock mass unravelling, as long as it does not fail. The softer fabrics have a much smaller capacity to prevent rock mass unravelling, but they do have a relatively large (elastic) energy absorption capacity. It is therefore important and relevant for any support system design to decide what the prevailing rock mass conditions are and how potential energy impulses are to be absorbed in the various components of such a system. Figure 1-1 demonstrates the concept of load transfer and Figure 1-2 illustrates the two extremes in terms of energy absorption.

Figure 1-2 *Energy absorption through bulging (top) and into tendons (bottom)*

In this project, relatively soft fabric components, in combination with yielding tendons, have been evaluated in an artificial rock mass that could be described as “incompetent”. The results indicate the limitations of this type of support system in that the yielding of the tendons is often not invoked. A situation as shown in the top of Figure 1-2 is typical for most of the tests conducted: relatively soft fabric combined with stiff tendons leading to bulging of the rock mass and ultimate failure of the, relatively weak, fabric. Most of the impact energy is absorbed by the fabric and the dilating rock mass; the tendons hardly contribute in this scenario.

A response as sketched in the bottom of Figure 1-2 may be obtained with a relatively stiff fabric support. However, depending on the shape of the excavation, the associated deformations may be restricted. If that is the case, energy cannot be absorbed through large deformations and the system may thus attract large forces and be prone to violent failure. This issue requires further research, as it is extremely important to have a realistic understanding of energy absorption potential.

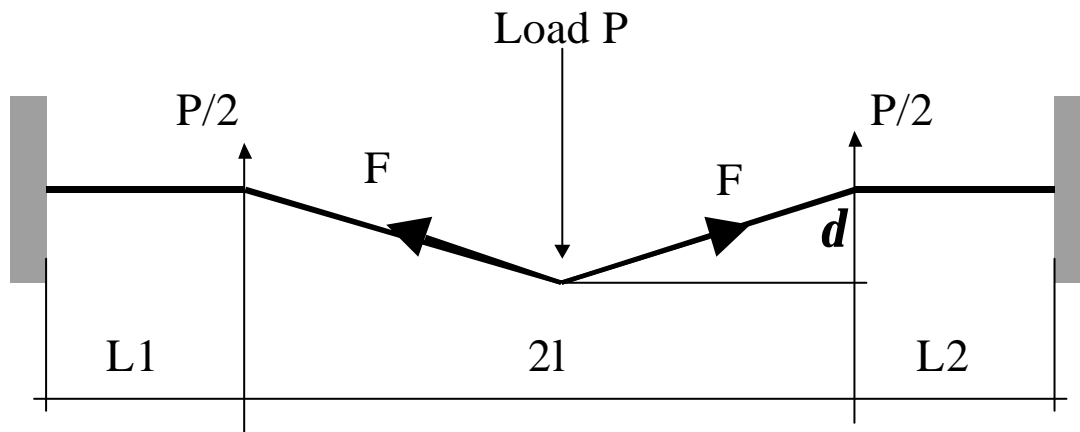
Figure 3-1 is a two dimensional representation and the load should be considered a line load in the case of mesh. Nevertheless, this representation illustrates the parameters that are relevant with respect to load deformation characteristics of mesh and lacing.

Figure 3-1 Typical load distribution in mesh and lacing subjected to a point load

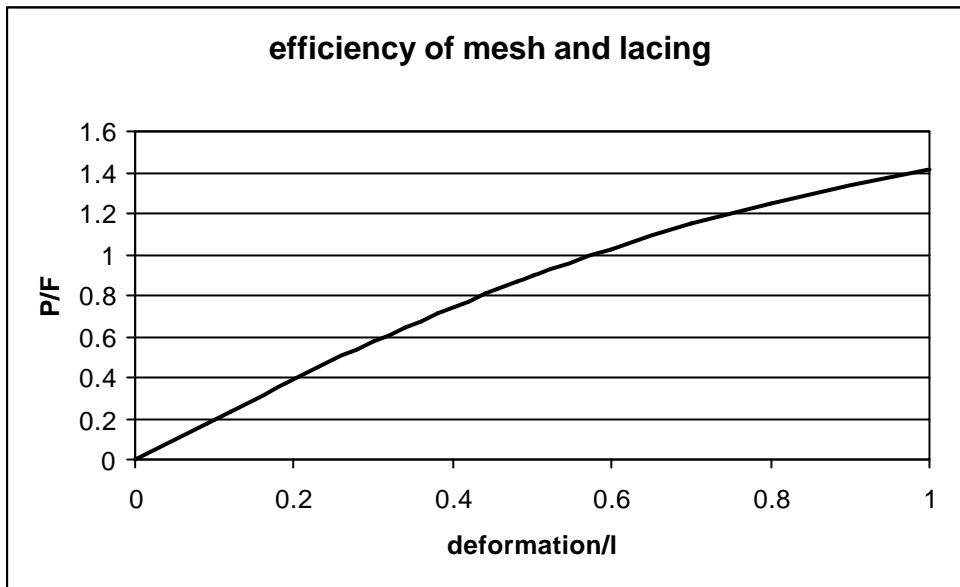
Relationship (3.2.1) expresses the “efficiency” of the mesh and/or lacing and it is obvious that small deformations are associated with limited efficiency (Figure 3-2). The stiffness of the system does not affect this relationship, although it does affect the absolute values of force and load.

Figure 3-2 Ratio between vertical load and mesh/cable force as a function of deformation

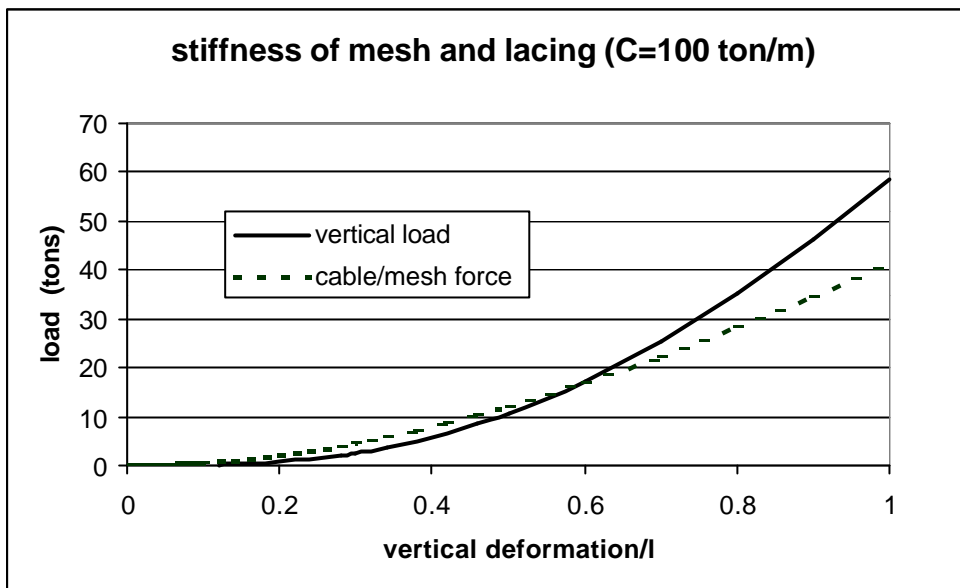
Expressions (3.2.3) and (3.2.4) are graphically displayed in Figure 3-3 for a particular stiffness $C = 100\text{ton}/m$ and $C = 1000\text{ton}/m$. Note that both the vertical load and the in-plane force are linearly related to the *in-plane* stiffness. An increase in stiffness will therefore lead to an increase in both the cable and/or mesh force as well as in the vertical load. Note how the system stiffness ($dP/d\mathbf{d}$) increases with increasing vertical deformation. This non-linear system stiffness is essential to the behaviour of mesh and lacing.

Figure 3-3 Load deformation characteristics for mesh and lacing with an in-plane stiffness of 100 ton/m

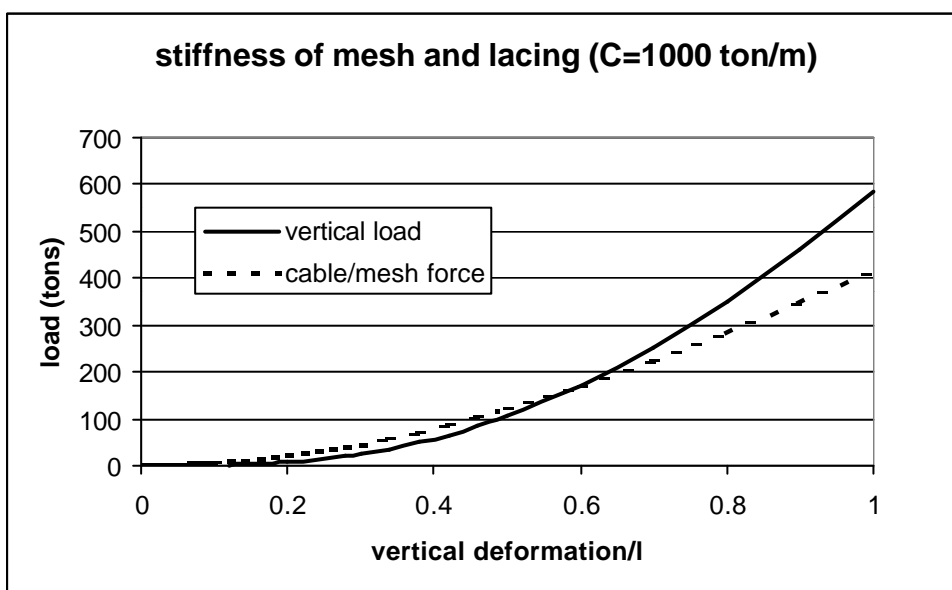
Figure 3-4 Load-deformation characteristics for mesh and lacing with an in-plane stiffness of 1000 ton/m

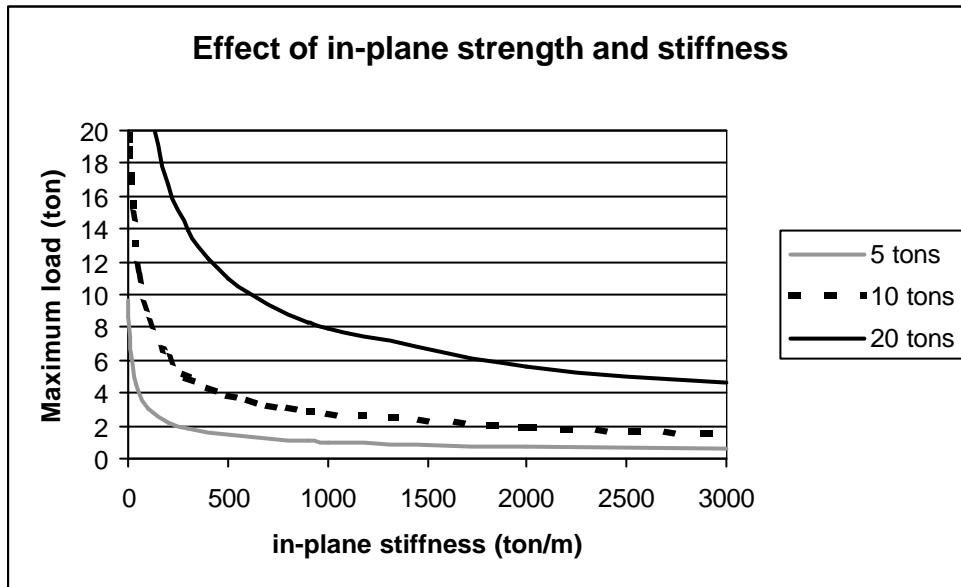
Figure 3-5 demonstrates how the *in-plane* stiffness C and the *in-plane* strength F_{\max} affect the load carrying capacity.

Figure 3-5 Load carrying capacity for varying in-plane strength and stiffness

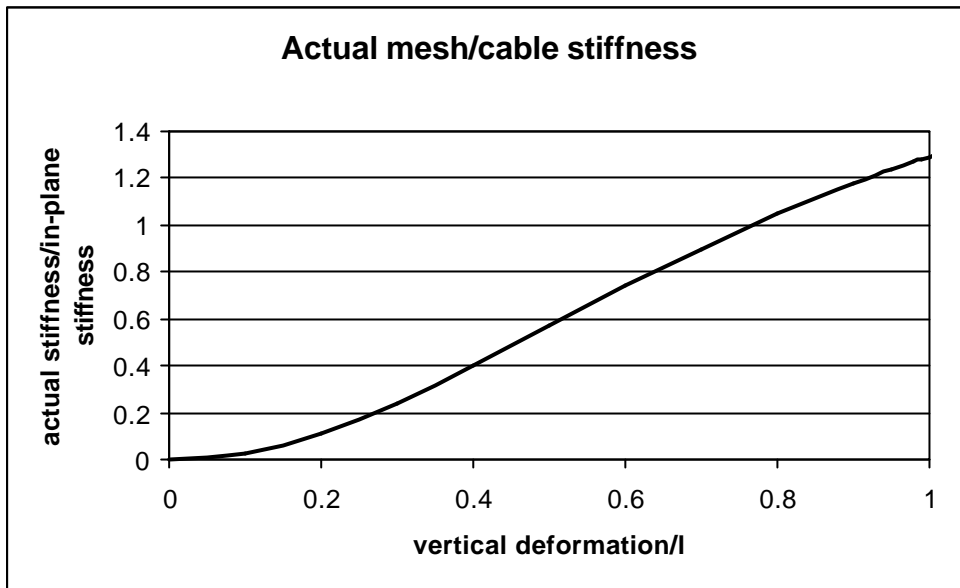
Figure 3-6 is a graphical representation of Equation (3.2.6) and shows how the actual stiffness develops with increasing deformation.

Figure 3-6 Actual stiffness as a function of deformation and in-plane stiffness

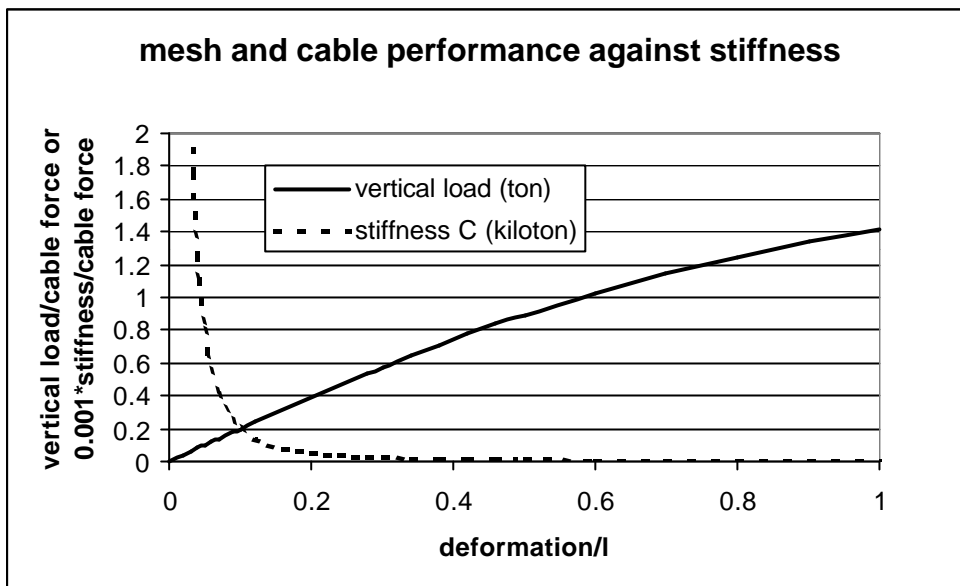
The vertical load shown in Figure 3-7 is derived from Equation 3.2.1 by assuming a constant mesh/cable force F . Such a condition could be achieved by pre-stressing the mesh/cable and by implementing some kind of yielding device. In such a case, optimum use is made of the potential of the mesh/cable. It is clear from this graph that, compared with the conventional situation as shown in Figure 3-3 and Figure 3-4, the mesh/cable is far more efficient at lower deformations.

In Figure 3-7 the *in-plane* stiffness, which would be required to induce the constant mesh/cable force, is also shown. In the absence of any pre-stressing and/or yielding devices, a variable *in-plane* stiffness could provide the same results. However, this appears to be an impractical solution.

Figure 3-7 Load bearing capacity and required stiffness for a constant mesh/cable force of 10 tons

From Figures 3-7 and Figure 3-8, it is clear that pre-stressing and maintaining a constant *in-plane* mesh/cable force can dramatically improve actual stiffness and resistance. However, some form of yielding device is required in order to prevent increasing *in-plane* forces and associated failure.

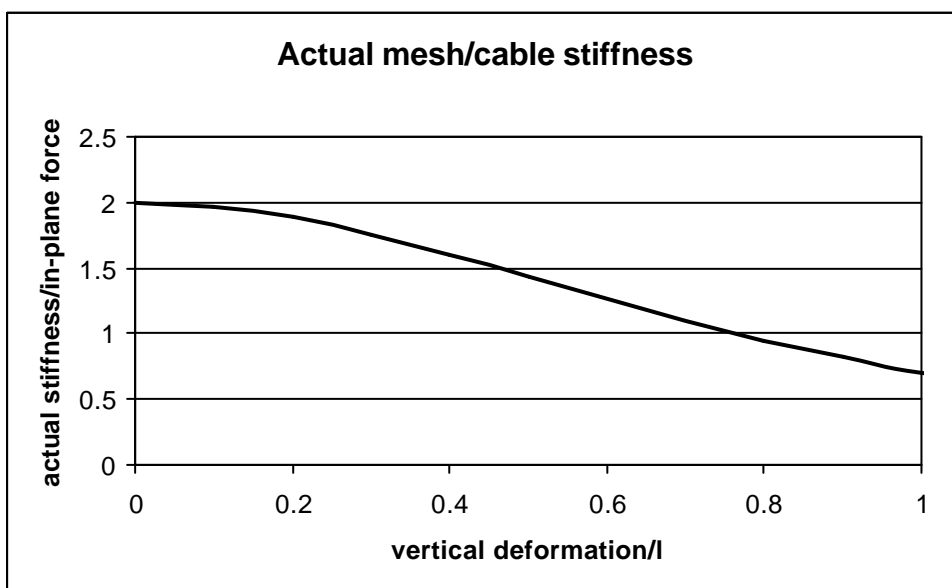
This expression is graphically depicted in Figure 3-8 where it is shown that the actual stiffness decreases with increasing deformation and that the actual stiffness is linearly related to the mesh/cable force. A direct comparison between Figure 3-8 and Figure 3-6 is not straightforward, as the actual stiffness is linearly related to the *in-plane* stiffness in the conventional case as shown in Figure 3-6. With increasing deformation, the mesh/cable force also increases in the conventional case and the strength of the mesh/cable will limit the allowable deformations and associated actual stiffness.

Figure 3-8 Actual stiffness as a function of (constant) in-plane force and deformations

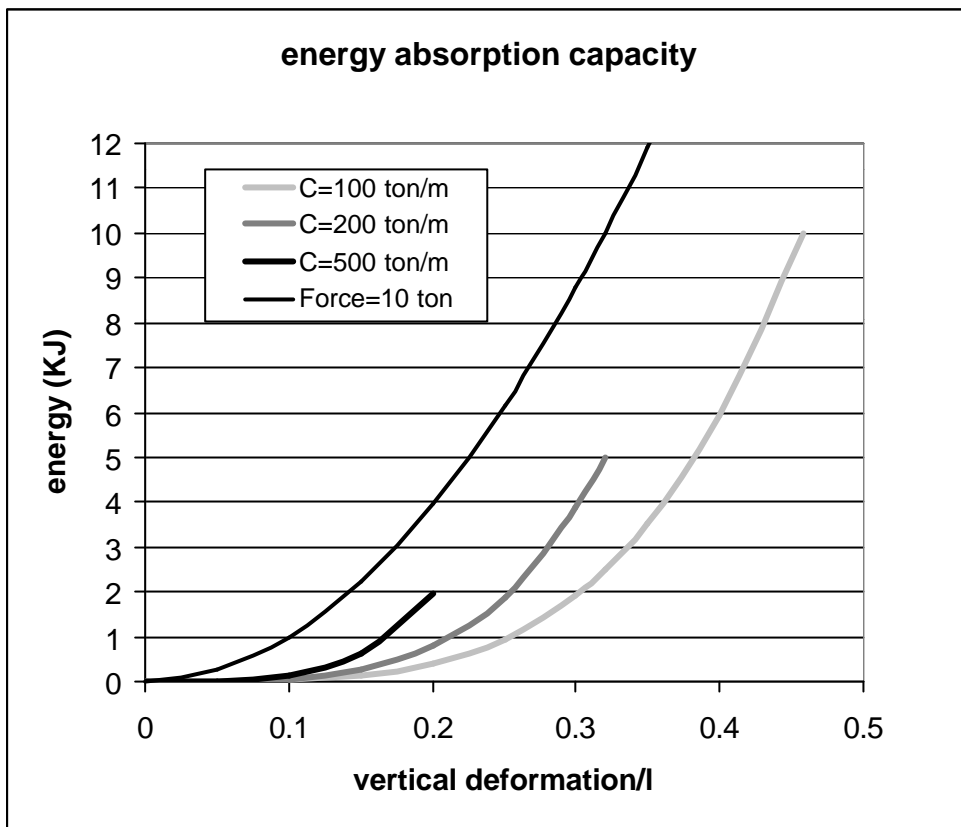
Equations 3.2.8 and 3.2.10 are graphically expressed in Figures 3-9 and 3-10 where the effect of stiffness on energy absorption capacity of the mesh/lacing can be observed for two *in-plane* strength values. The span l has been taken as 1 in both cases. Increasing stiffness leads to a decreased deformation capacity and thus energy absorption capacity. The constant force situation leads in all cases to the most efficient system allowing (theoretically) unlimited deformation. An increase in strength results in a similar increase of energy absorption capacity in the case of a constant *in-plane* force F . However, in the more common case of a constant *in-plane* stiffness C , an increase in strength leads to a disproportional increase in energy absorption capacity. Doubling the strength in the example cases resulted approximately in a six-fold increase of energy absorption capacity. (Termination of the graphs indicate the relevant failure point).

Figure 3-9 Effect of varying in-plane stiffness on energy absorption capacity for a mesh/cable strength of 10 ton

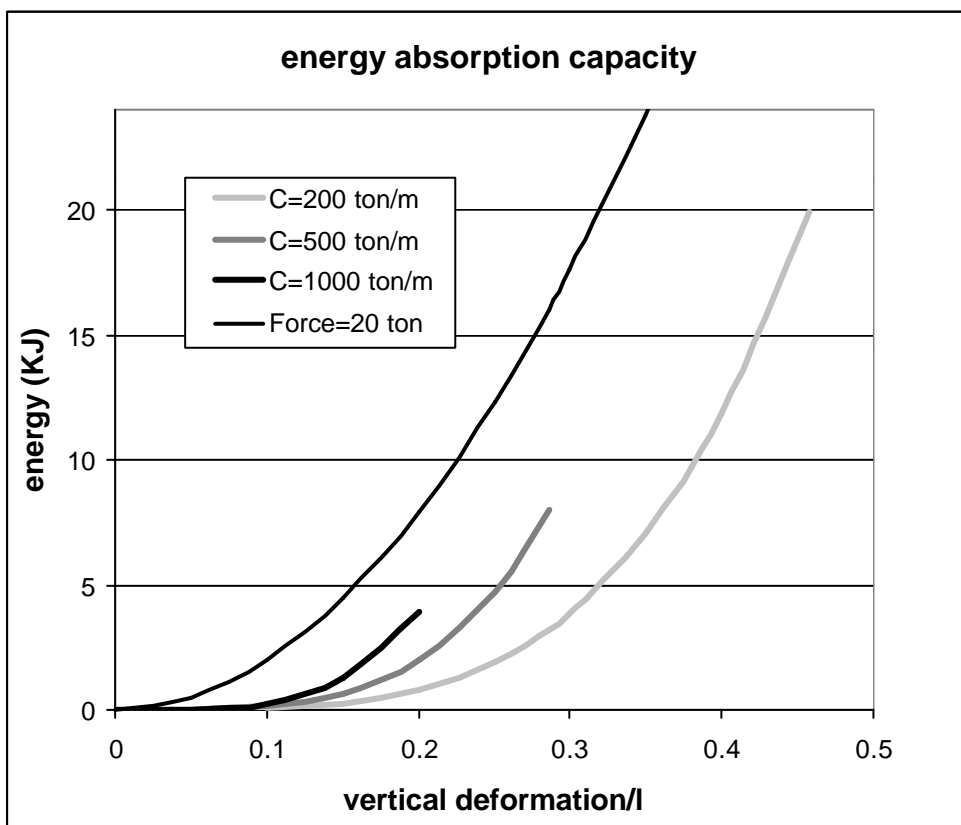
Figure 3-10 Effect of varying in-plane stiffness on energy absorption capacity for a mesh/cable strength of 20 ton

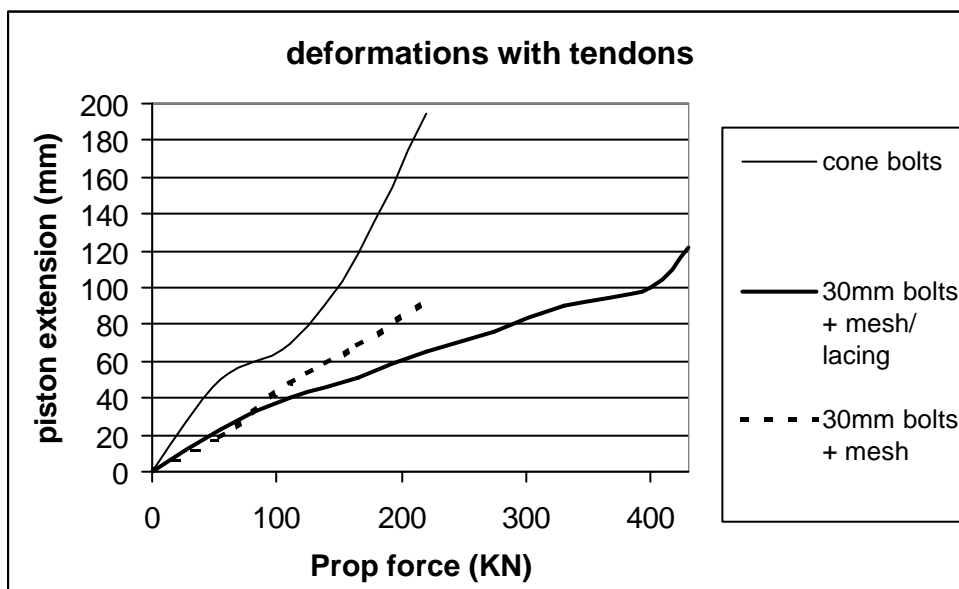
Typical mesh used was either a diamond mesh with an aperture of 100 mm and a wire thickness of 4.2 mm or a welded mesh with the same aperture but with a wire thickness of 3.15 mm.

Figure 4-1 Tests in which tendons were used to support the mesh/lacing

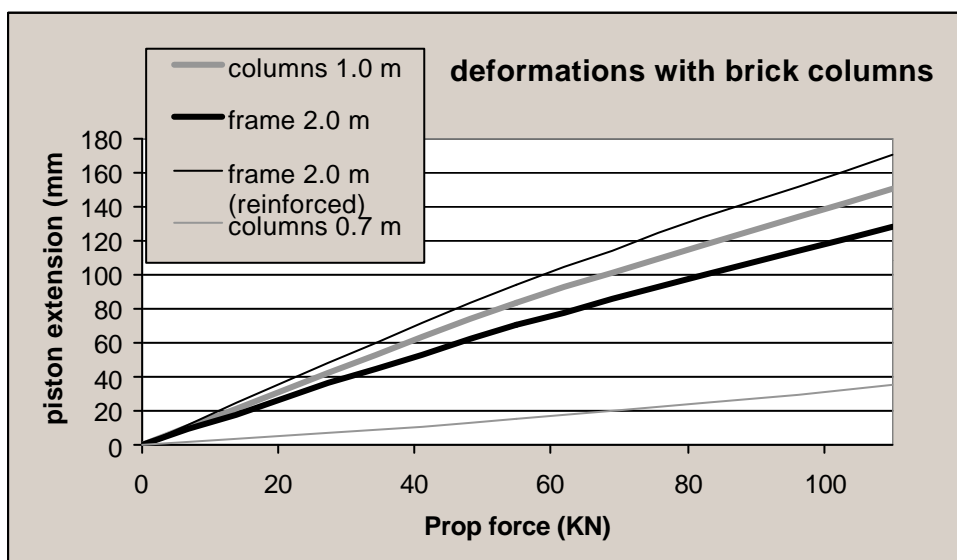
Reducing the column spacing from 1.0 m to 0.7 m led to a dramatic increase in stiffness. It is believed that in this case only a limited amount of load was transmitted through the mesh while the bulk is directed straight into the columns. However, localised mesh failure still took place around the columns at a prop force in excess of 110 kN. Even the reduced mesh load resulted in premature failure due to a combination of increased mesh stiffness and stress concentrations.

Figure 4-2 Tests in which brick columns were used to support the mesh

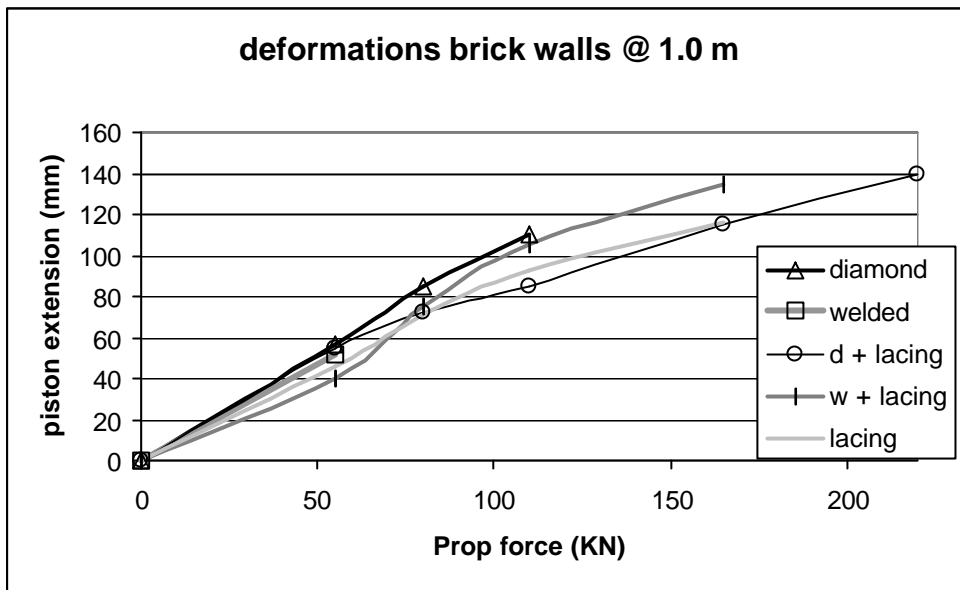
are depicted in Figures 4-3 and 4-4 where the variations in stiffness and strength can be observed.

Figure 4-3 Tests in which brick walls were used to support the mesh/lacing (spaced at 1.0 m)

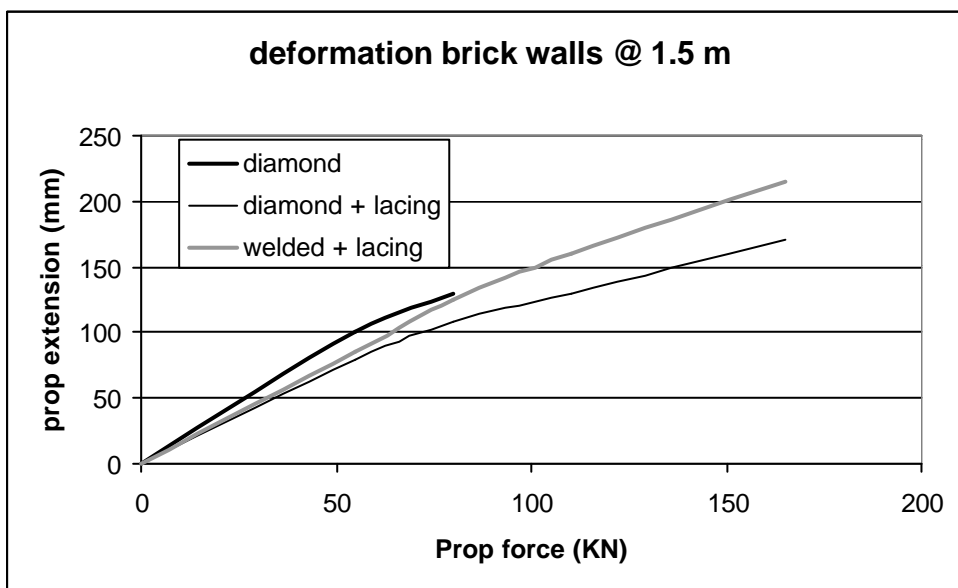
Figure 4-4 Tests in which brick walls were used to support the mesh/lacing (spaced at 1.5 m)

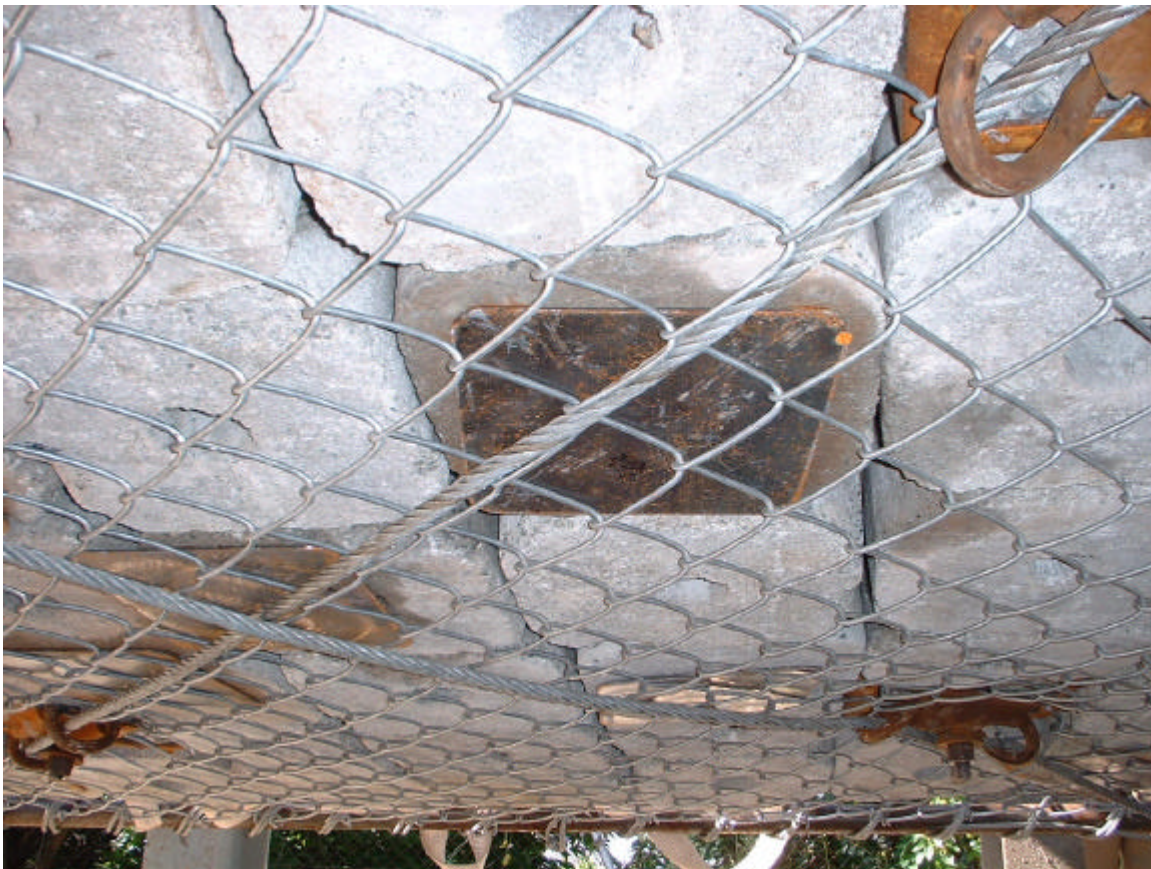
For this test, a diamond mesh with an aperture of 100 mm and a wire thickness of 4.2 mm was used. Lacing was done with a cable as shown in Figure A-1. Four cone bolts, grouted in thin walled pipes and spaced at 1 m, were used to suspend the assembly of concrete bricks that is shown in Figure A-1.

Figure A-1 *Lacing and diamond mesh used in the test on 30/10/01*

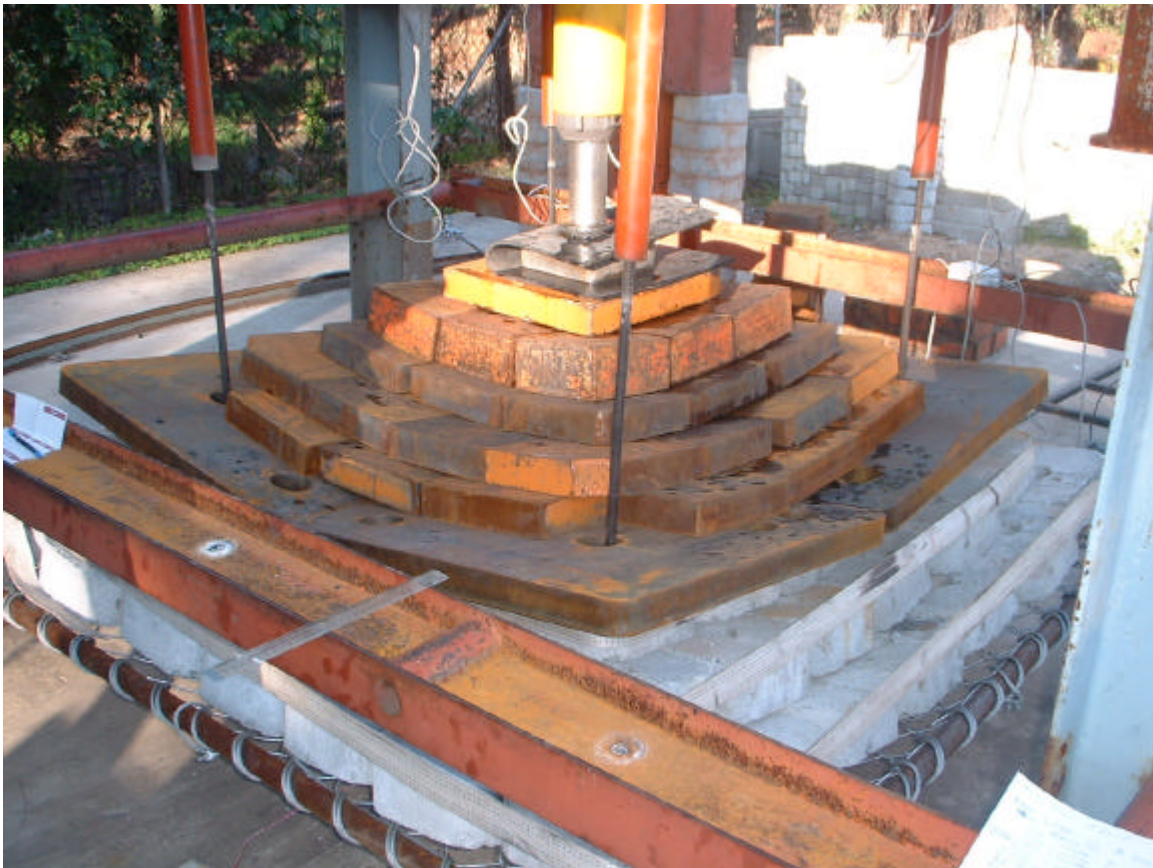
Figure A-2 Yielding of cone bolts at the end of the test on 30/10/01 (indicated by white tape relative to the bottom of the tube)

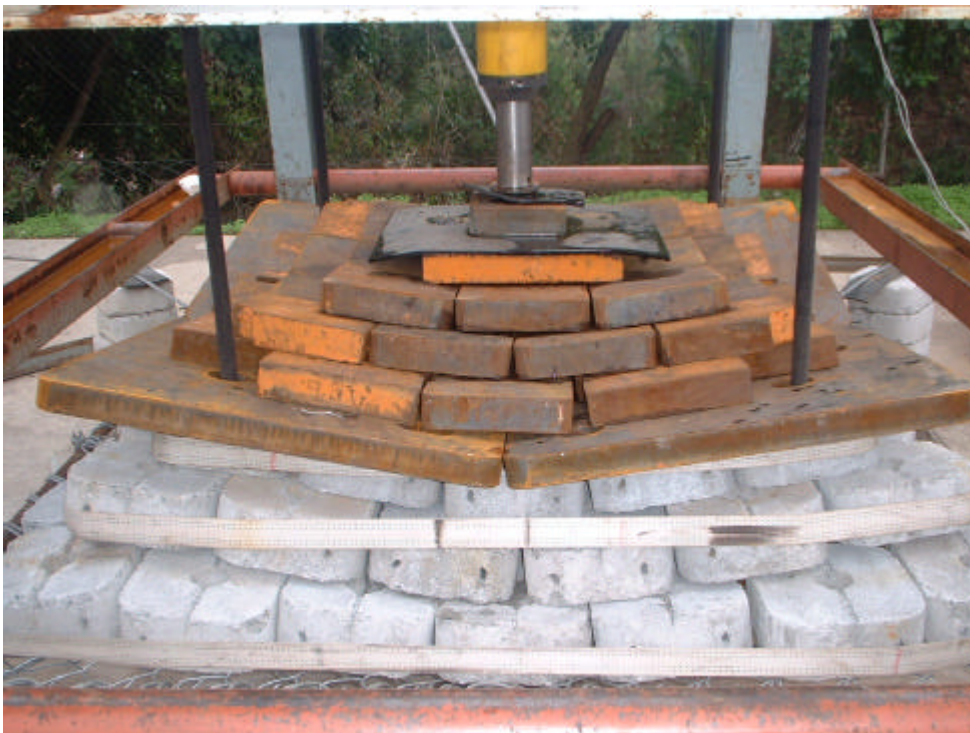
Extra strong tendons were selected for this test in order to test the fabric capacity. This test also allows a comparison with the previous test with cone bolts. Bolts with a diameter of 30 mm were used in this test and the theoretical yield strength should be in excess of 150 kN.

Figure A-5 *Test on 09/11/01 with 30 mm bolts*

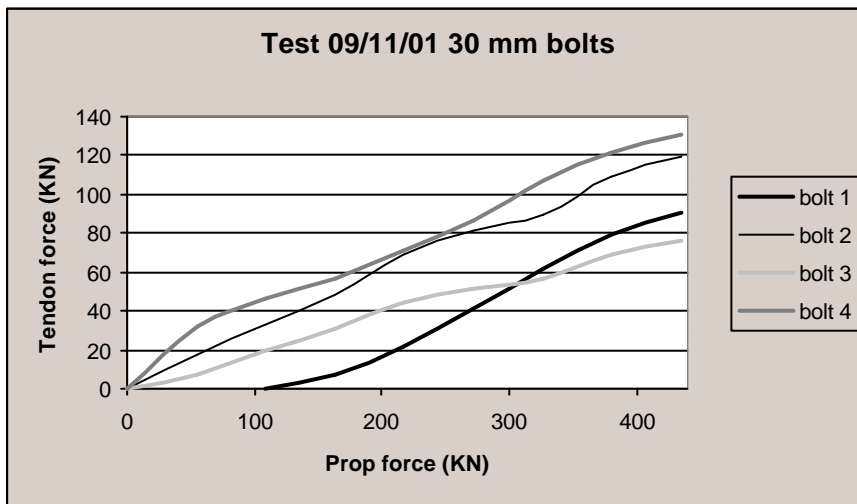
Figure A-7 Monitored tendon forces

At a maximum prop force of around 440 kN, the system still did not fail. Tendon forces in excess of 100 kN were measured and the only evidence of failure could be observed around the washers at some of the tendons (Figure A -7). The imposed load is accounted for by the sum of the tendon forces. It is therefore unlikely that much load is transmitted through the lacing away from the tendons.

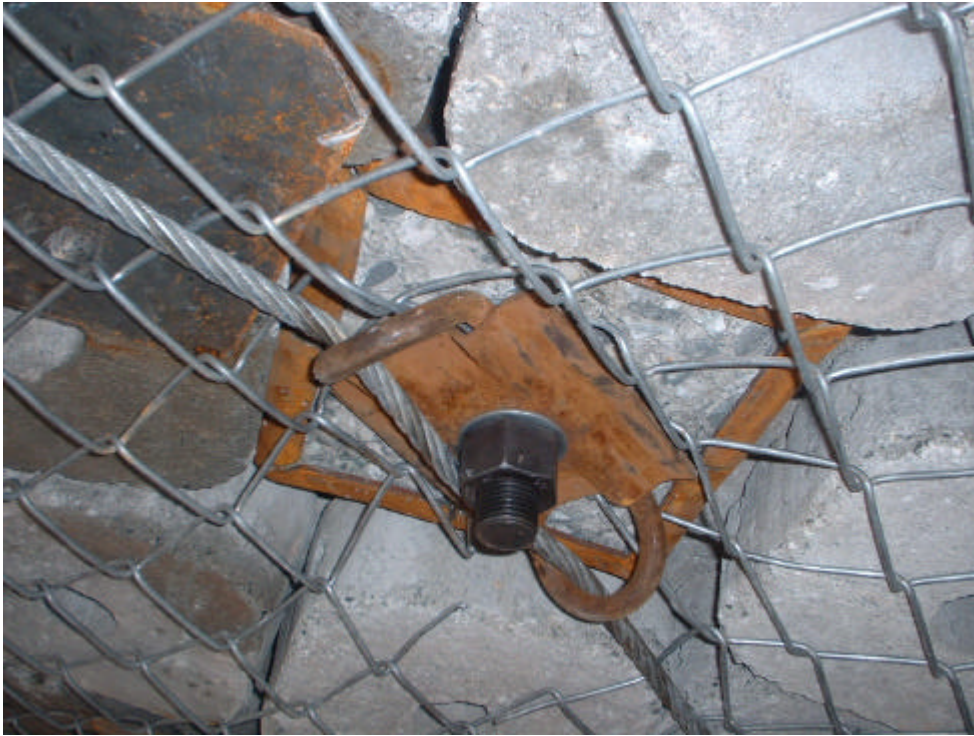
Figure A-8 *Localised mesh failure near the tendon*

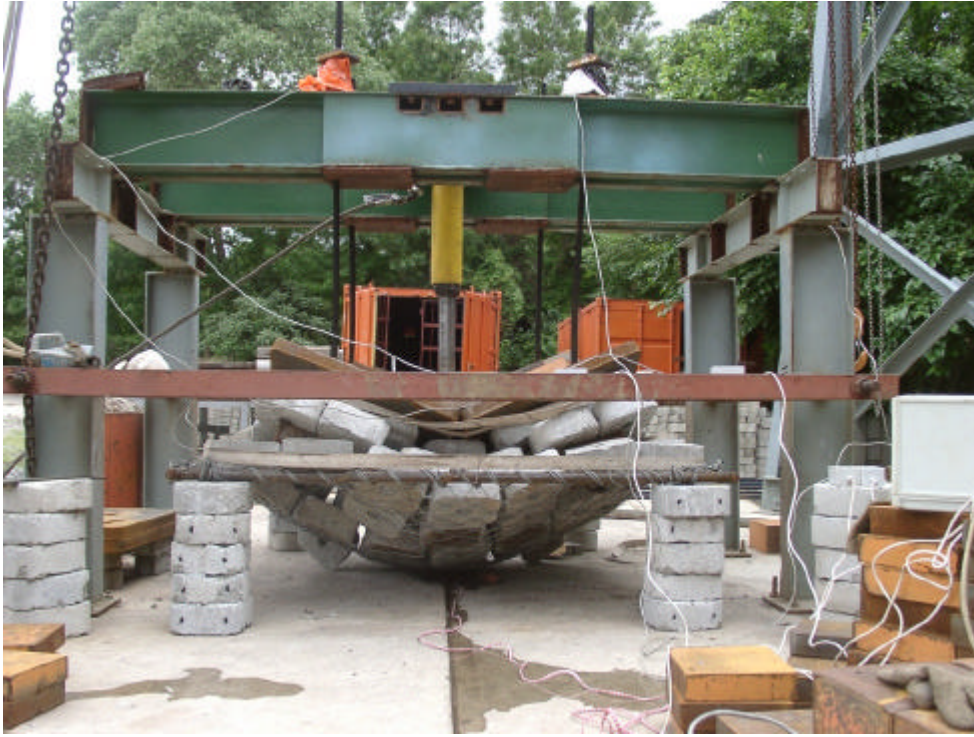
This test was similar to the previous one except for the fact that no lacing was used in this case. The 30 mm bolts spaced at 1.0 m were applied again with the diamond mesh. The frame, in which the mesh was suspended, was however supported by brick columns in this case.

Figure A-9 **Test 19/11/01 with 30 mm bolts and without lacing**

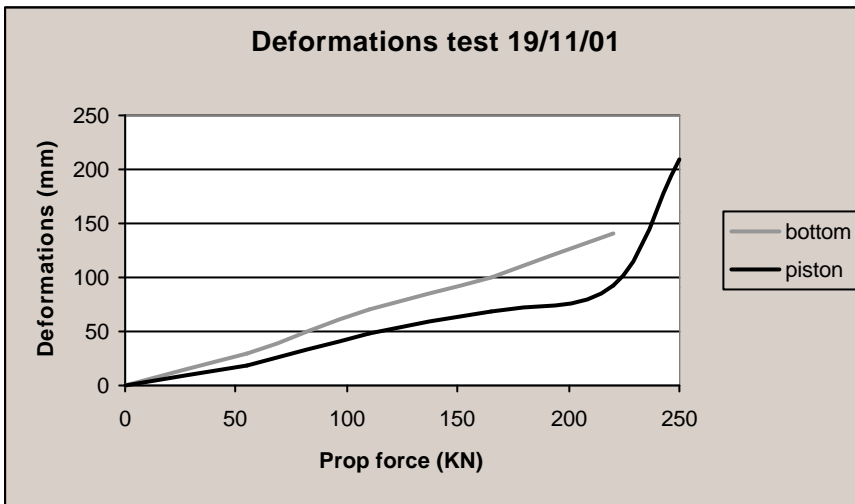
Unlike the previous test, the fabric (mesh in this case) appears to carry less than 40 % of the load near the end of the test. This estimation is based on the results of the tests on 13/12/01 and 11/01/02. As the deformations are smaller, reduced fabric contribution is explained based on a relative competent "rock mass". With further deformations, the concrete bricks will loose coherence and in increasing percentage of load will have to be carried by the fabric.

Figure A-10 *Monitored load-deformation characteristics*

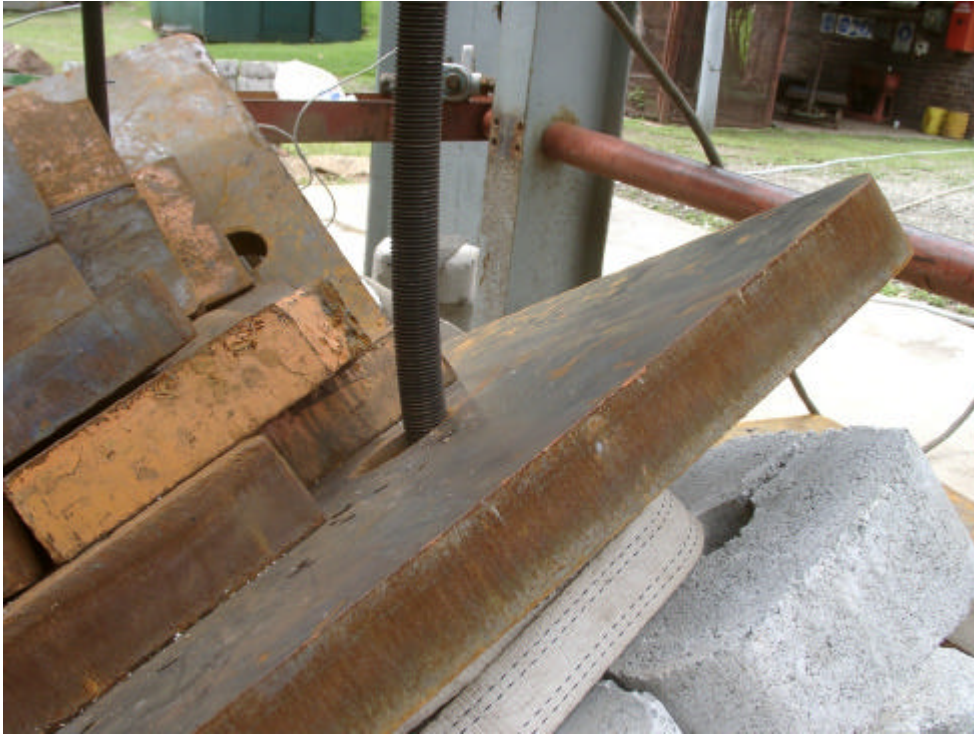
Figure A-12 **Failure of mesh (and system) in test 19/11/01**

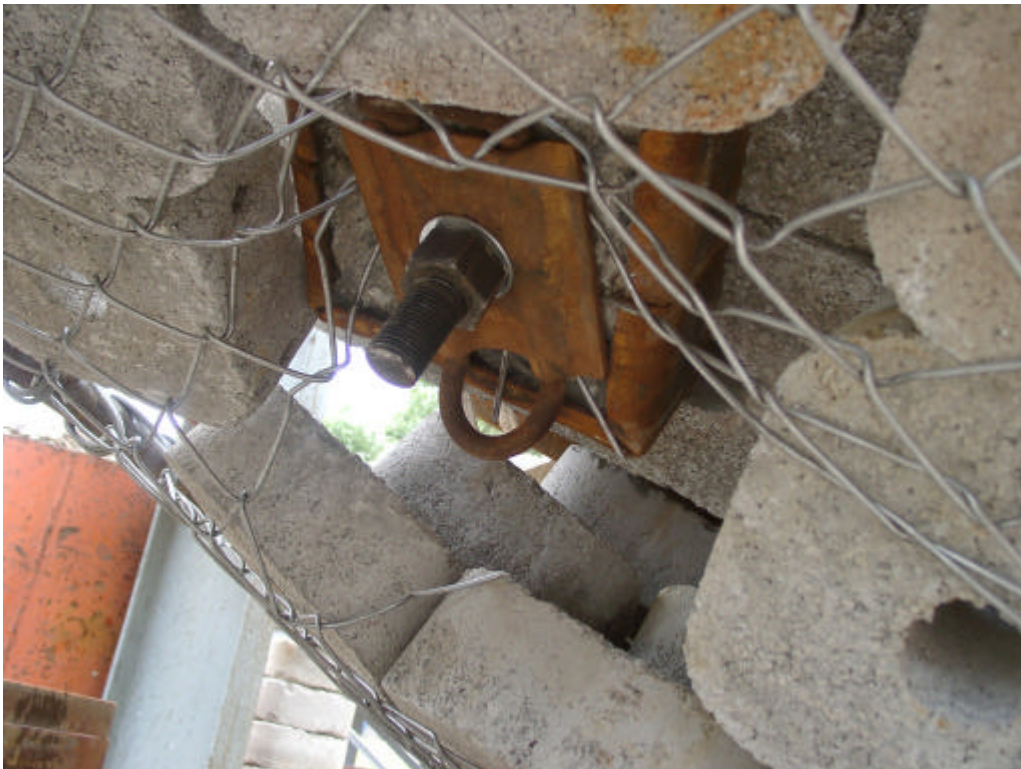
Figure A-13 **Bending of bolts in test 19/11/01**

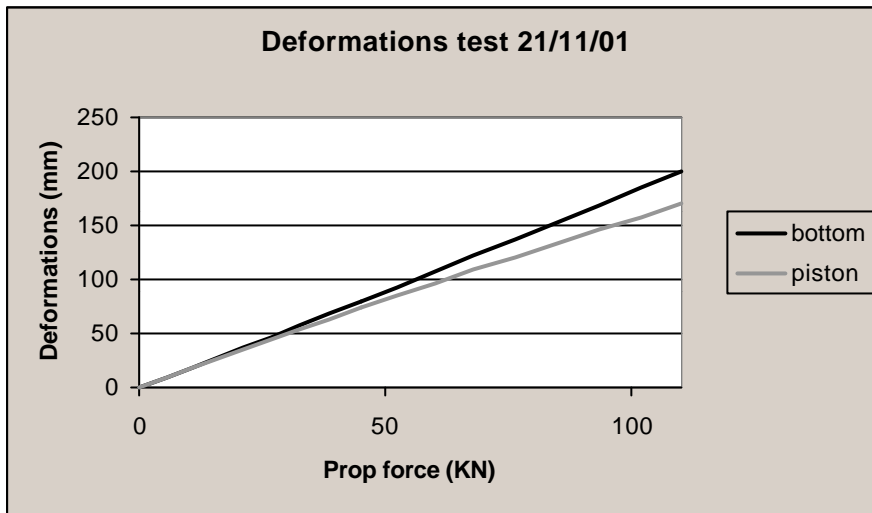
Diamond mesh with an aperture of 100 mm and a wire thickness of 4.2 mm was used again in this test. Suspended in the standard bar frame and supported on brick columns underneath the frame. The effective span was therefore 2.0 m. The load spreading system consisted of three layers of concrete blocks (5 x 5, 4 x 4 and 3 x 3), one layer of square steel blocks of 32 cm length, and one layer of square steel blocks of 28 cm length. The load deformation characteristics are displayed in Figure A-14. Unfortunately, no photographs are available.

Figure A-14 Monitored load deformation characteristics.

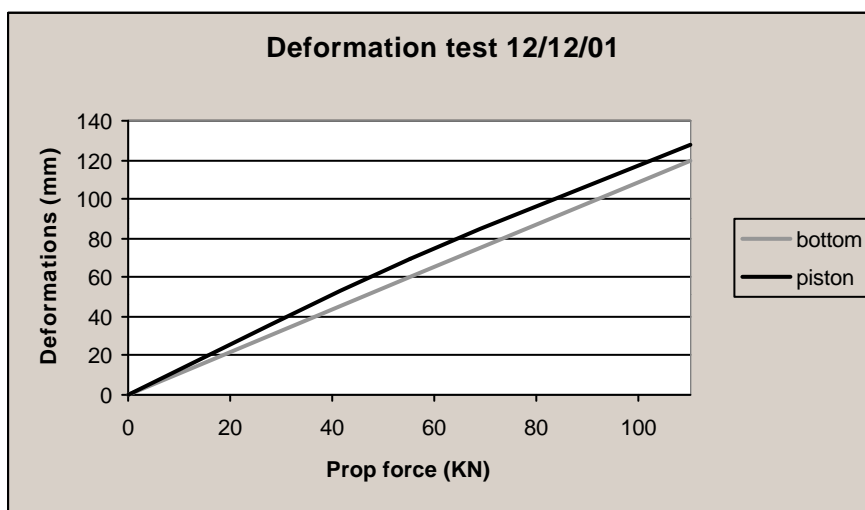
Diamond mesh with an aperture of 100 mm and a wire thickness of 4.2 mm was used again for this test. The mesh was suspended in the standard bar frame and supported on brick columns underneath the frame. The effective span was therefore 2.0 m. The load spreader consisting three layers of concrete bricks (5 x 5, 4 x 4 and 3 x 3), one large steel plate, one steel plate 40 x 40cm, two steel plates 30 x 24 cm, and three steel plates 25 x 25 cm. The results are depicted in Figure A -15 where it can be seen that the system response is much stiffer than in the case of test on 21/11/01. The reason for this difference is the absence of any frame reinforcement in the latter test. While the bar frame did not yield, the mesh was ripped of the bar frame at a load in excess of 110 kN.

Figure A-15 Monitored load-deformation characteristics.

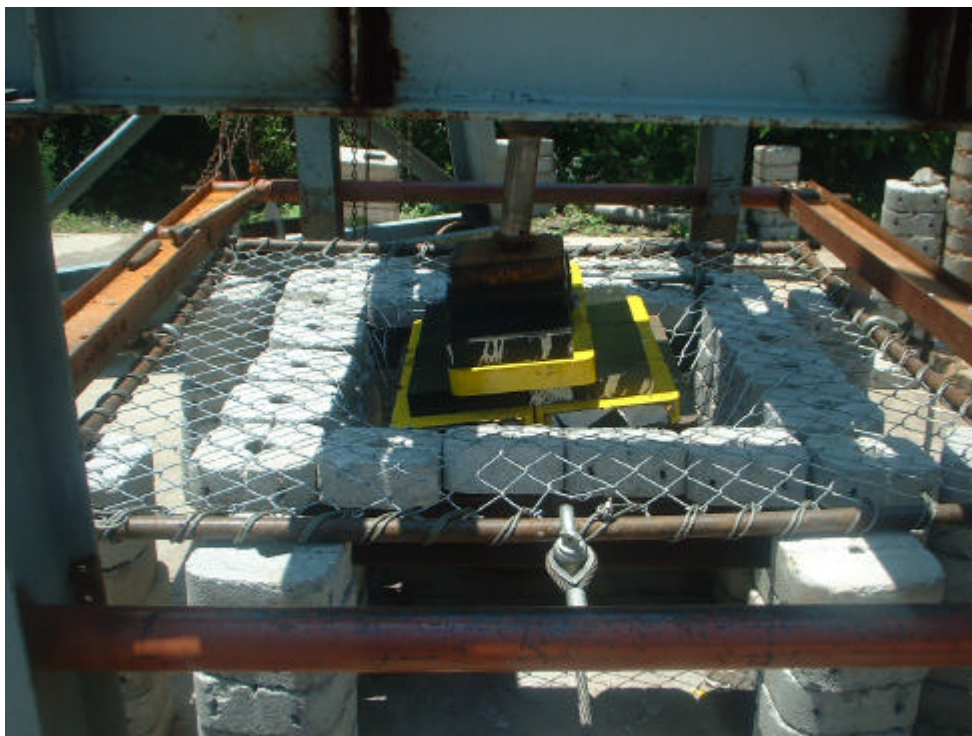
Diamond mesh with an aperture of 100 mm and a wire thickness of 4.2 mm and suspended in the standard bar frame. Directly loaded onto a 75 x 75 cm steel plate with additional steel blocks on top. Supported by brick walls spaced 1.0 m wall to wall (see Figure A 9.1). This set up was selected in order to avoid the stress concentrations associated with the brick columns.

Figure A-18 Failure of mesh in test 11/01/02

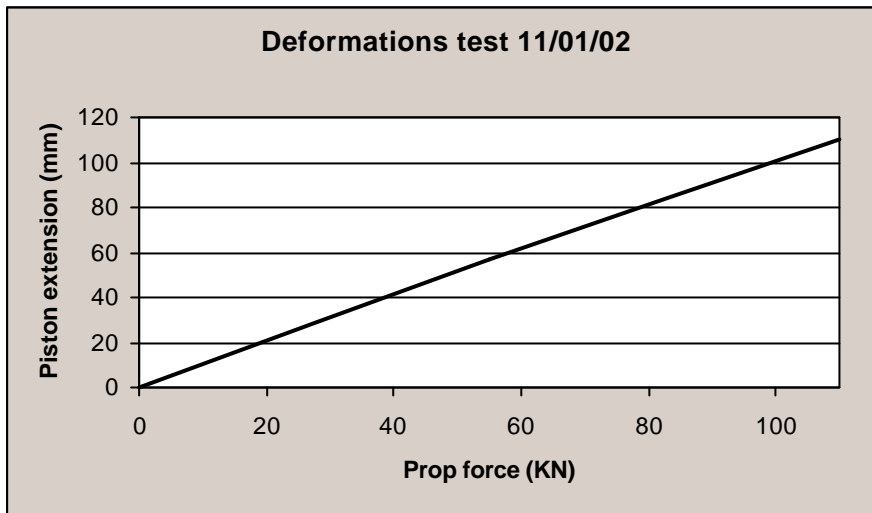
The monitored deformations are shown in Figure A -19.

Figure A-19 *Monitored load-deformation characteristics*

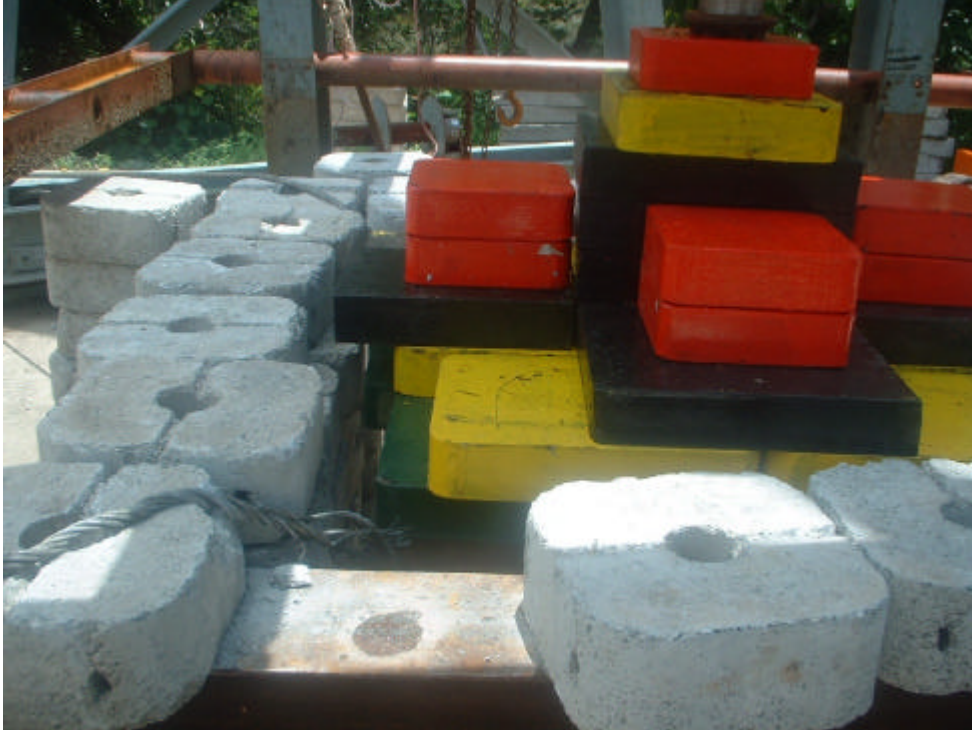
In this test the effect of lacing was evaluated. The lacing was supported across brick walls with an internal spacing of 1 m. Load was applied through a large steel plate while various other

steel blocks were used as spacers. (Figure A -20)

The monitored deformations are shown in Figure A-21, where it can be seen that the system stiffness gradually increases with increasing load and deformation. This is to be expected as the lacing becomes more effective with increasing vertical deformation. Final failure occurred at a prop force in excess of 165 kN and manifested itself as cable breakage initiating from the edge of the steel plate. At a prop force of 110 kN it was observed that some of the concrete bricks, which were in direct contact with the lacing, showed signs of local crushing (Figure A -20).

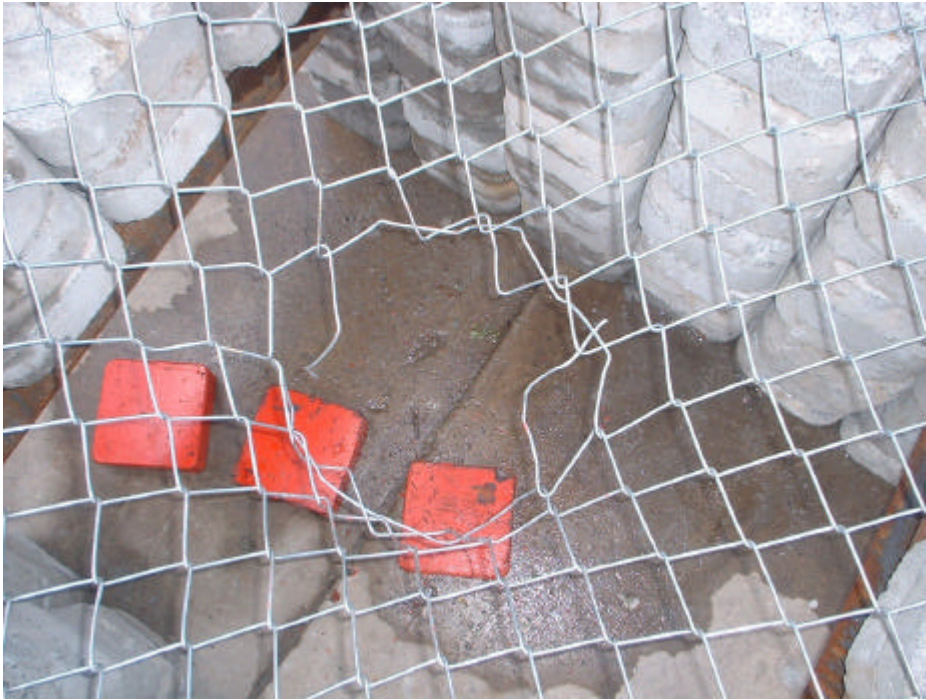
Figure A -22 shows how the small steel plate has punched through the mesh.

Figure A-22 **Failure in the test on 21/01/02**
