Safety in Mines Research Advisory Committee

Final Project Report

**Performance of various types of
containment support under quasi-static
and dynamic loading conditions**

Project number: GAP 810

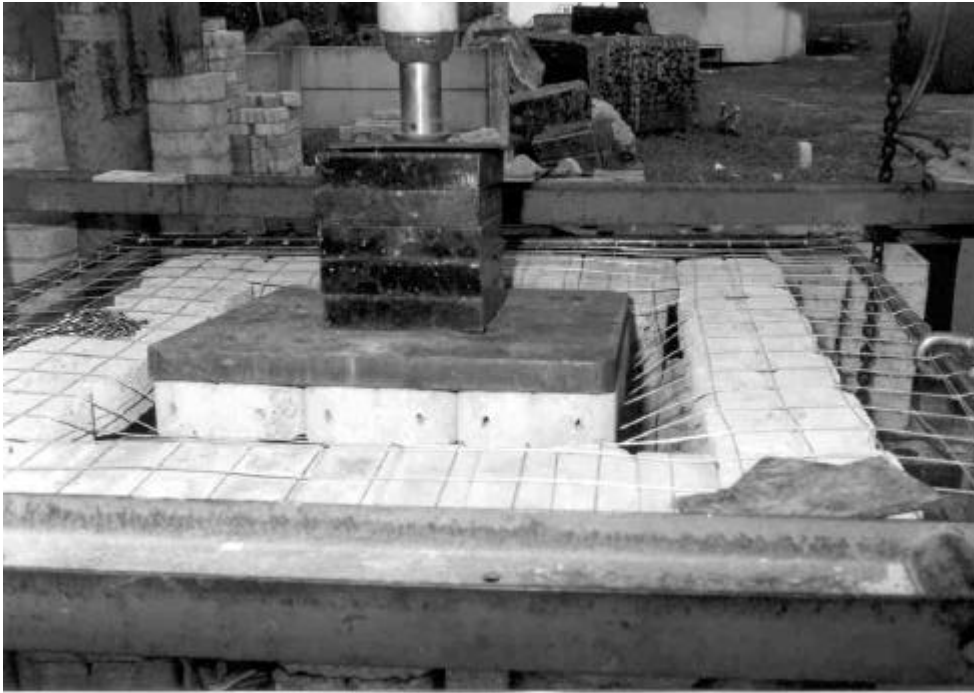
In this test, a welded mesh with an aperture of 100 mm and a wire thickness of 3.15 mm was used. The mesh was suspended in the standard bar frame which in turn was supported on brick walls with an internal spacing of 1.0 m. The load was applied via a layer of concrete bricks underneath the 75 x 75 cm steel plate. Final failure took place at a prop force of approximately 70 kN and manifested itself as broken strands along the edges of the brick wall and the edges of the layer of concrete bricks. The monitored deformations are shown in Figure A -24 and these results are comparable with the results on diamond mesh in the test on 11/01/02, which are depicted in Figure A-19 Although a nominal increase in stiffness can be observed in the welded mesh, the difference appears to be marginal and not sufficient to explain the decrease in strength. The smaller wire thickness in the welded mesh will account for a theoretical reduction in strength, as well as stiffness, of around 60 %. This may account for the strength reduction. Welded mesh is typically found to be much stiffer than diamond mesh; a stiffness reduction of 60 % would normally not be sufficient to reduce the stiffness of welded mesh to that of a diamond mesh. It is possible that due to the geometry of these tests, whereby the loaded area is relatively large compared to the total mesh area, the effect of mesh stiffness is less pronounced than in tests with a (relatively) smaller loaded area.

Figure A-23 *Failure of welded mesh in test 24/01/02*

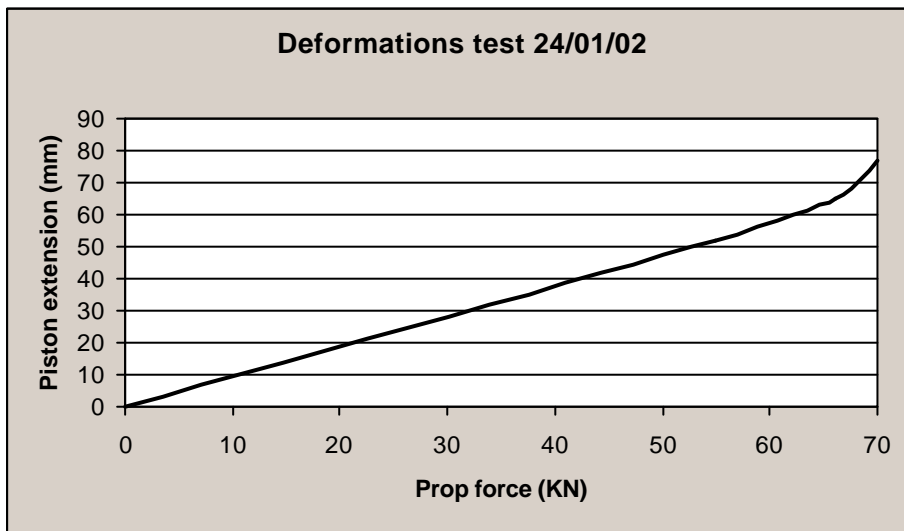
Figure A-24 *Monitored load-deformation characteristics*

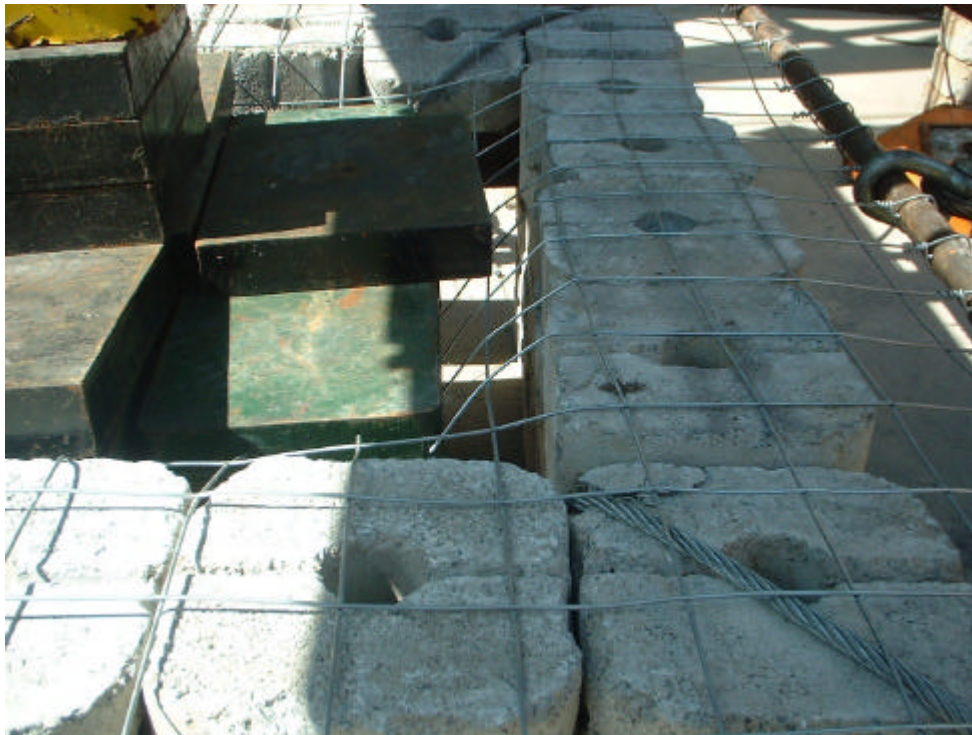
Welded mesh with an aperture of 100 mm and a wire thickness of 3.15 mm suspended in the standard bar frame was used for this test. In addition to the mesh, the standard lacing was used. The system was supported on brick walls with an internal spacing of 1.0 m. Loading was via a 75 x 75 cm steel plate directly onto the mesh. The resulting deformations are shown in Figure A -26. Mesh failure, at a prop force of less than 110 kN, appears to be associated with an increase in the rate of deformation. Further loading of the system resulted in a decrease in the rate of deformation, similar to that observed in the test on lacing (see Figure A -21).

Figure A-25 Failure in the test on 12/02/02

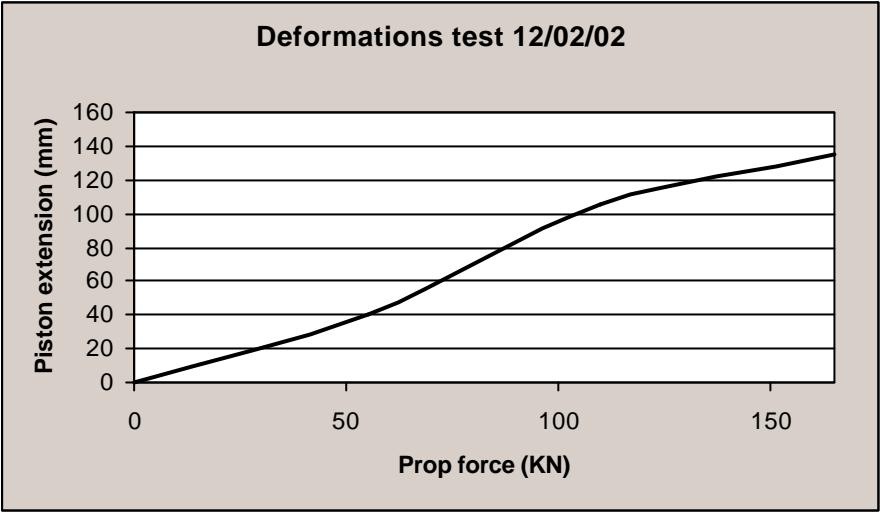
Figure A-26 *Monitored load-deformation characteristics*

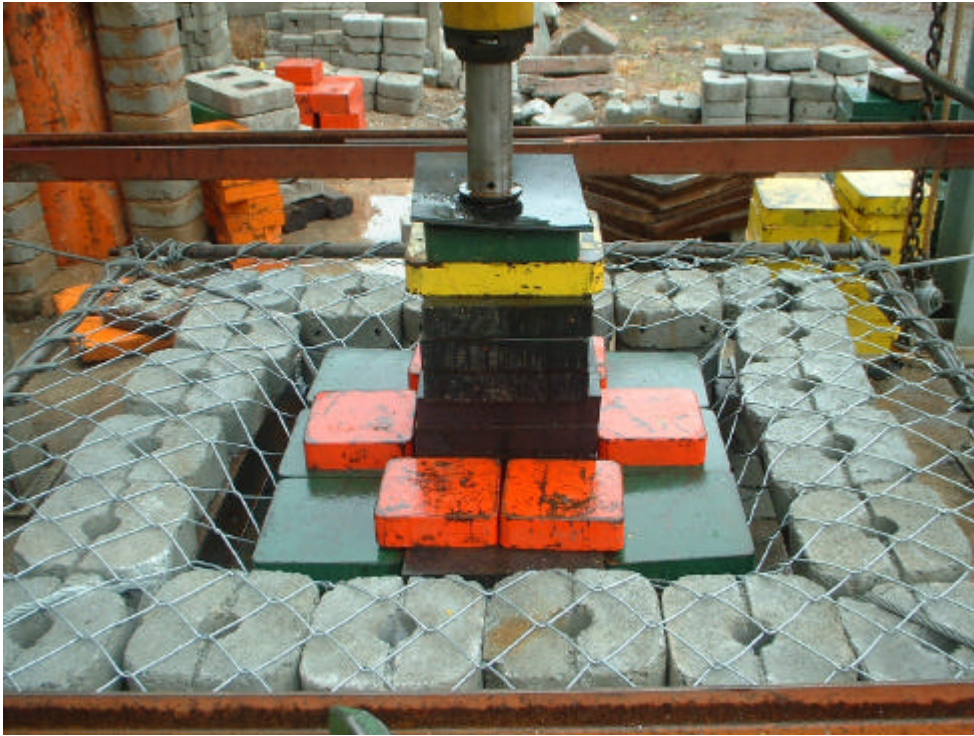
Figure A-27 Failure of mesh and lacing in the test on 14/02/02

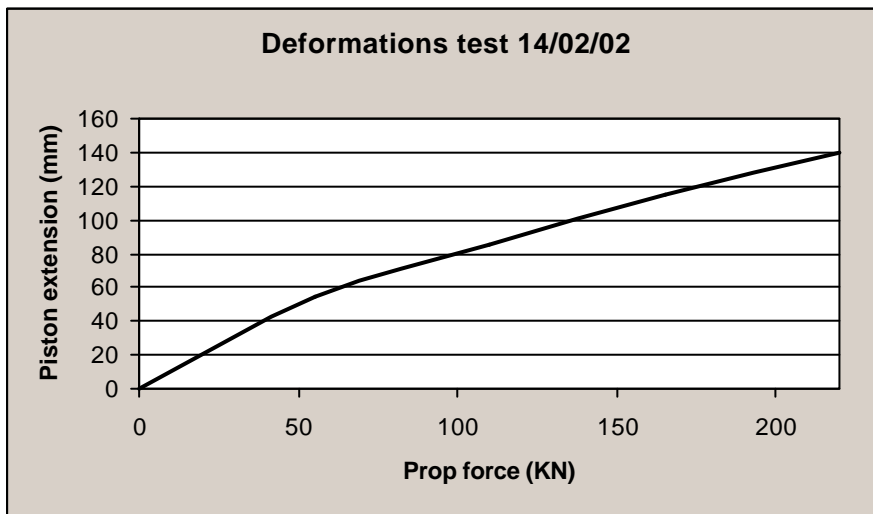
Figure A-28 Monitored load-deformation characteristics

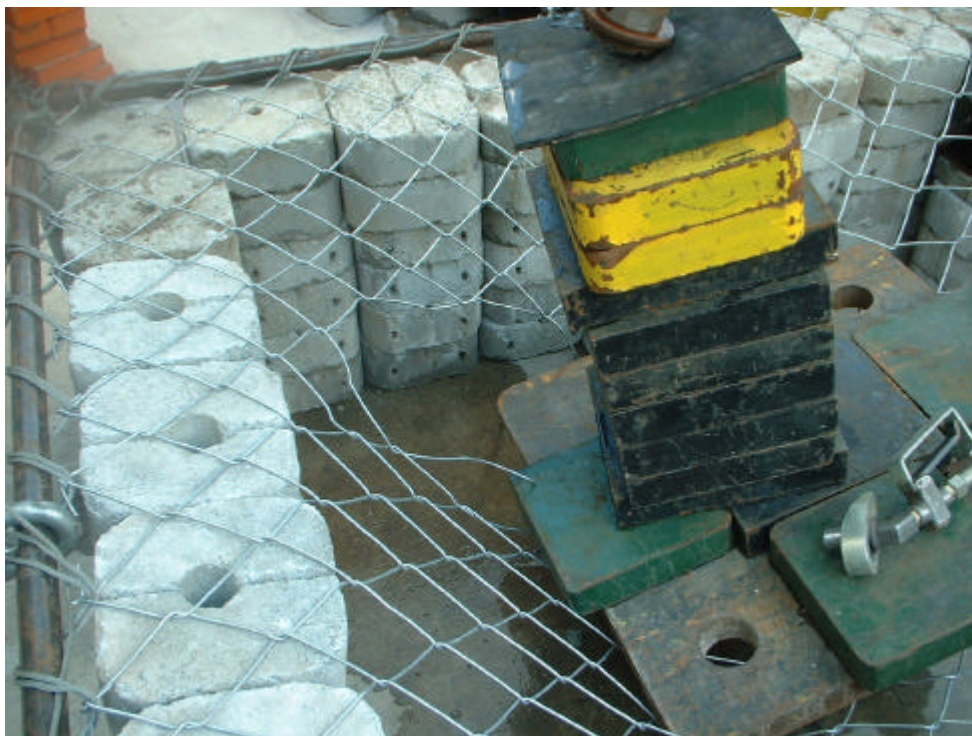
FigureA-29 *Mesh failure in the test on 20/02/02*

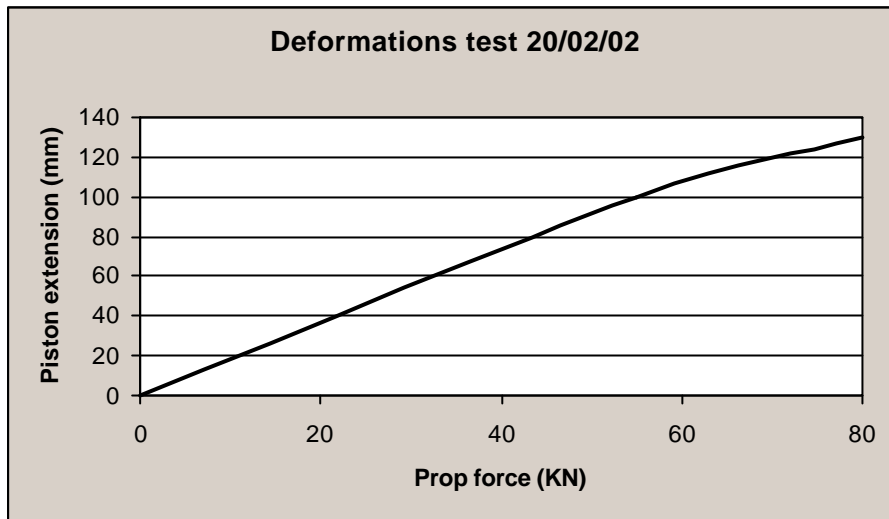
Figure A-30 *Monitored load-deformation characteristic*

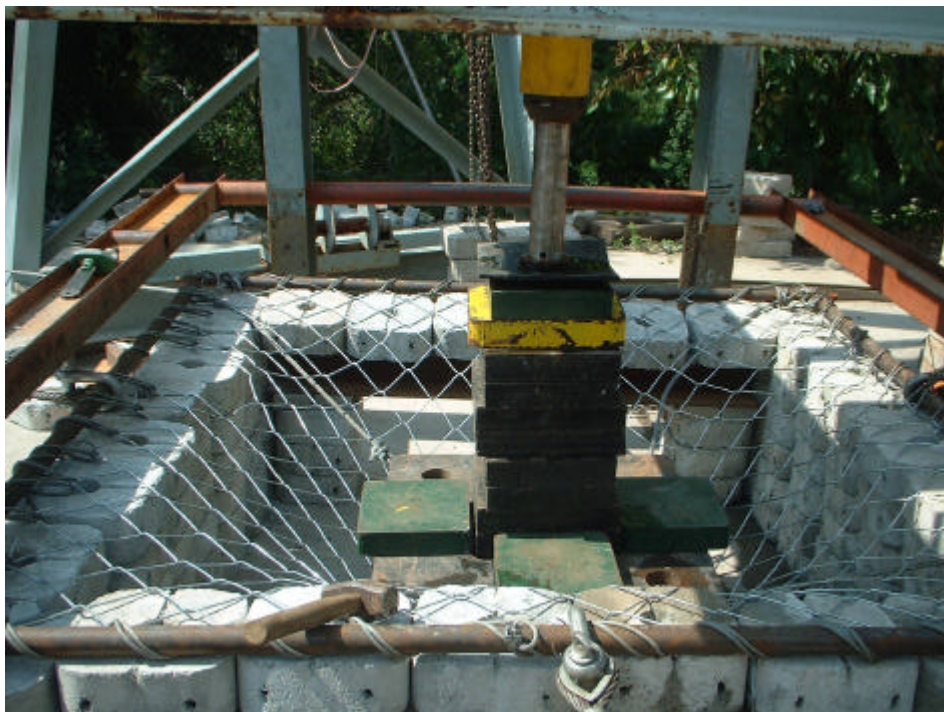
Figure A-31 Failure of mesh and lacing in the test on 27/02/02

cables become detached. It was also observed that the mesh started to tear off the frame, but this may have been a secondary effect. No other failure was observed.

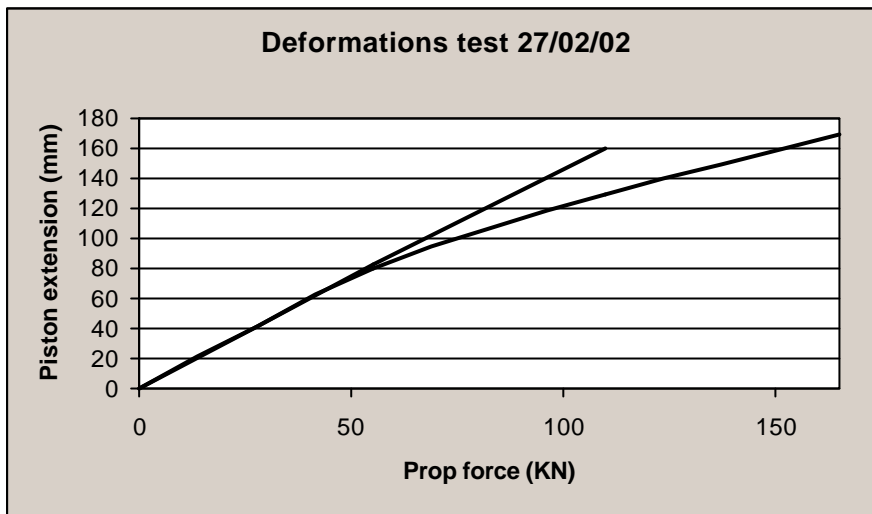
Figure A-32 Monitored load-deformation characteristics for both tests

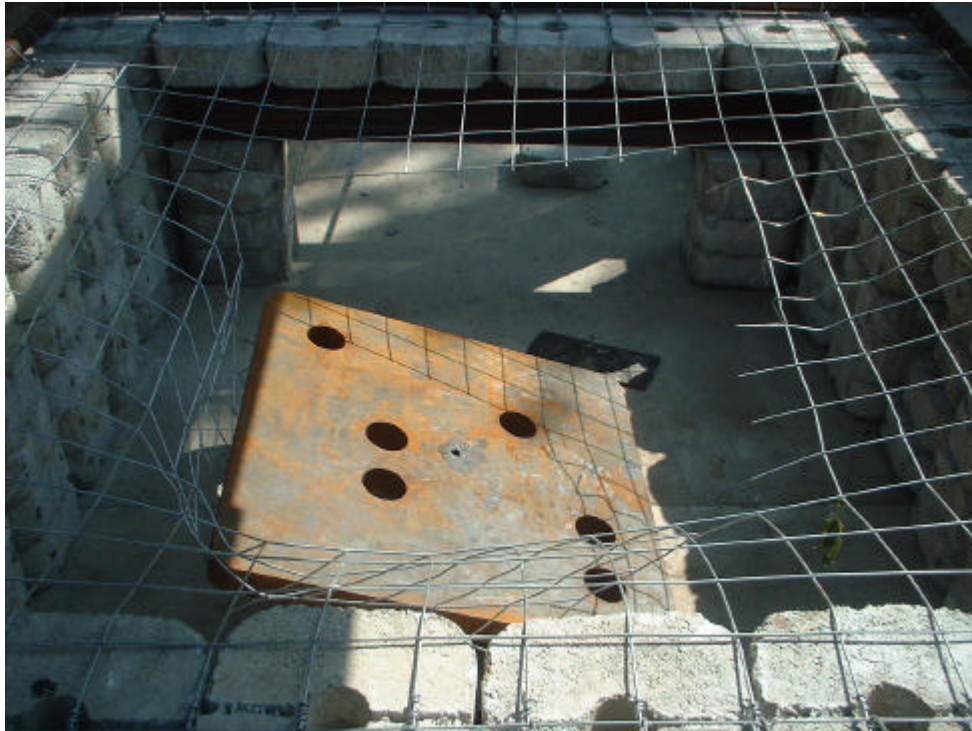
Figure A-33 Mesh failure in the test on 05/03/02

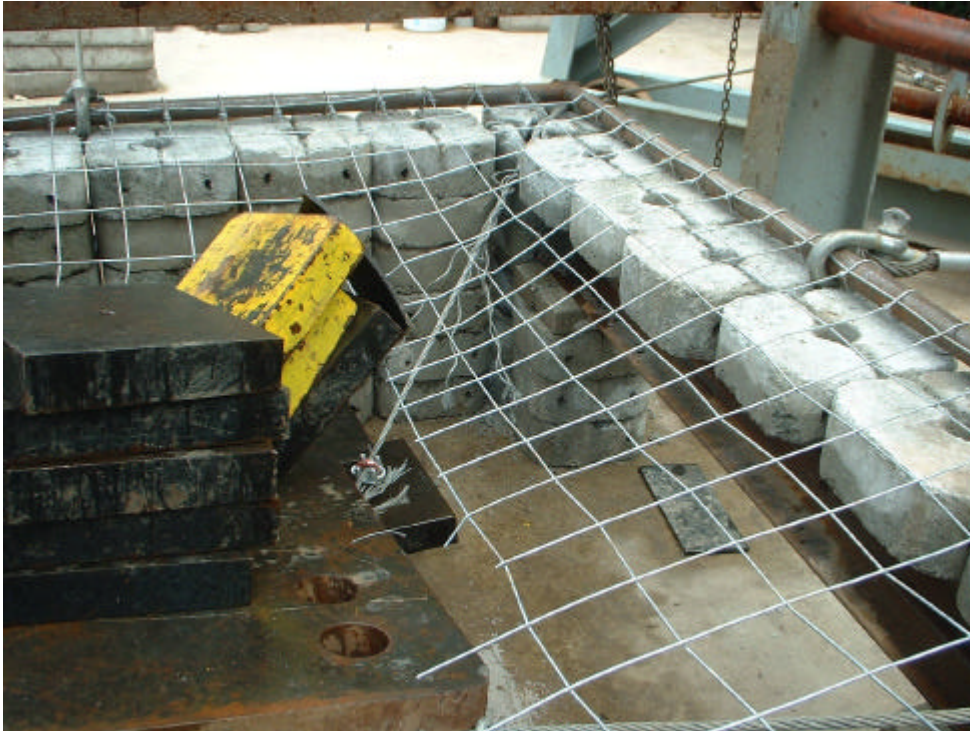
Figure A-34 Mesh and cable failure in the test on 07/03/02

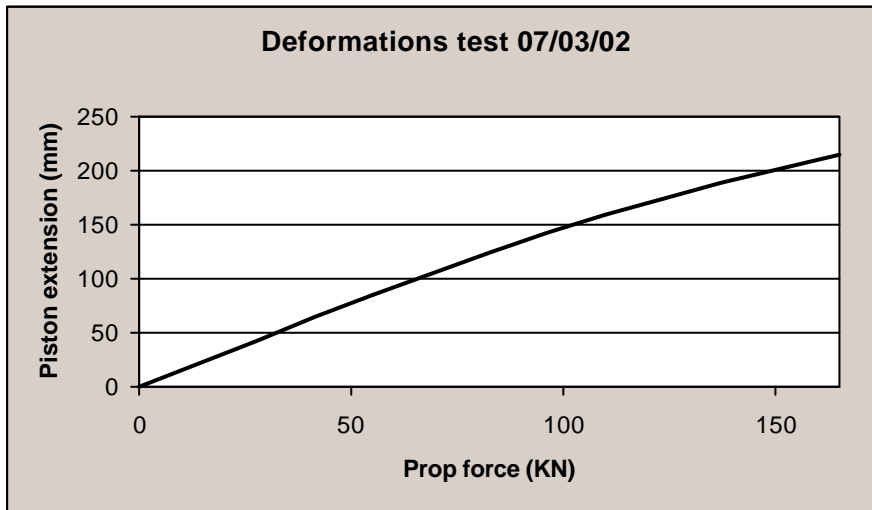
Figure A-35 Monitored load-deformation characteristics

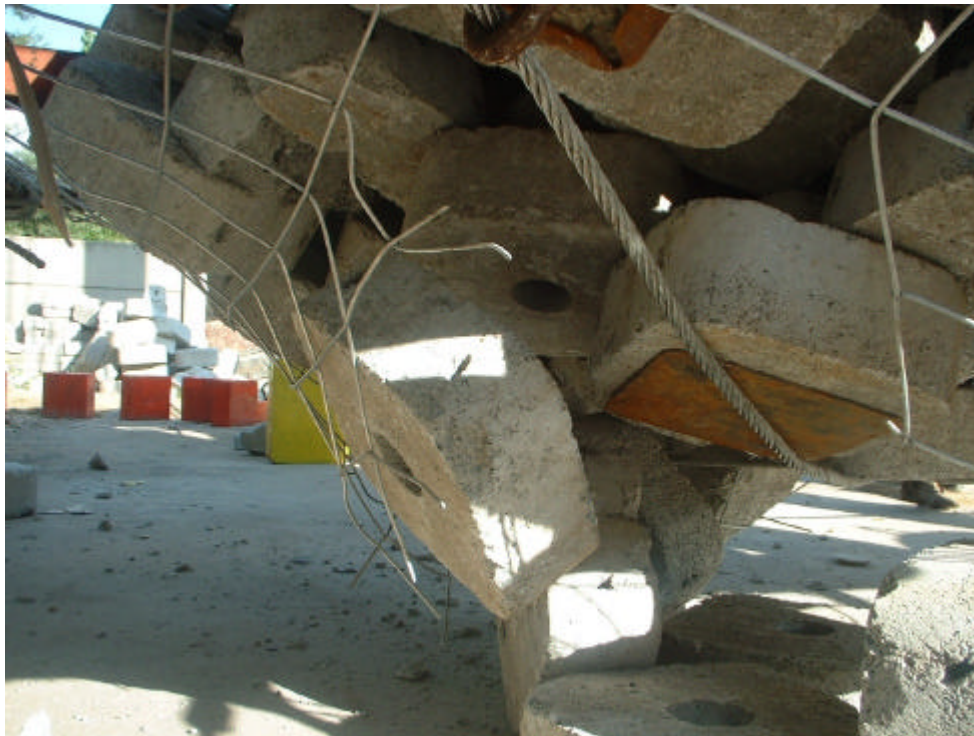
Figure A-38 *Mesh failure in the test on 17/01/02*

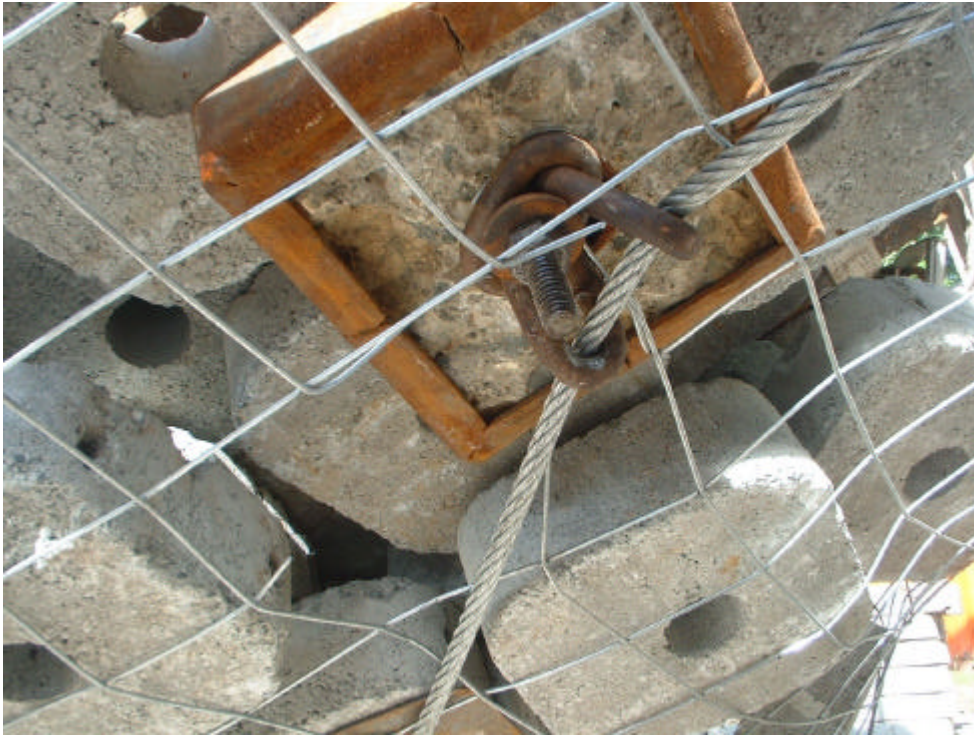
Figure A-39 *Initiation of mesh failure in the test on 17/01/02*

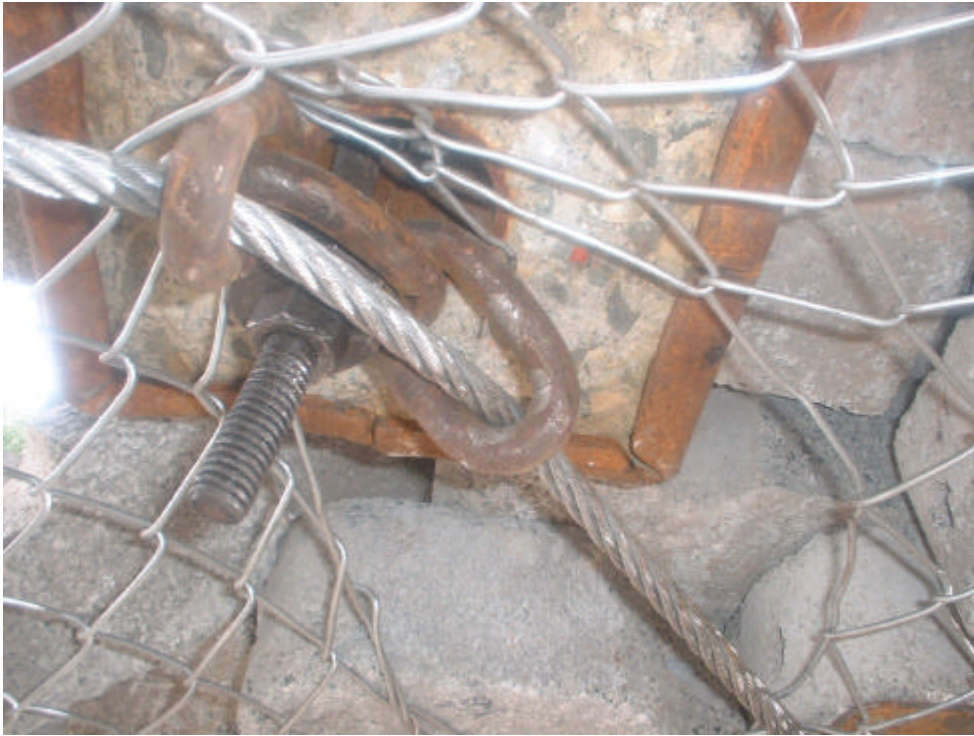
Figure A-40 Localised mesh damage around tendons in the test on 23/01/02

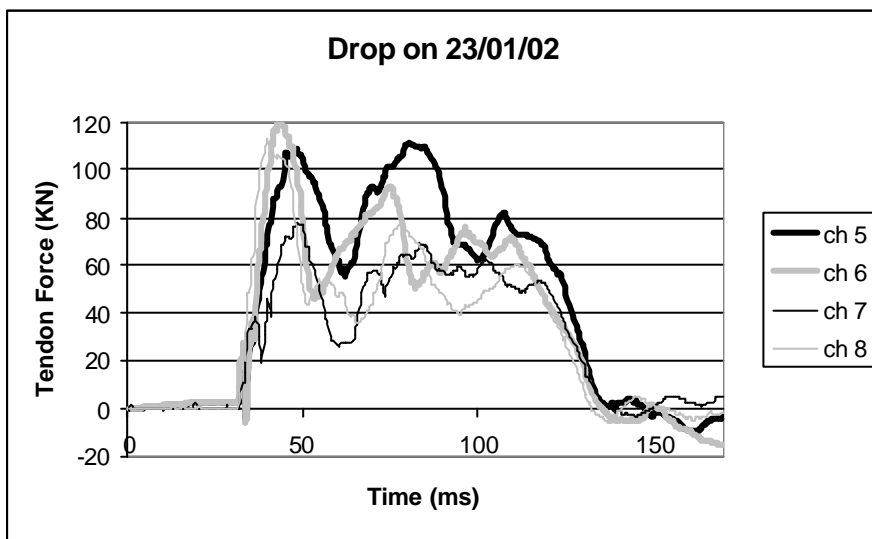
Figure A-41 Impact forces recorded during the test on 23/01/02

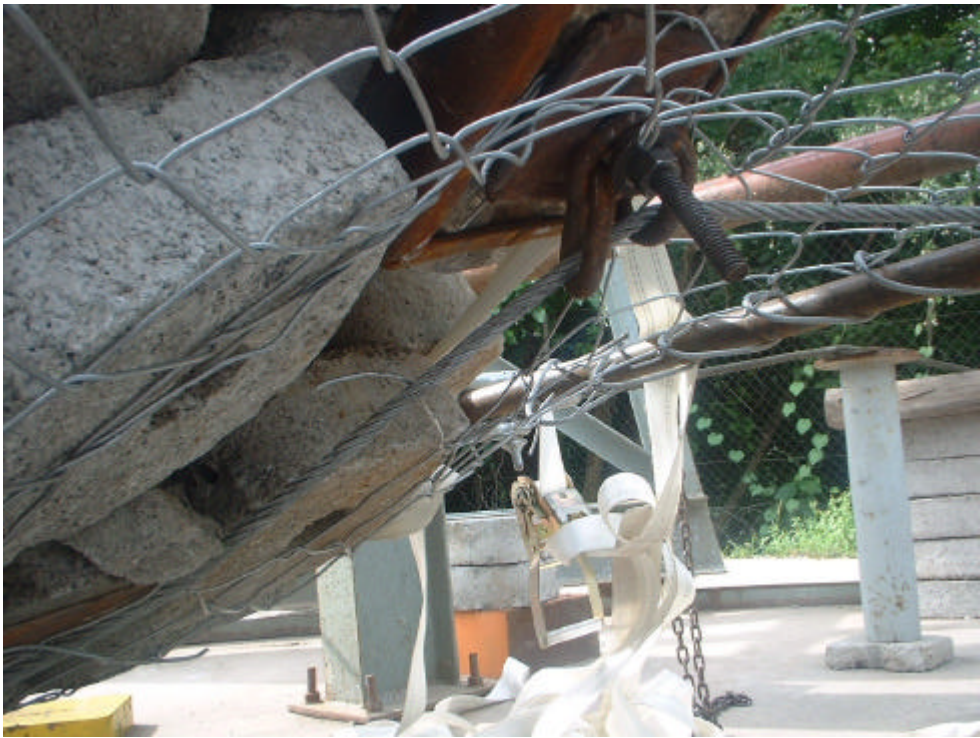
Figure A-43 Localised mesh damage around a bearing plate in the test on 29/01/02

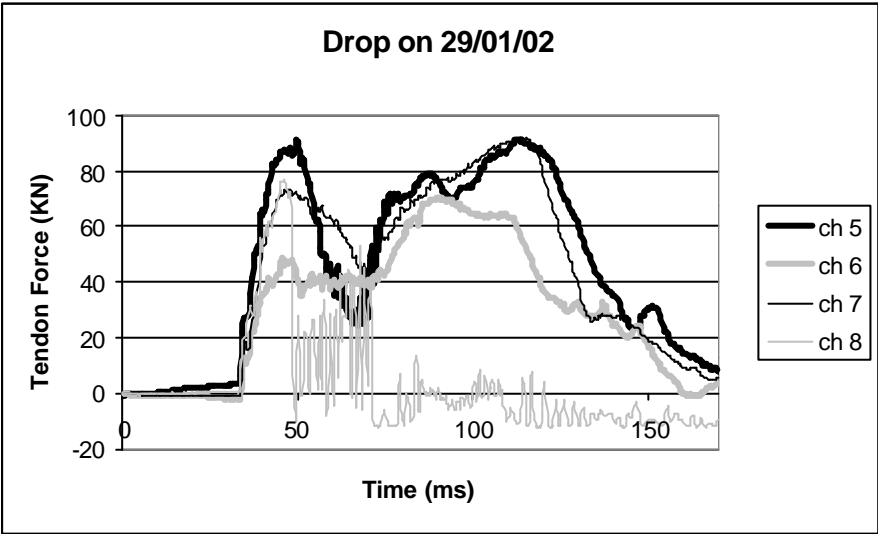
Figure A-44 Forces monitored during the impact on 29/01/02

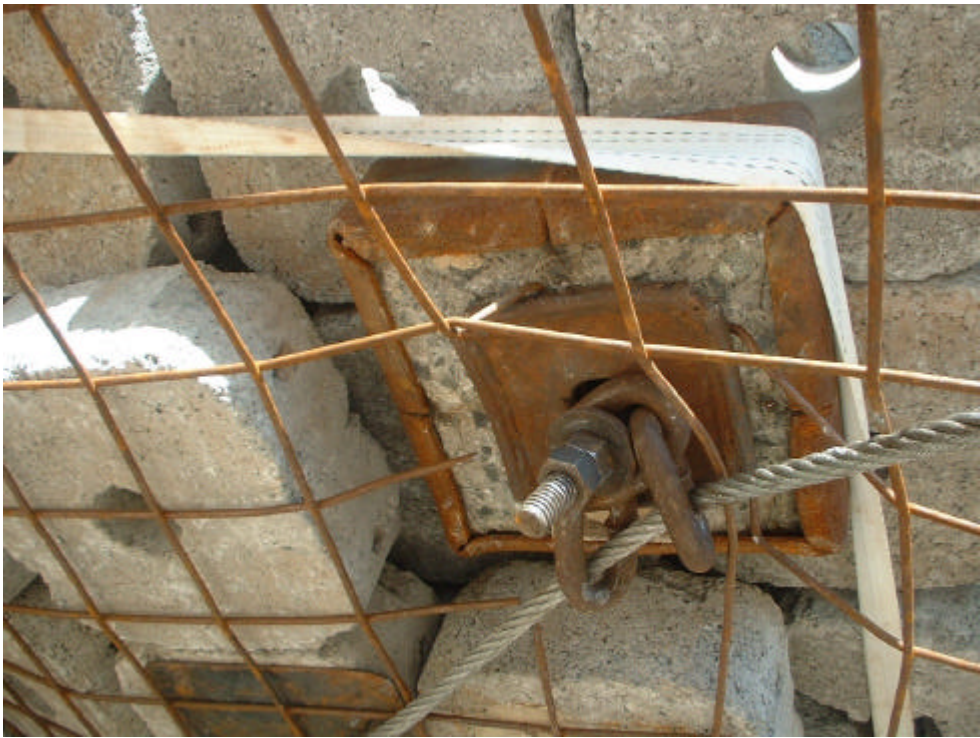
Figure A-45 Limited mesh damage around a bearing plate in the test on 02/02/02

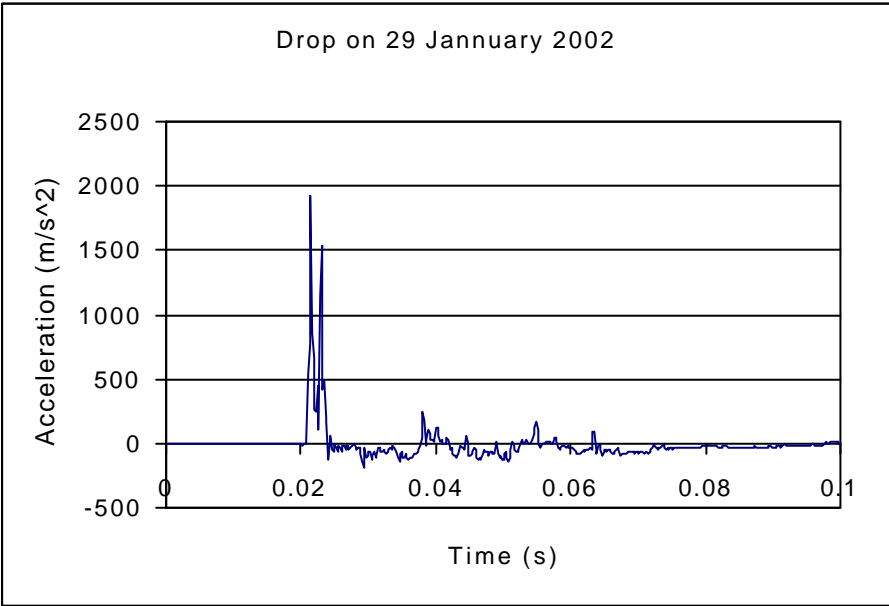
Figure A-46 Accelerations monitored during the impact on 29/01/02

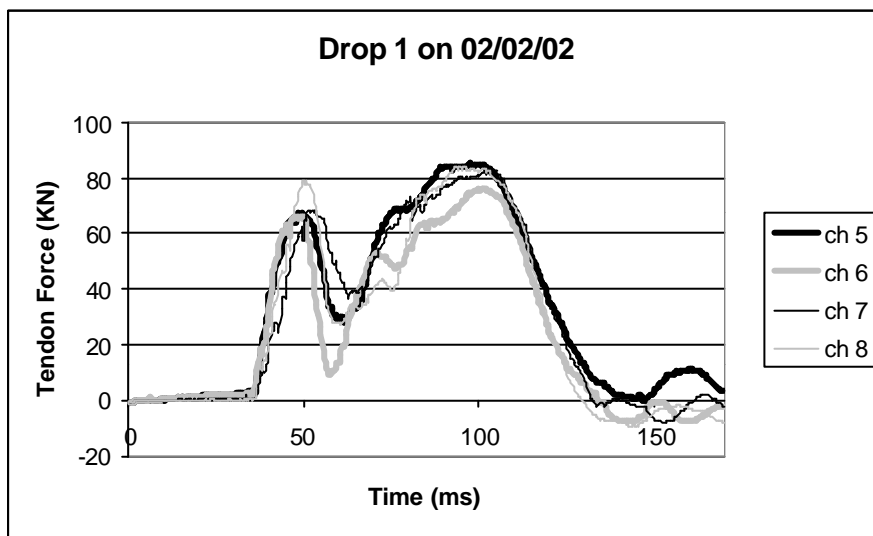
Figure A-47 Forces monitored during the first impact on 02/02/02

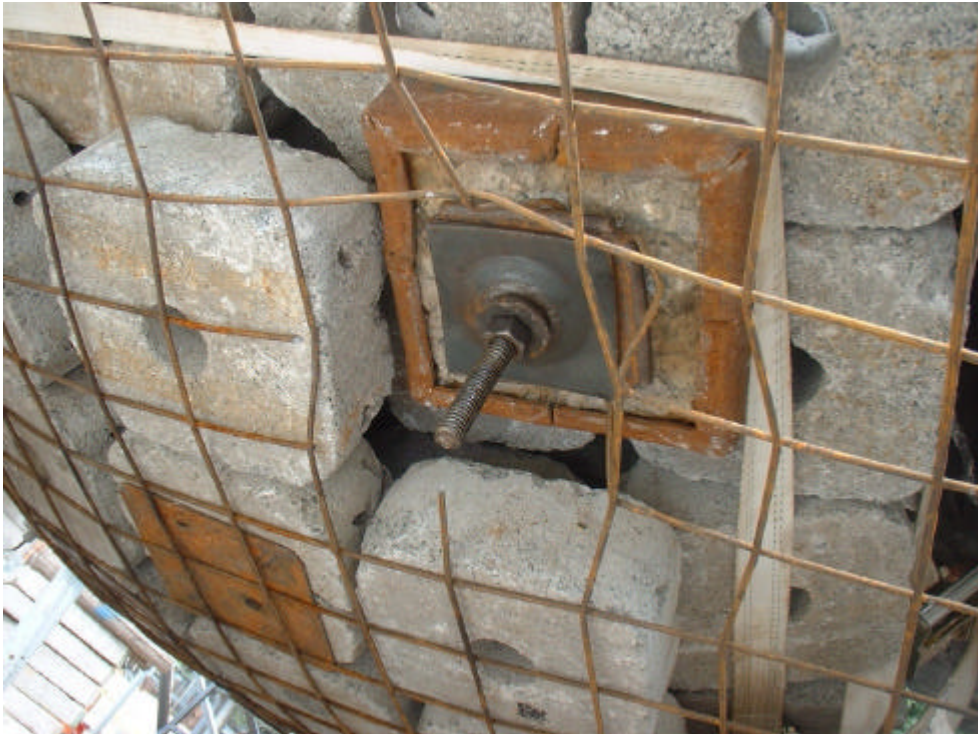
Figure A-50 Localised mesh damage around a bearing plate in the test on 07/02/02

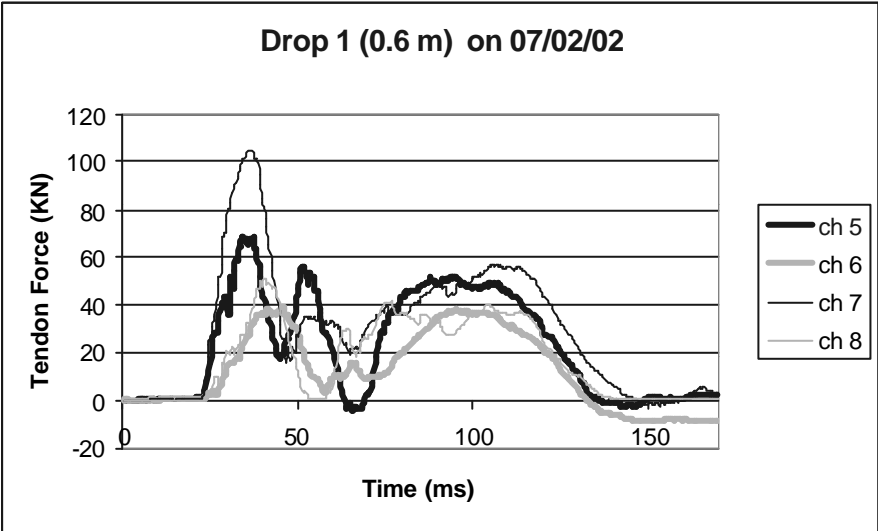
Figure A-51 Forces monitored during the first impact on 07/02/02

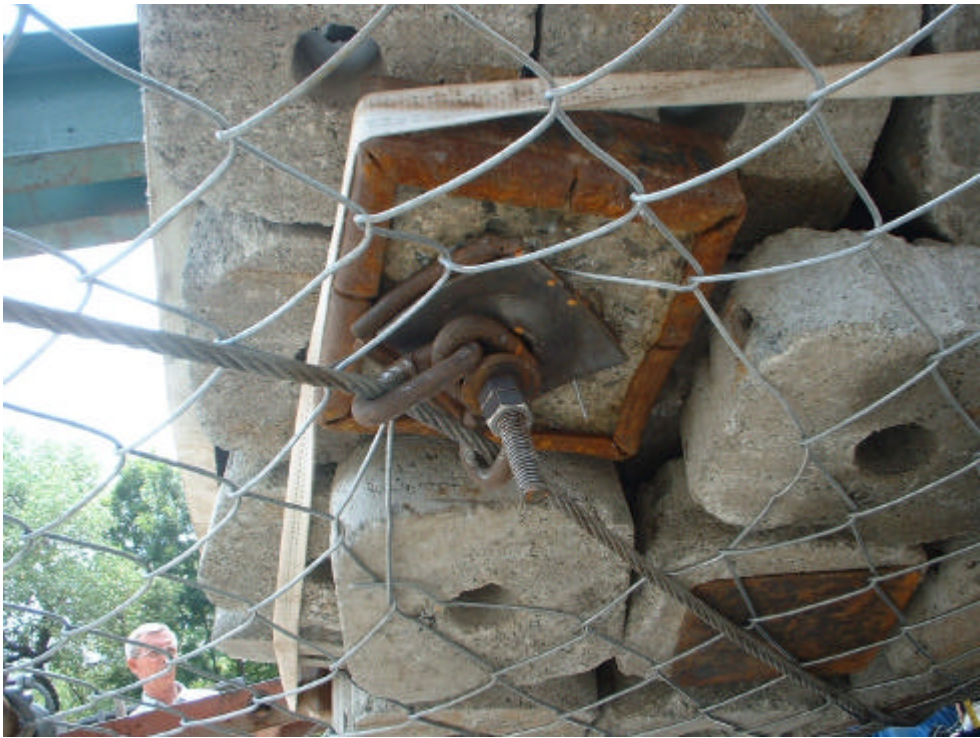
Figure A-53 Mesh damage around the bearing plate in the test on 19/02/02

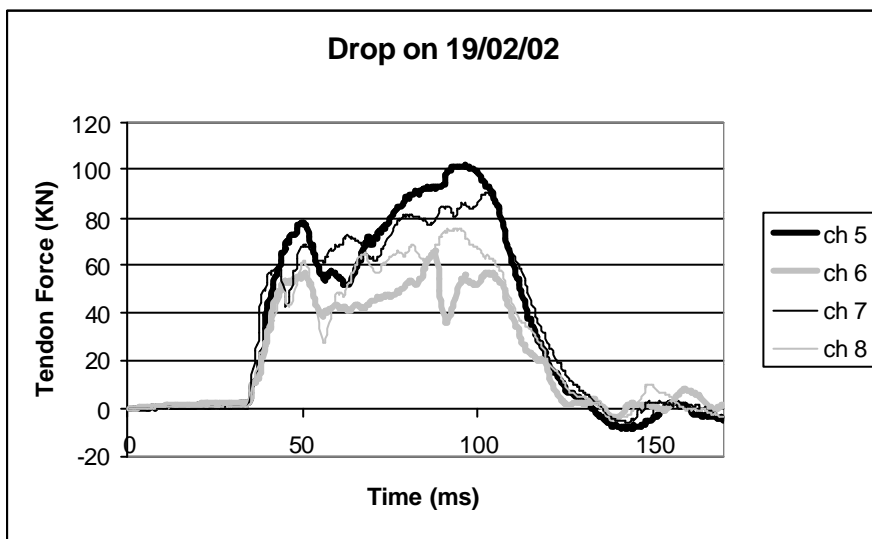
Figure A-54 Forces monitored during the impact on 19/02/02

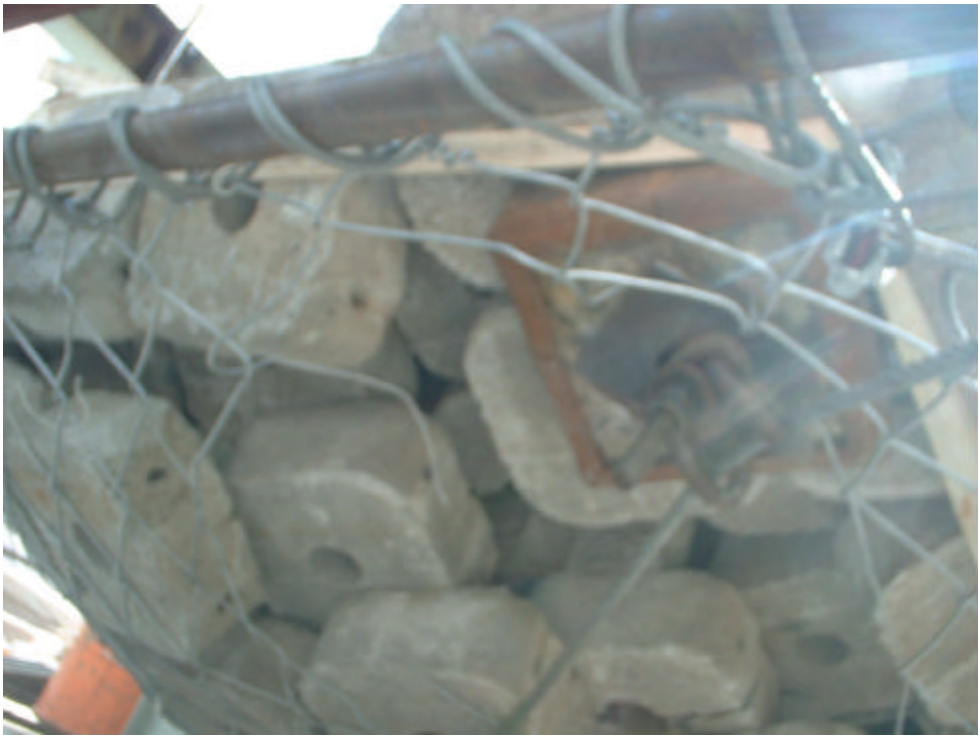
Figure A-56 Localised mesh damage around the bearing plates in the test on 25/02/02

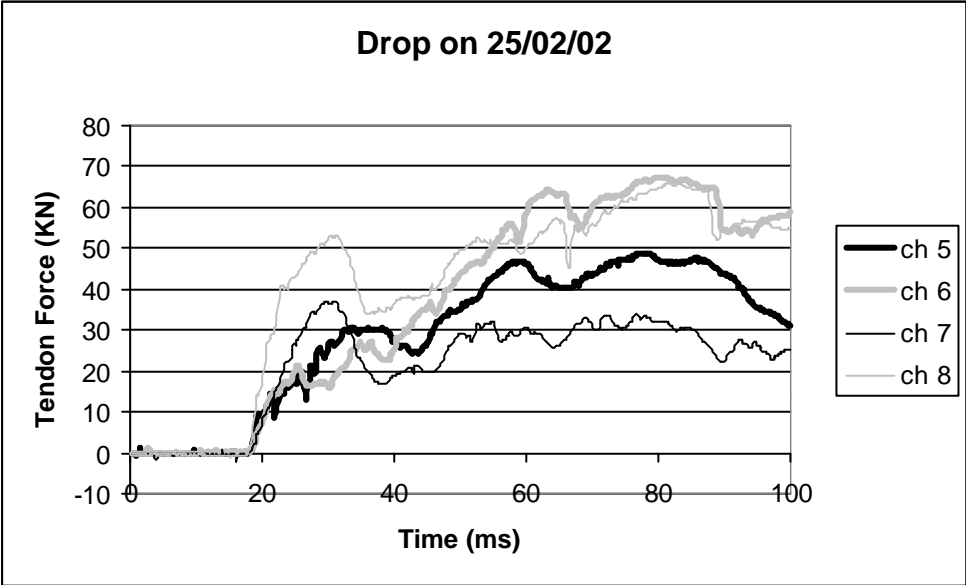
Figure A-57 Forces monitored during the impact on 25/02/02

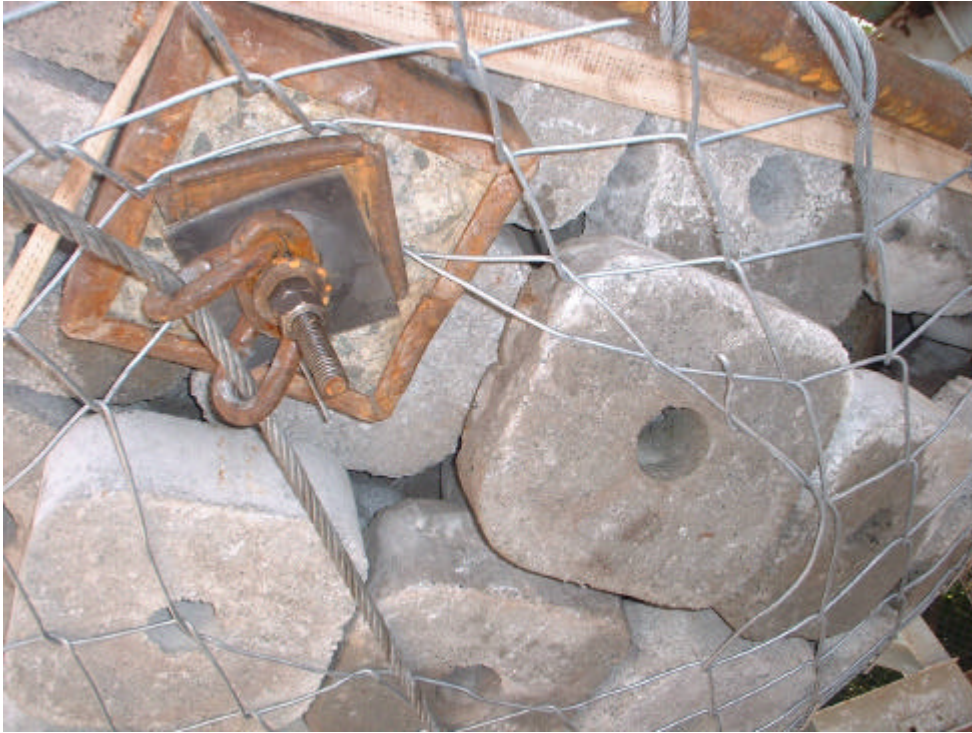
Figure A-59 *Mesh failure around bearing plates in the test on 04/03/02*

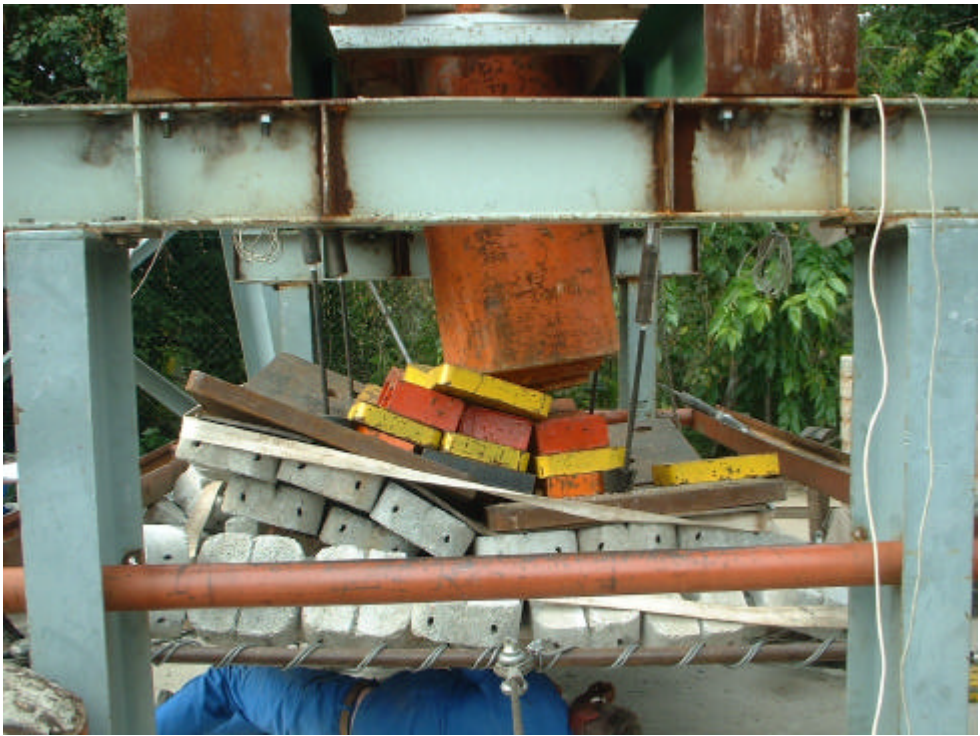
Figure A-60 Rupture of two tendons in the test on 11/03/01

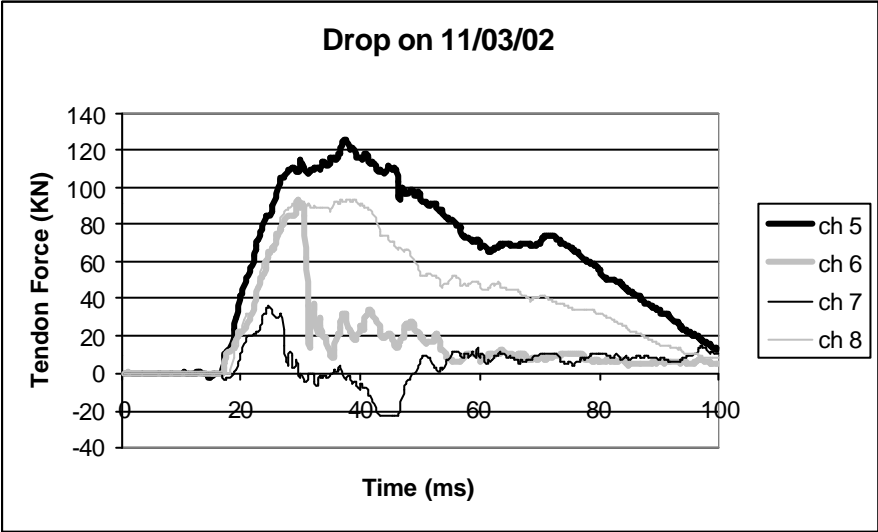
Figure A-61 Forces monitored during the impact on 11/03/02

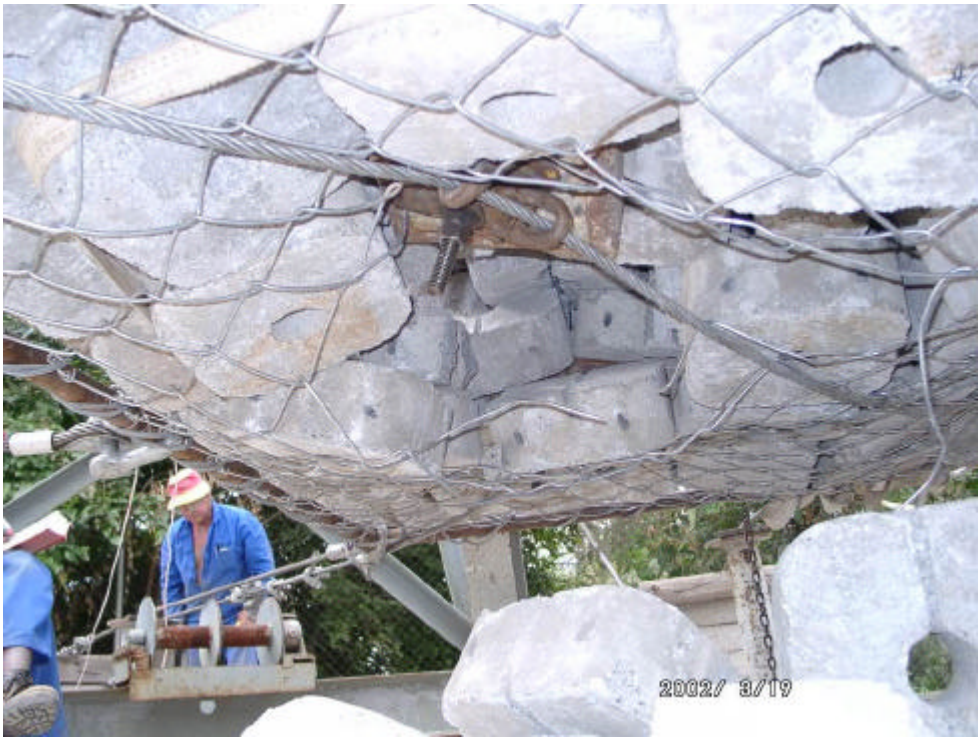
Figure A-63 Mesh damage around bearing plate in the test on 19/03/02

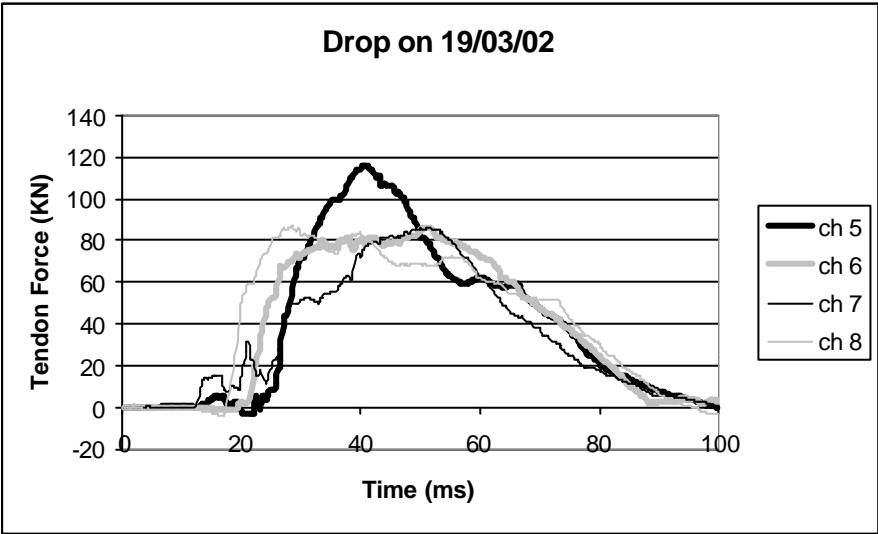
Figure A-64 Forces monitored during the impact on 19/03/02

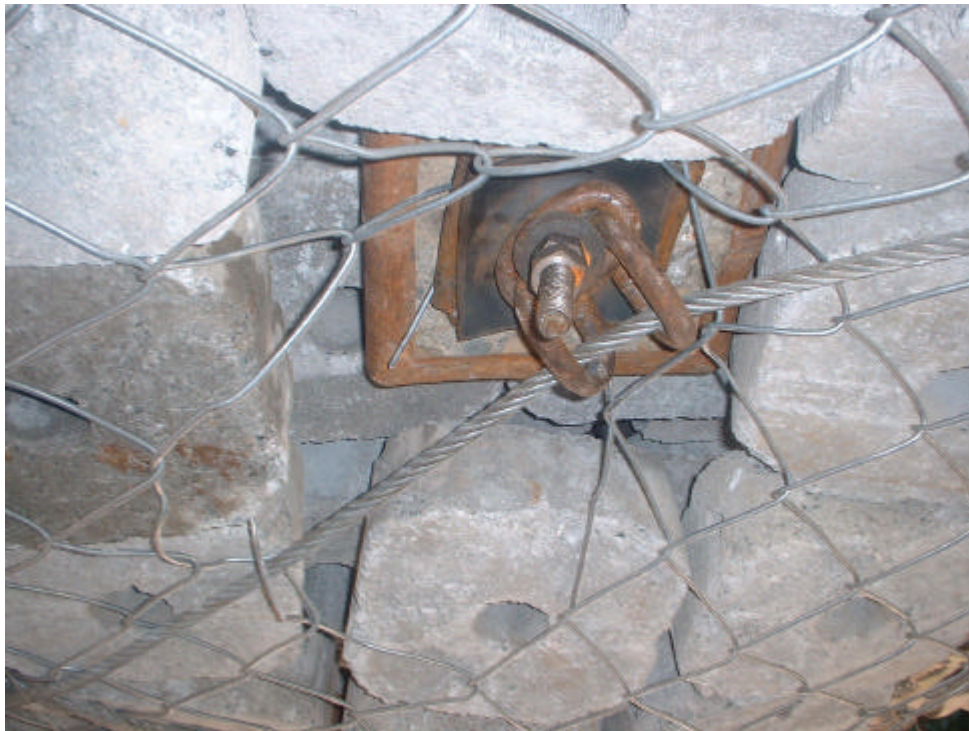
Figure A-66 Local mesh damage around lacing and tendon in the test on 22/03/02

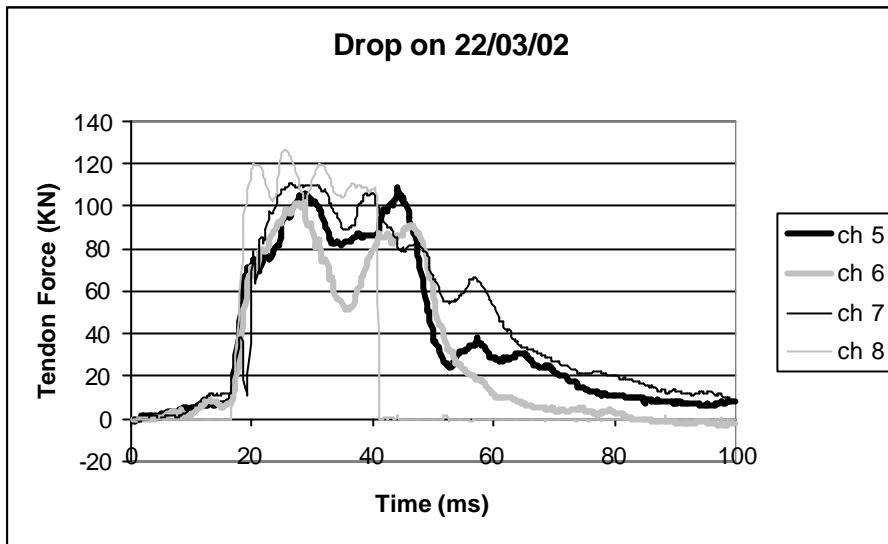
Figure A-67 Forces monitored during the impact on 22/03/02

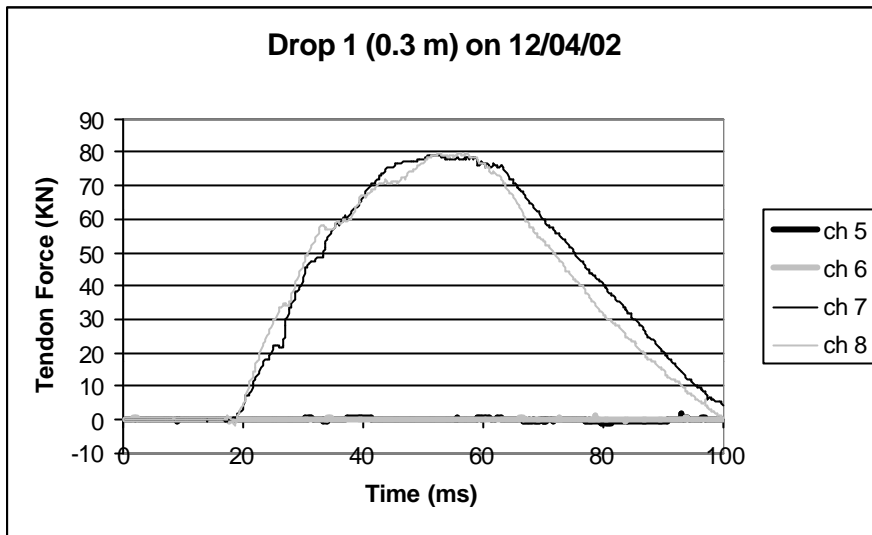
Figure A-70 Forces monitored during the first drop on 12/04/02
