## **Evaluation of Precast Concrete Slabs Using a Heavy Vehicle Simulator**

Erwin Kohler<sup>1</sup>, John Harvey<sup>2</sup>, Louw DuPlessis<sup>3</sup>, and Hecther Theyse<sup>4</sup>

### **ABSTRACT**

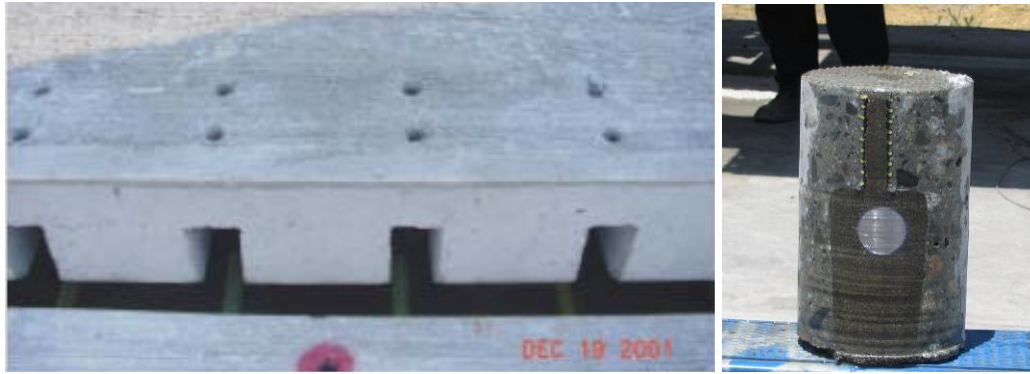
**Figure 1. Doweled joint and core showing dovetail slot/dowel bar connection**

Standard load transfer steel dowels are cast at one end of each slab at locations that match the location of dovetail-shaped slots as seen in Figure 1. Similarly, standard tie bars (or the female half of a standard tie bar) are cast at one side of each slab matching the location of slots cast in the adjacent slab. Figure 1 is a close up view of how dowels and slots align during the placement process.

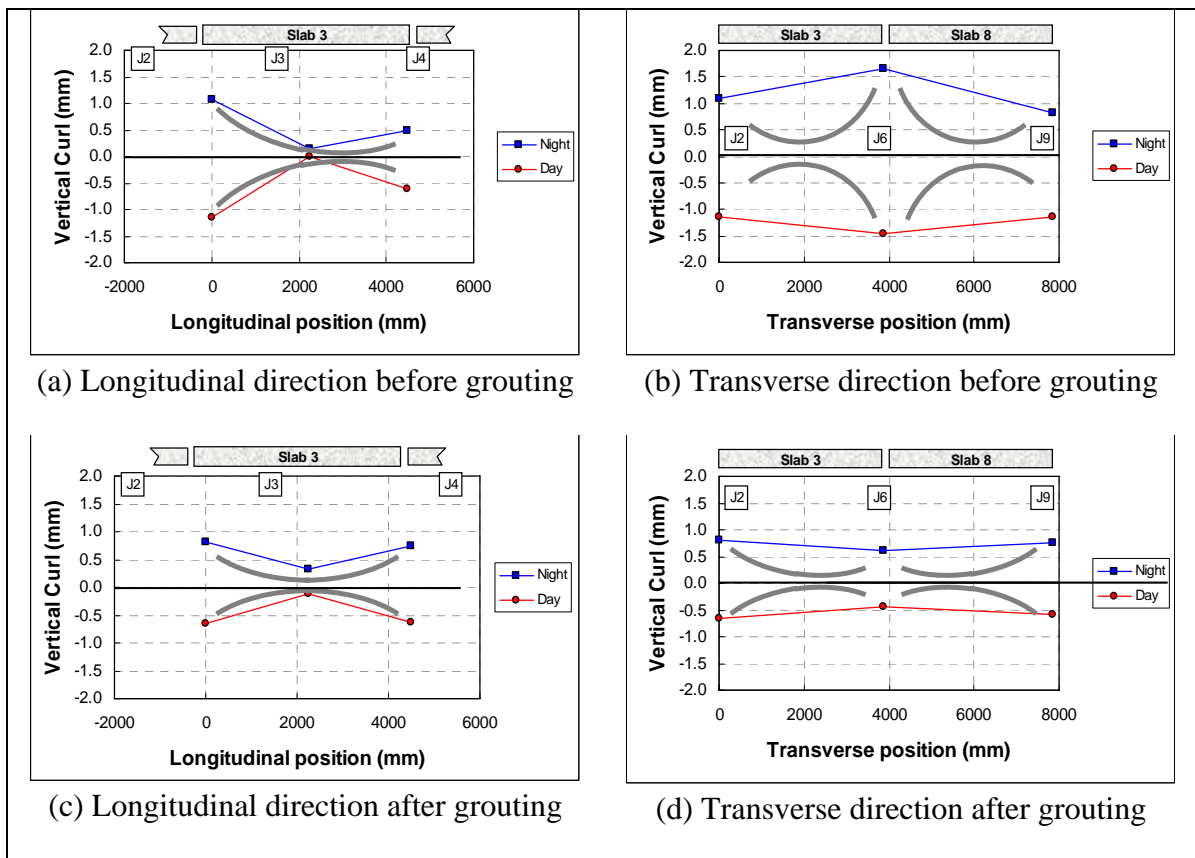
Figure 7. Comparison of the vertical deformations caused by thermal curl of the slabs before and after grouting, in the transverse and longitudinal directions

The thermal deformations (with no traffic loads) were compared before and after grouting. The vertical daily displacements at an interior corner were reduced by grouting from  $\pm 1.5$  to  $\pm 0.5$  mm as shown in Figure 7. In the un-grouted condition each slab curled separately, while after grouting the presence of tie-bars and grout in the joint (coming from the tie-bar grout slots), restrained the movement, reducing self-weight stresses and ensuring better support conditions. Along the longitudinal direction, on the exterior corners, on what would be adjacent to the shoulder, the effect of grouting was minimal (see Figure 7).

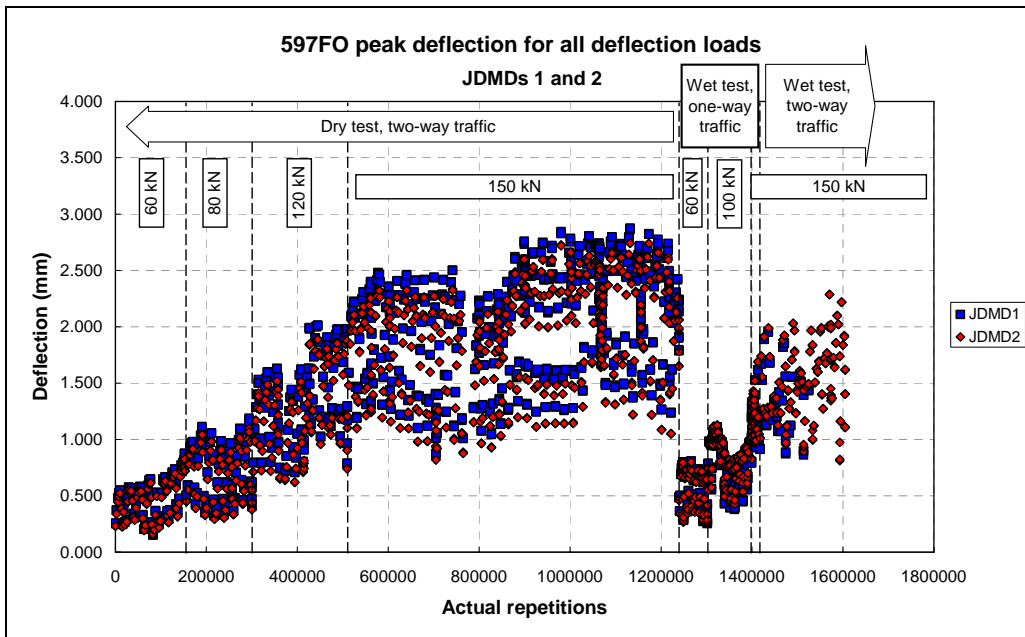
Figure 9: JDMD peak joint deflections in Section 1.

Probably because of the sandy soil, the signal condition from the MDDs had deteriorated to such an extent that at the time of the start of the wet test it was decided to continue with only the JDMDs. Figure 9 presents vertical deflections from the two JDMDs in one of the joints while Figure 10 shows a summary plot of the peak deflections for one of the four MDDs in Section 1 for the duration of the test. The peak deflections are shown for all the deflection loads from 60 to 150 kN, and the trafficking loads are shown at the top of each chart. The data exhibit daily cycles and three are the factors affecting the peak deflection: a) the magnitude of the deflection load, b) the daily temperature changes, and c) the amount of damage caused to the pavement.

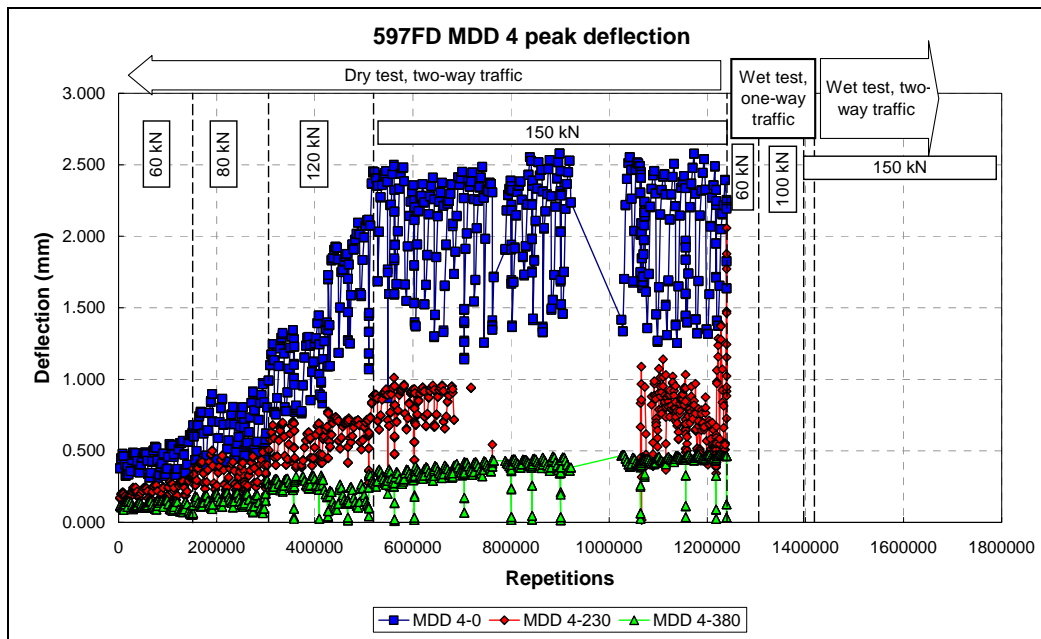
**Figure 10. MDD peak joint deflections in Section 1.**

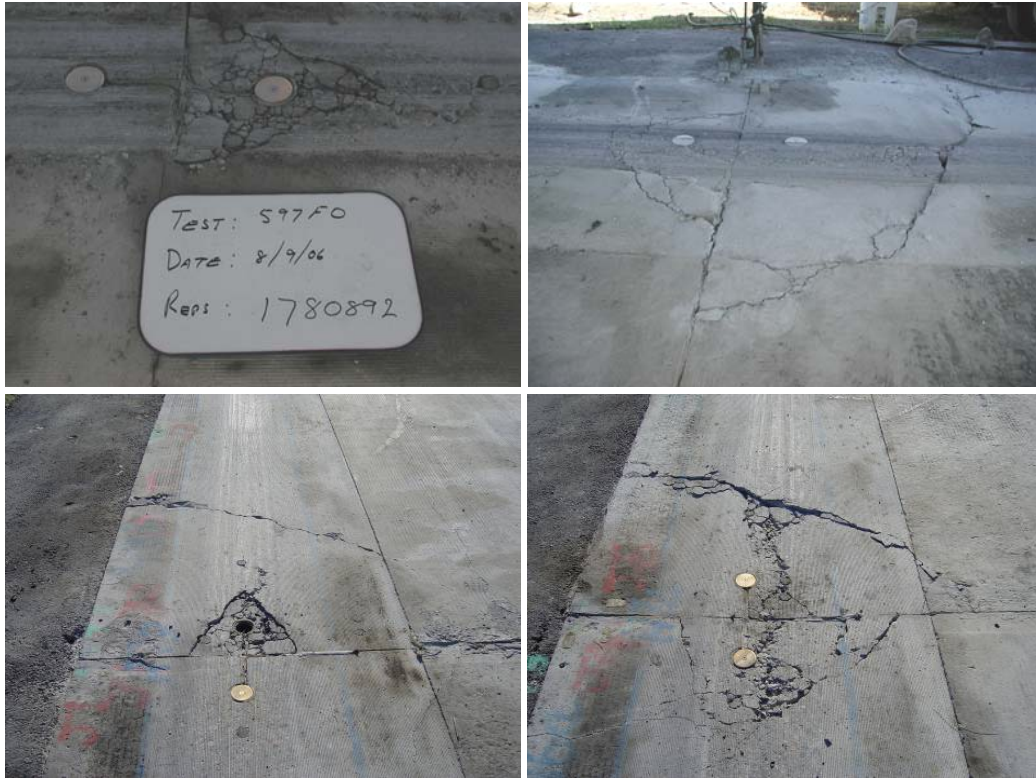
**Figure 11. Transverse and longitudinal view of the two failed joints at the end of pavement life in Section 1**

Failure of the section was reached in the form of a localized collapse in one of the joints and a more extended corner crack on the other. Forensic investigation revealed that the localized failure happened in-between dowel bars, exactly where the channelized traffic loaded the pavement. Even though the failure happened at the location of one of the multi-depth deflectometer sensors, it was concluded that this had no effect. The combined observations point toward concrete fatigue under channelized traffic and the loss of support caused by pumping. The other joint presented a failure that can be considered typical of cast-in-place, with large concrete cracks. Both failed joints are shown in Figure 11 in view perpendicular and parallel to the traffic. It is important to note that pumping was major factor observed in the experiment. The use of a bound bedding material (cement treated sand) was discussed prior to the test. The decision to use unbound stone sand (not treated with cement) was made, since that was the material most commonly used on previous projects, recognizing it would likely produce “worst case” results.

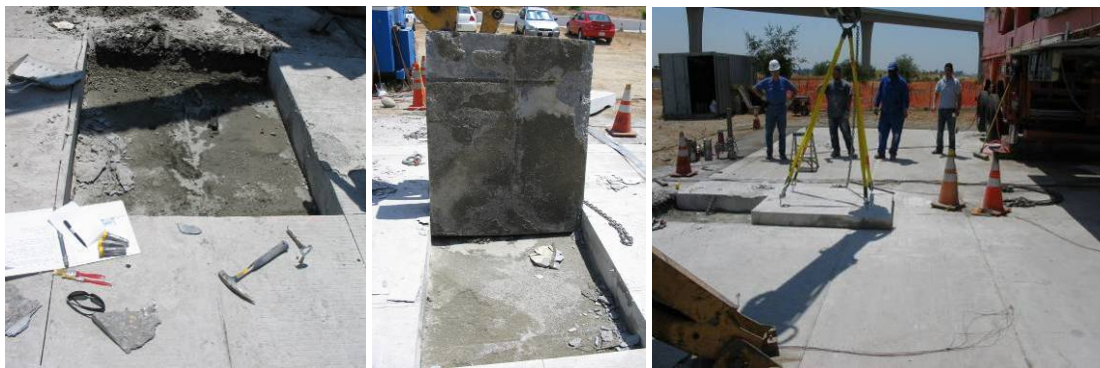
**Figure 12. Investigation of void under the slab in Section 2**

As mentioned, no distresses were observed in Section 2 either during the dry test or during the wet test, despite the fact that considerable pumping of material from under the slab occurred during the wet trafficking. The pumping of fine sand, however, did not result in any significant rise in corner deflections. An investigation was carried out to evaluate the extent of the suspected voids under the slab caused by pumping. It revealed that the pumped material was comprised of the finer particles from the sand bedding layer and disintegrated bedding grout. There was no clearly noticeable void in the wheelpath under the joint, but there were rather widespread marks of washed fines. Drill cores obtained from various locations in both test sections indicated very good performance of the dowel grout. No sign of looseness of the dowel, which in other words means that the grout was strong enough to sustain the compressive forces of the dowel as load was transmitted across the joint. Likewise, there were no signs of bonding issues between grout and the surrounding concrete of the slot.

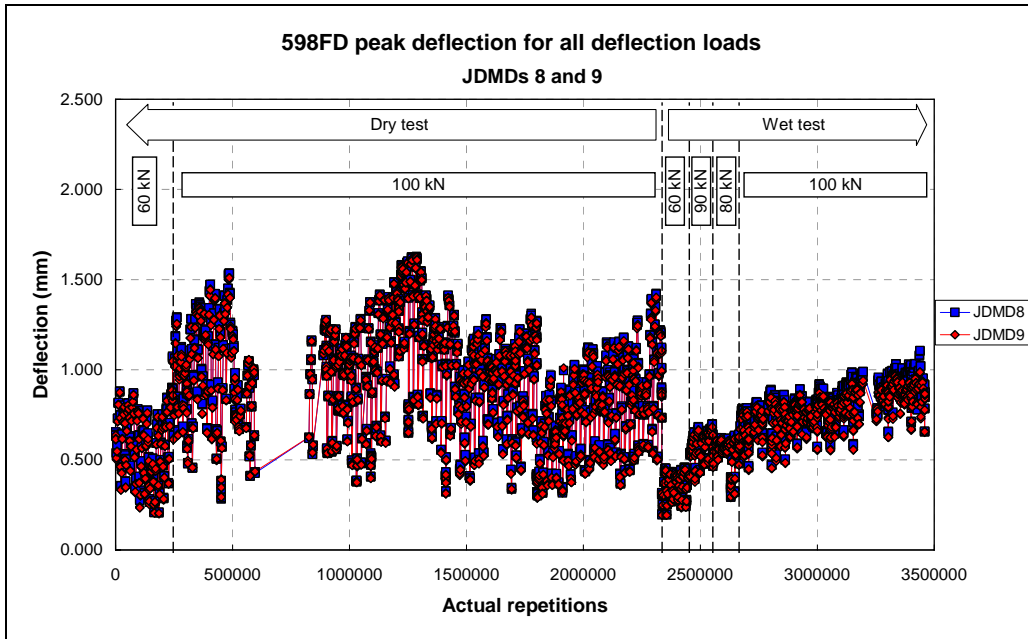
Figure 13. JDMD peak joint deflections in Section 2.

Similarly to what was presented for Section 1, Figure 13 and Figure 14 show representative JDMD and MDD joint deflections for the entire duration of the test on Section 2.

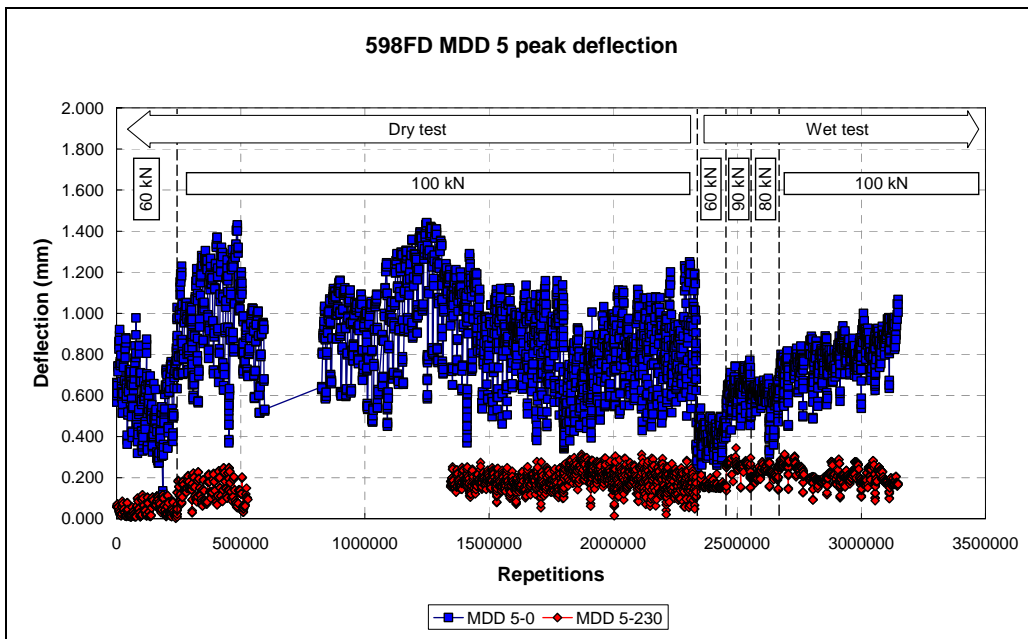
Figure 14. MDD peak joint deflections in Section 2.
