# Test & Measurement International Conference & Workshop

## CSIR Dynamometer Testing Facility Woven Brake Liner Tests

18 September 2024 13h00  
CSIR ICC, Pretoria

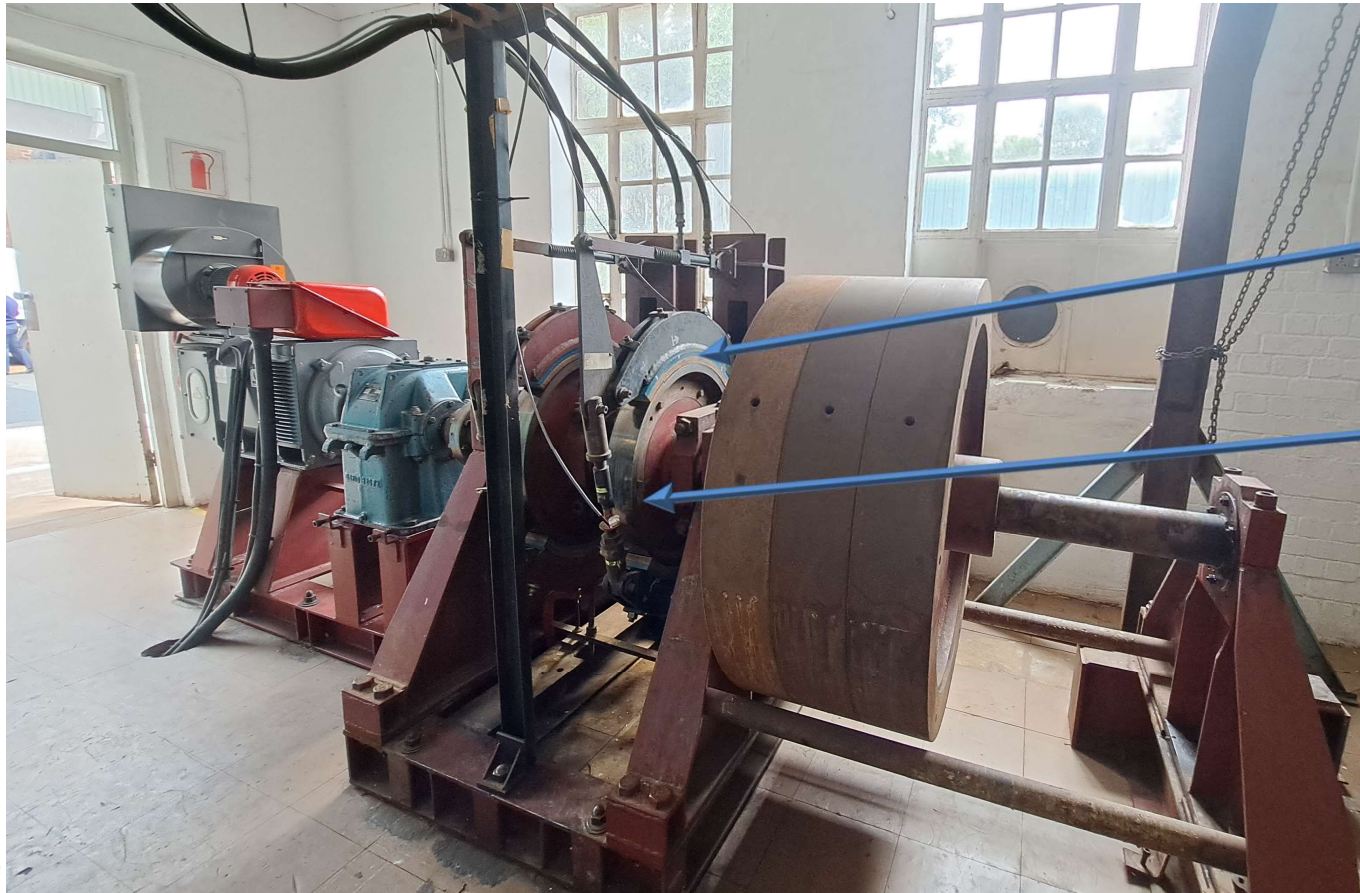
Brake liner

Brake drum

To evaluate the brake liner's ability to stop a high-speed conveyance during an emergency

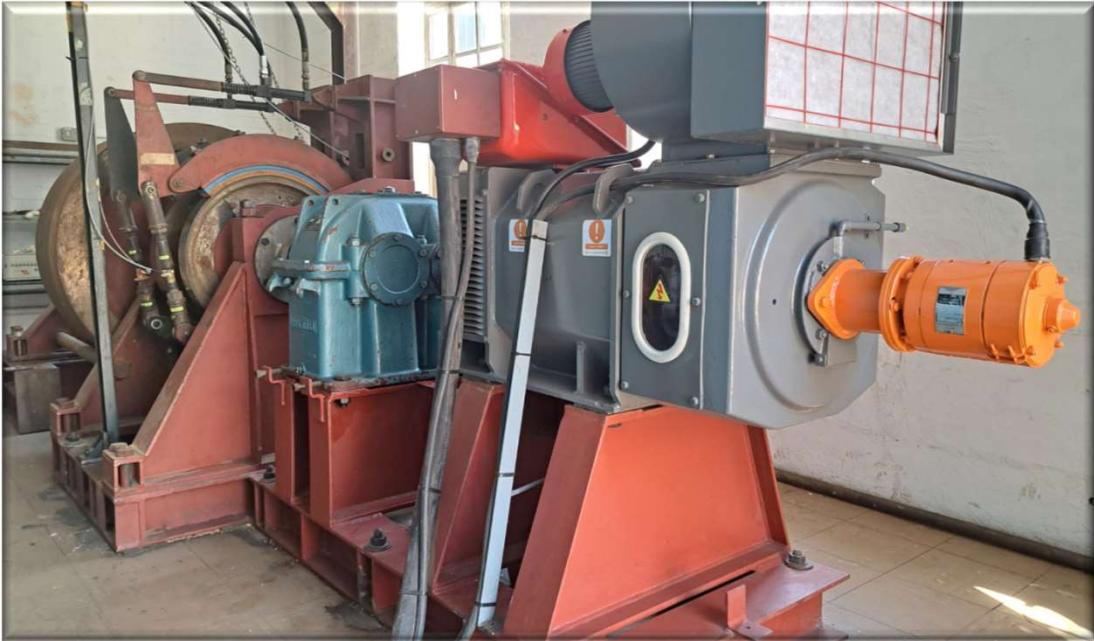
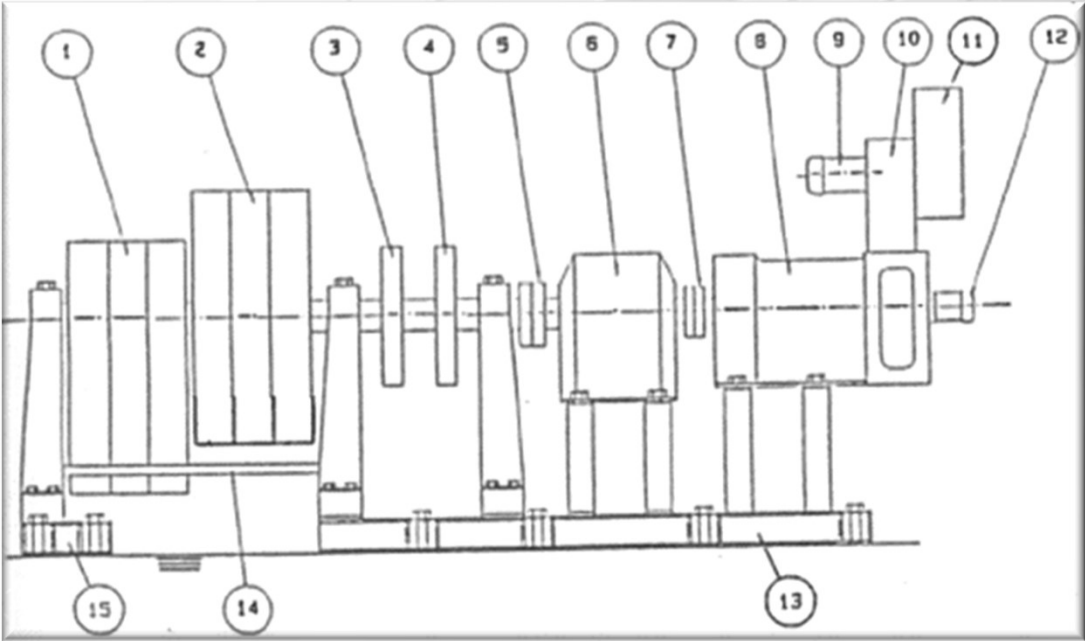
1 Unused Flywheels	6 2:1 Reduction Gearbox	11 Air Filter
2 Flywheels on shaft	7 Coupling	12 Tachogenerator
3 Brake Drum (flywheel side)	8 100 kW DC Motor	13 Base
4 Brake Drum (motor side)	9 Fan Motor	14 Flywheel Support
5 Coupling	10 Fan	15 Bearing Base

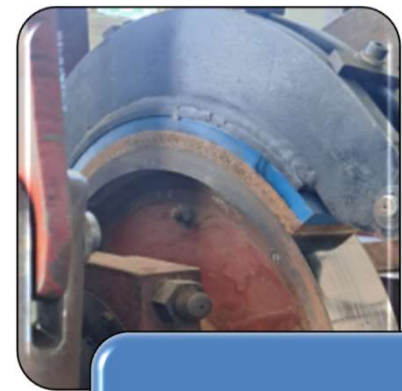
Prepare the liners to align with the drum circumference

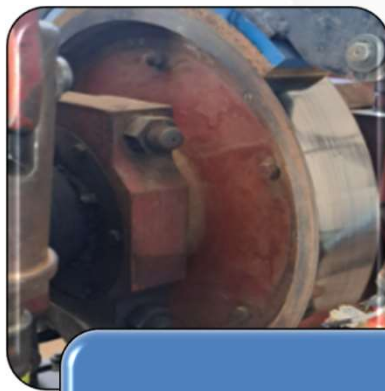
Bed the liners to achieve consistent friction coefficient

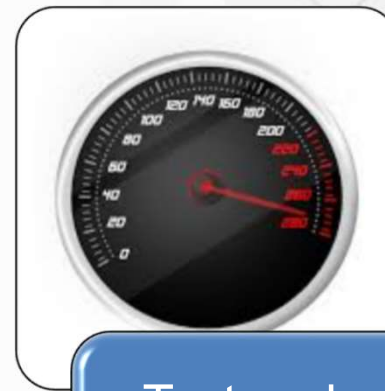
Test under severe emergency conditions (18 m/s)

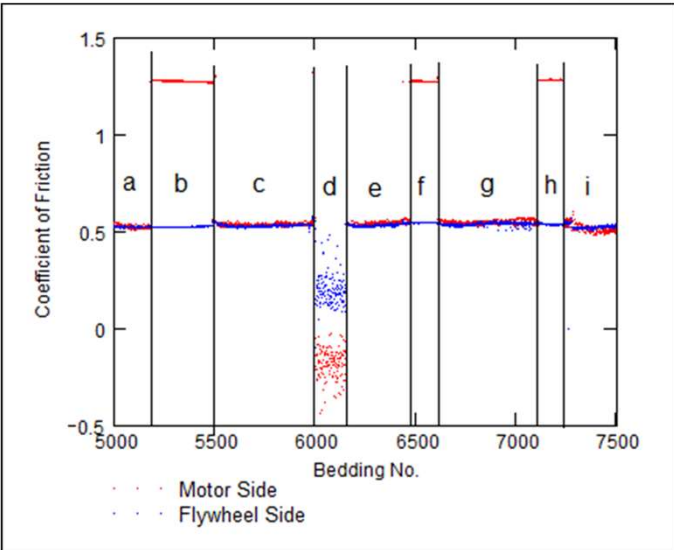
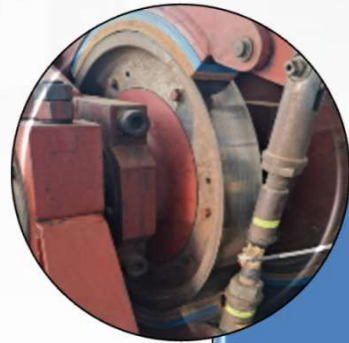
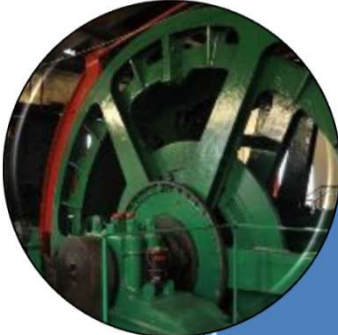
# Bedding-In

Consistent CoF  
(benchmark ~0.4)

Several brake applications at 1m/s

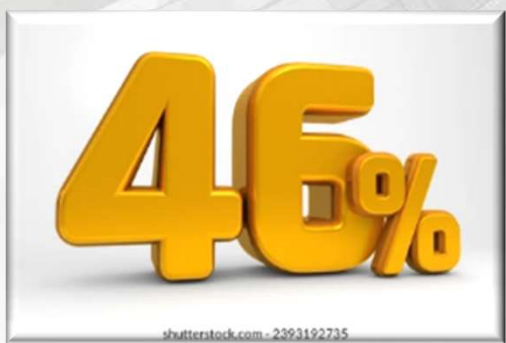
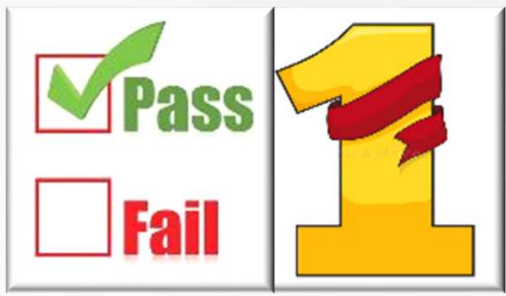
### Brake Dynamometer Test Results

Test No.: 139  
 Test Date: 2023/01/26 02:43:07 PM  
 Material: Kapabrake  
 Motor Torque: 3088 N-m  
 Brake Torque: 4843 N-m  
 Initial Speed: 18 m/s  
 Initial Temperature: 38 °C  
 Peak Temperature: 474 °C  
 Final Temperature: 250 °C  
 Distance Travelled: 114 m  
 Peak Heat Flux: 2.1 MW/m<sup>2</sup>  
 Total Heat Absorbed: 1743 kJ  
 = 11.6 MJ/m<sup>2</sup>  
 = 482 MJ/m<sup>3</sup>

Comments:

Lining No.	Material	CoF	Reduction in temp (%)	Pass / Fail	Distance travelled (m)
A	Woven lining	0.4	40	Pass	116
B	Asbestos – DR	0.1	28	Fail	107
C	Asbestos – D2	0.1	14	Fail	160
D	Asbestos – TA	0.7	32	Fail	111
E	Asbestos – TAB	0.3	29	Fail	112
F	Moulded non-asbestos	0.4	20	Pass	112
G	Woven non-asbestos	0.3	22	Pass	116
H	Flexible moulded asbestos	0.2	28	Fail	145

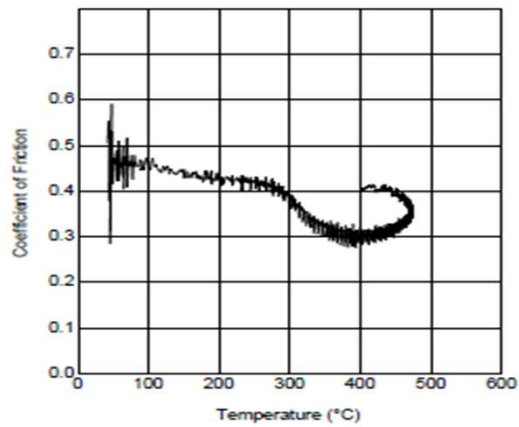
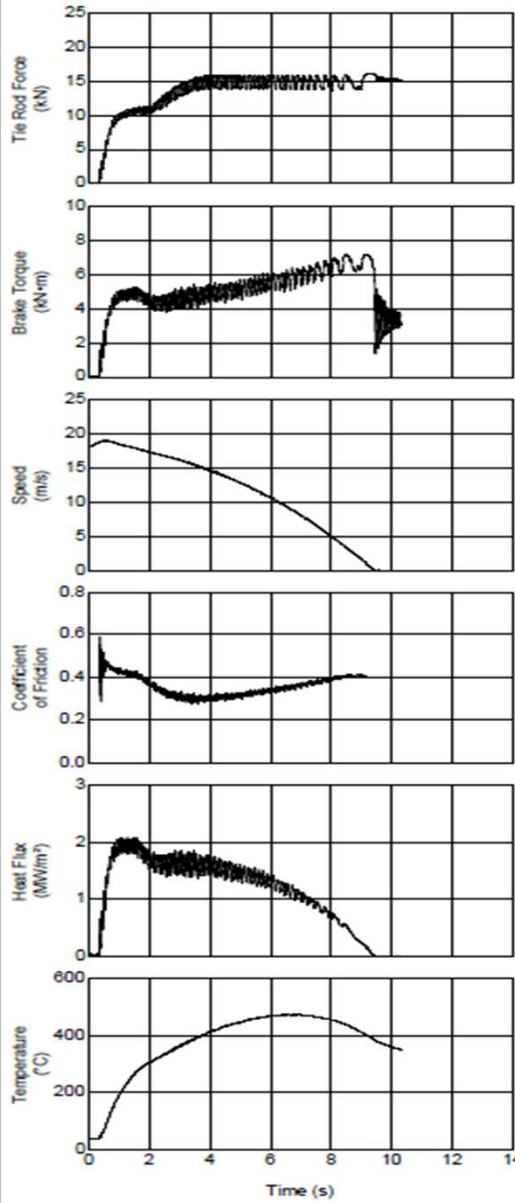
### Brake Dynamometer Test Results

Test No.: 140  
 Test Date: 2023/01/26 02:45:20 PM  
 Material: Kapabrake  
 Motor Torque: 3088 N-m  
 Brake Torque: 4843 N-m  
 Initial Speed: 18 m/s  
 Initial Temperature: 164 °C  
 Peak Temperature: 570 °C  
 Final Temperature: 340 °C  
 Distance Travelled: 116 m  
 Peak Heat Flux: 2.2 MW/m<sup>2</sup>  
 Total Heat Absorbed: 1732 kJ  
 = 11.5 MJ/m<sup>2</sup>  
 = 479 MJ/m<sup>3</sup>

Comments:  
Smokes slightly
