# The identification and treatment of poor durability Karoo dolerite base course aggregate – evidence from case studies

R C Leyland, M Momayez, J L van Rooy

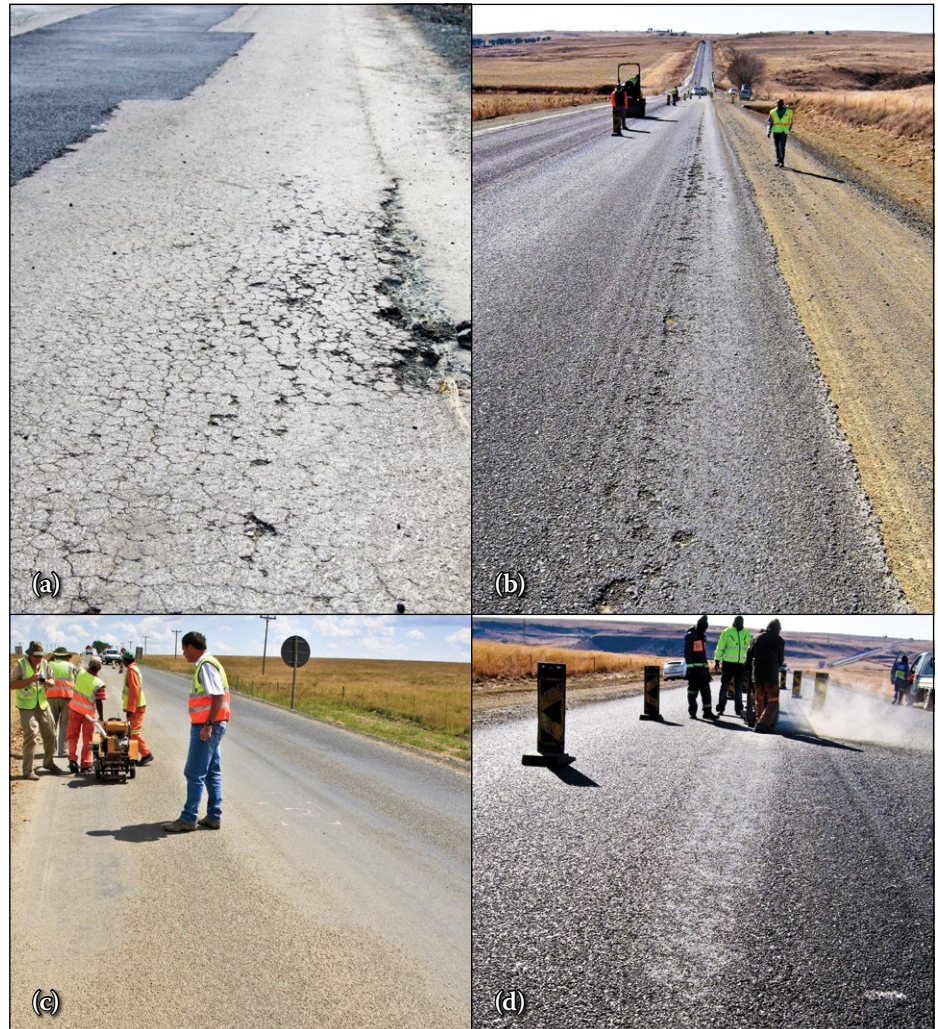
**Figure 2** Examples of premature failures at case study sites: (a) general surface failure, (b) rutting and aggregate loss in wheel tracks, (c) bleeding in wheel tracks, (d) bleeding in isolated areas

and one site was located in the Lebombo Group (Figure 1). The climatic N-value (Weinert 1980) of the sites varied from 3 to 9. The pavement layer materials are summarised in Table 2, and the observed defects at these sites included rutting and aggregate loss in wheel tracks, bleeding in wheel tracks over extended areas, bleeding in isolated areas and total surface failure (Figure 2). Material was sampled from the base layer of each pavement and from the original material source quarry. Since the three sites at which rapid pavement failures were observed experienced failure while sections of the road

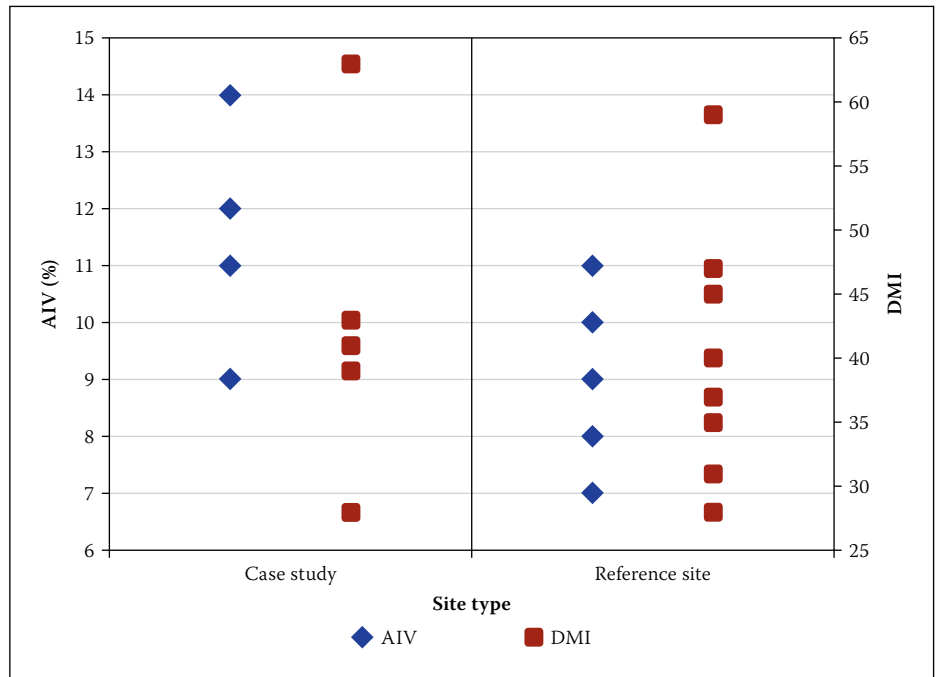
Figure 3 Comparison of case study (left) and reference site (right) quarry sample AIV and DMI results

The AIV values obtained for the case study quarry samples were generally higher than the reference sample values, but the ranges did overlap (Figure 3). According to Sampson and Roux (1982), crushed rock AIVs can be equated to aggregate crushing values (ACVs), and when this was considered all samples were seen to be well below the current ACV limit of 29%. The DMI result ranges overlapped even more and were all well below the limit of 125 (Figure 3).

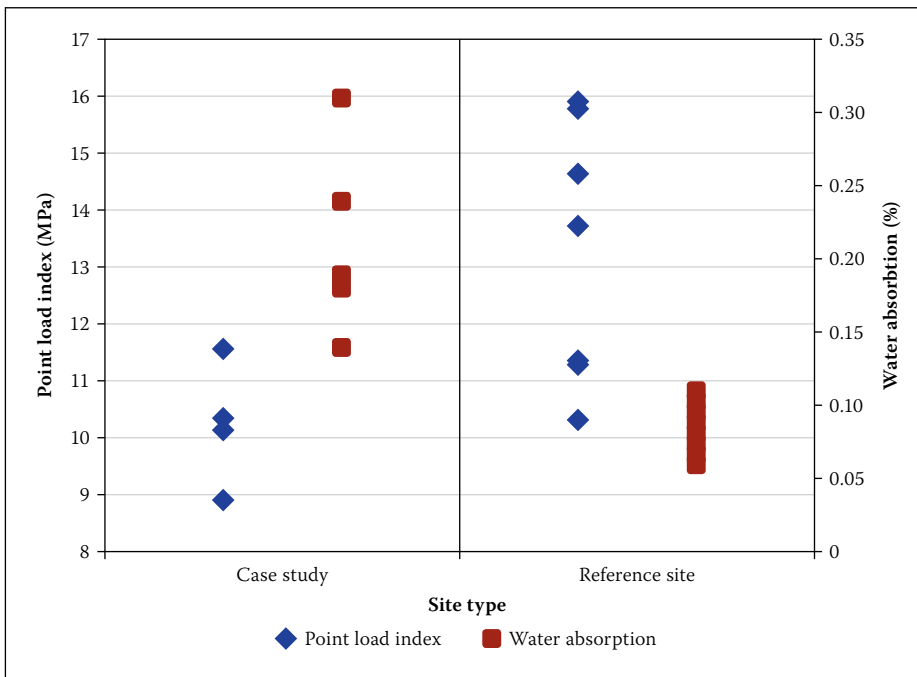
**Figure 6** Comparison of case study (left) and reference site (right) quarry sample point load index and water absorption results
