TRANSPORTATION RESEARCH

Number E-C139

Use of Accelerated Pavement Testing to Evaluate Maintenance and Pavement Preservation Treatments

Accelerated Pavement Testing Experiment to Assess the Use of Modified Binders to Limit Reflective Cracking in Thin Asphalt Concrete Overlays

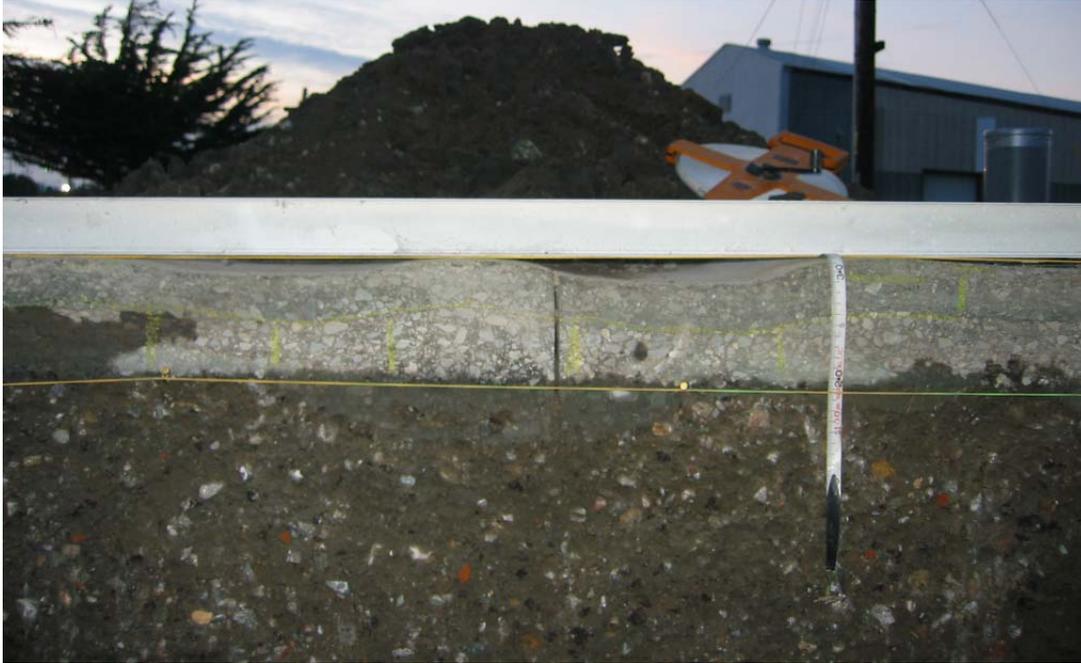
FIGURE 10 Test pit face showing rutting pattern on 45-mm MAC15 and 90-mm DGAC.

This result shows that assessment of the high temperature rutting performance of thin overlays must be assessed by trenching. It has been found in a previous experiment, and in the trenching of the first rutting test in this experiment, that the rutting in pavements with thin overlays (less than 60 mm) often occurs in the AC beneath them. This is consistent with results of finite element analyses during a SHRP project.
