# Thermal damage study on diamond tools at varying laser heating time and temperature by Raman spectroscopy and SEM

SAIP 2011 Conference

12 – 15 July 2011

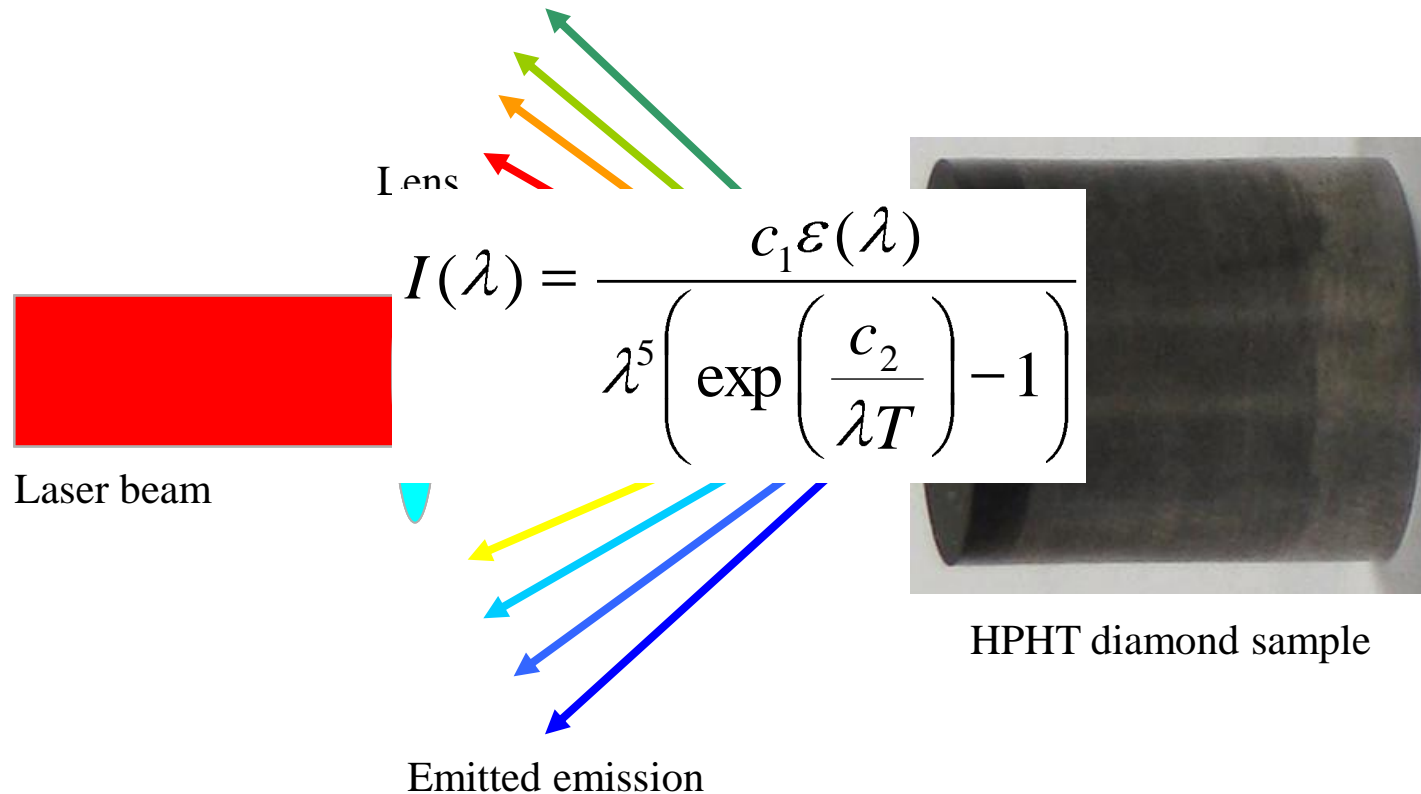
We raised the temperature of the diamond tool sample by laser heating it

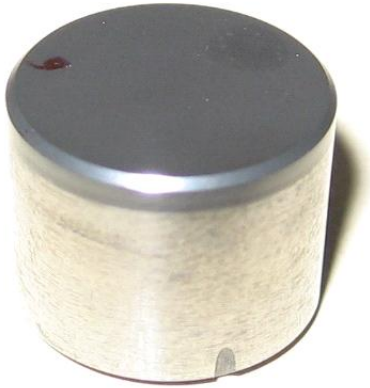
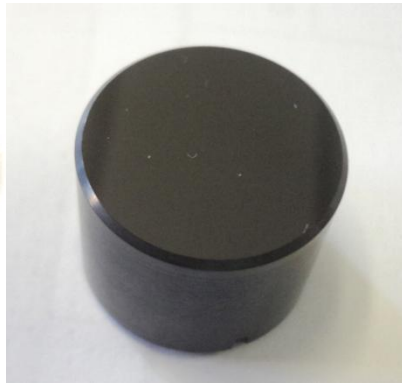
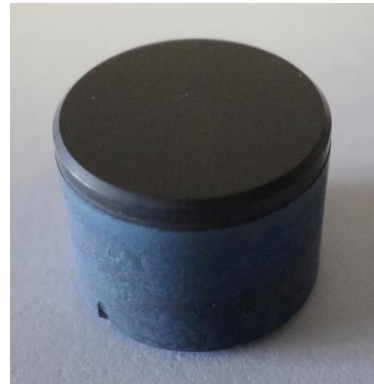
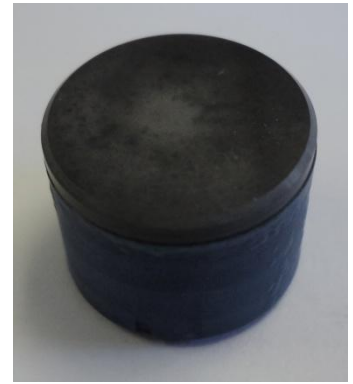
# Physical changes on the diamond tool samples due to the laser heating

Initial

5 min – 895 K

15 min – 968 K

25 min – 979 K

We show that the temperature in the diamond tool is sufficient to radically alter its physical and chemical properties, resulting in critical fracture.
