String Fault Finding on the Single Axis Tracker Photovoltaic Plant

Mudau Unarine ¹, Pratt Lawrence², Duma Talent ³ and Nithin Isaac⁴

This paper will describe the diagnostics and repairs done at the single axis tracker solar PV plant after the lightning strike in April 2019. The results before, during and after fault finding will be discussed as well as the overall lesson learned during the fault finding process.

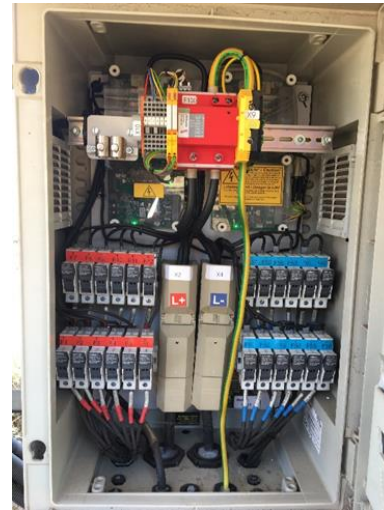
The investigation now shifted toward the combiner box. Figure 7 below shows the picture of the combiner box installed at the CSIR single axis tracker PV plant.

Figure 7 Combiner box

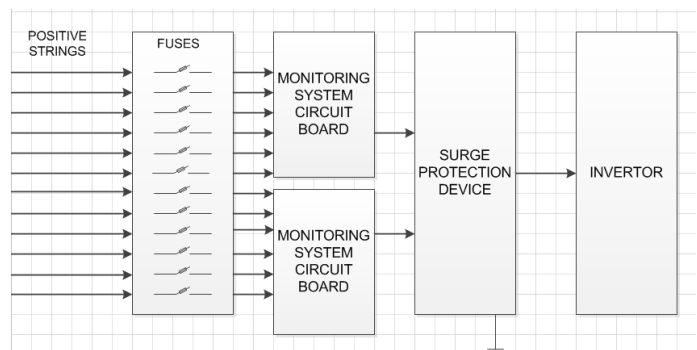
Figure 8 shows a block diagram of a combiner box. Five or six strings are connected to one of two fuse blocks with a dedicated fuse for each string. Both the positive and the negative conductors are fused. The positive conductors from the fuse block are connected to the monitoring system circuit board, five or six strings to each board. The strings are combined in the circuitry of the measurement board and a single cable from each of the two monitoring system circuit boards is connected to the surge protection device. Finally, one positive and one negative home run DC conductors connect the combiner box to the inverter.

Figure 8 Block diagram of the combiner box
