Safety In Mines Research Advisory Committee

Causes of Falls of Roof in South African Collieries

**J.N. van der Merwe
J.J. van Vuuren
R. Butcher
I. Canbulat**

**March 2001
Revised August 2001**

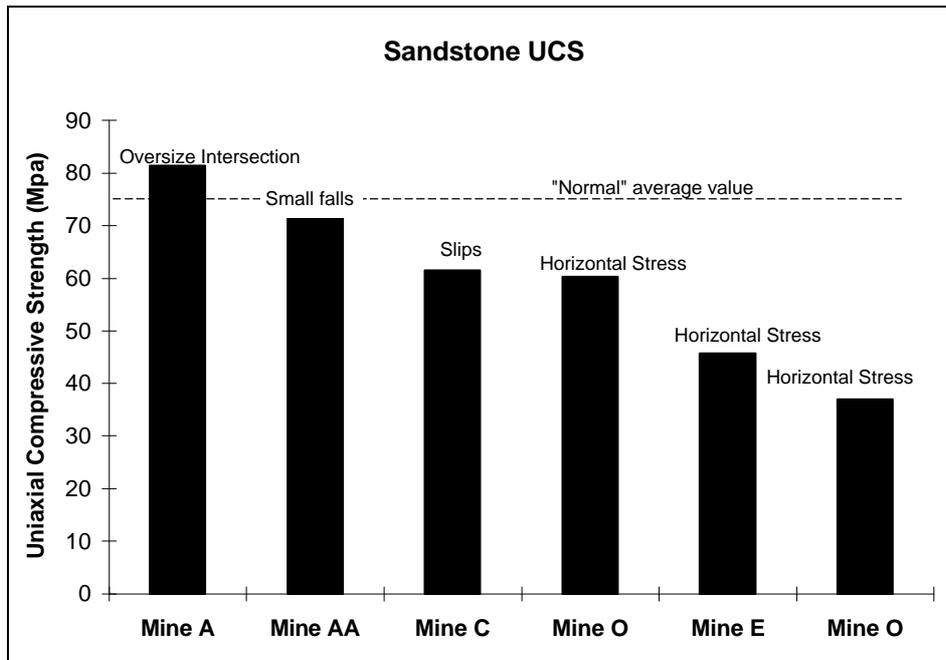
Figure 28. UCS values that were obtained from roof sandstone samples collected at the fall areas.

The UCS values for sandstone ranged from less than 40 MPa to 80 MPa, see Figure 28. This is less than the “normal” average value of approximately 75 MPa and indicates a reduced compressive strength in the fall areas.

The causes of the falls that were determined by the investigating team are also indicated on the figure. It is significant that the falls that were categorised as having been caused by horizontal stress had the lowest UCS of all the samples. This confirms that horizontal stress is more likely to become a problem in areas with reduced strength.

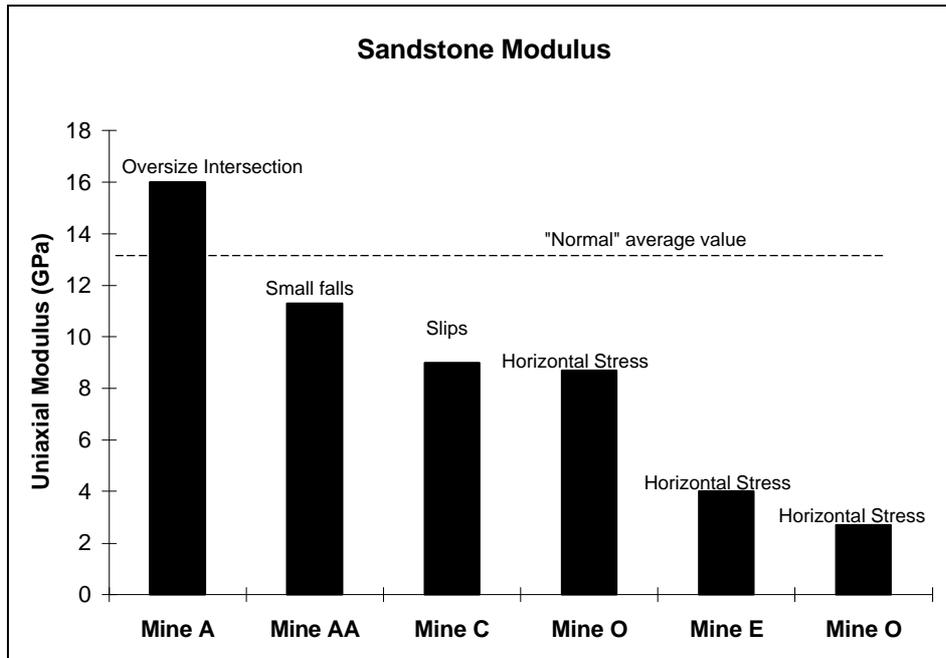
Figure 29. Modulus of Elasticity of sandstone samples from the fall areas.

The previous observation that the “horizontal stress falls” are characterised by reduced numbers, in this case stiffness, is repeated here. With the exception of one case, all the stiffness values are below the “normal” value of 13 GPa.

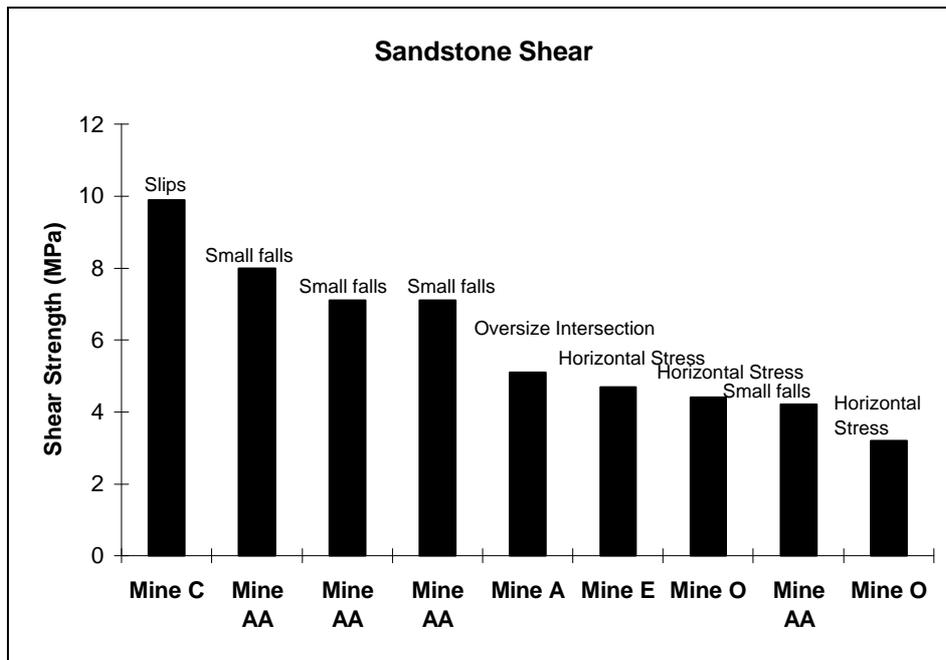
The shear strengths of the sandstone samples are shown in Figure 30 in similar format as the previous two figures. The reduction in strength is again apparent, the “normal” shear strength of sandstone being approximately 15 GPa. All the samples had reduced strength, the greatest reduction again being apparent from the samples where horizontal stress was the dominant cause of the roof falls.

Figure 30. Shear strength of the sandstone samples.

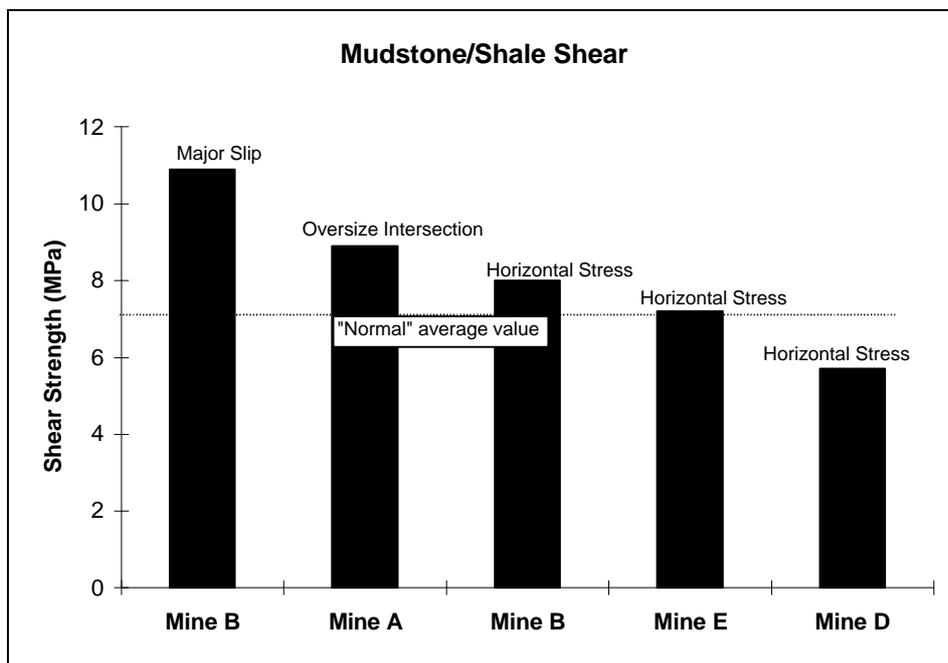
Curiously, the Shale/Mudstone samples, shown in Figure 31, did not suffer the same shear strength reduction as the sandstone samples. However, the “horizontal stress” samples are again at the low end of the range.

Figure 31. Shear strength of Mudstone/Shale samples

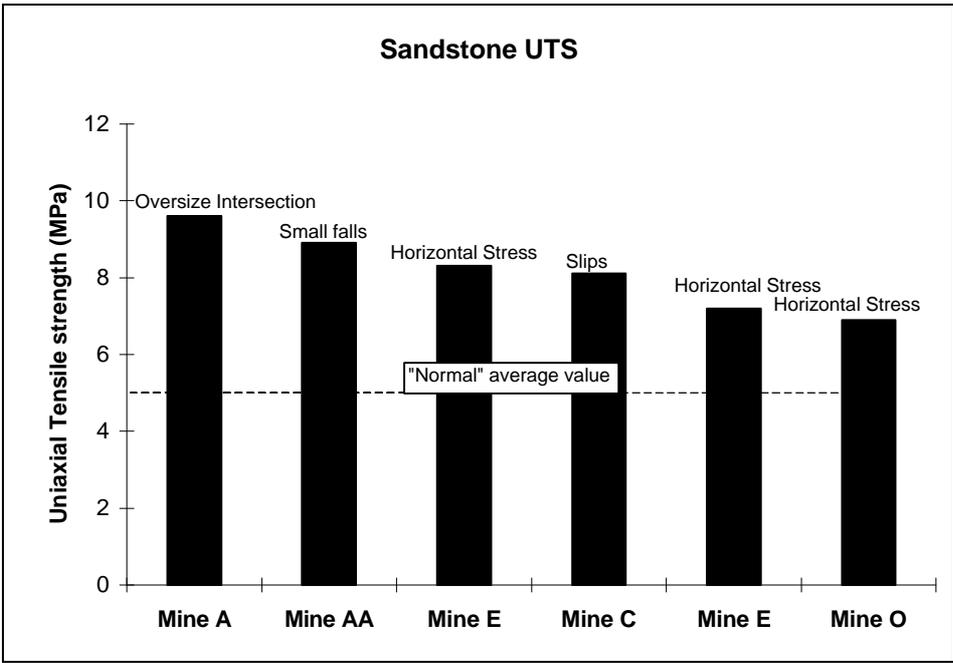
The UTS of the sandstone samples were obtained by performing the standard Brazilian strength test. The results are shown in Figure 32. In this case, there is no general strength reduction, although the “horizontal stress” samples maintain their consistent position at the low end of the scale.

Figure 32. Uniaxial Tensile Strength of the sandstone samples.

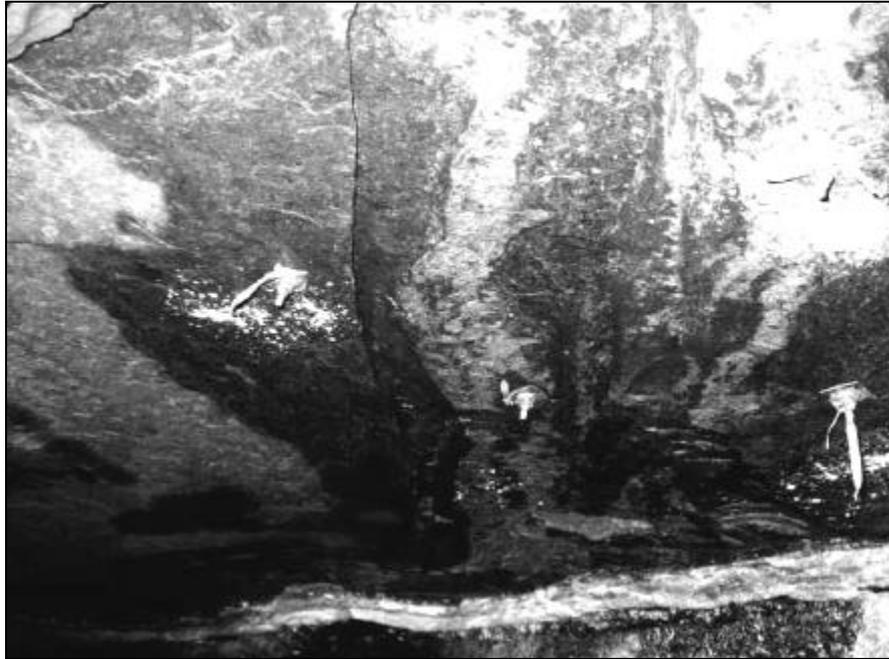
There are several well publicised methods to support joints but they were simply not found to have been implemented underground. In a number of cases, when unsupported joints were pointed out to underground personnel, some reactions were that that particular joint was a stable one and

Figures 33 and 34 are further examples of unsupported joints.

Figure 33. Even though this roof has been re-supported after a fall, the joint is still not adequately supported.

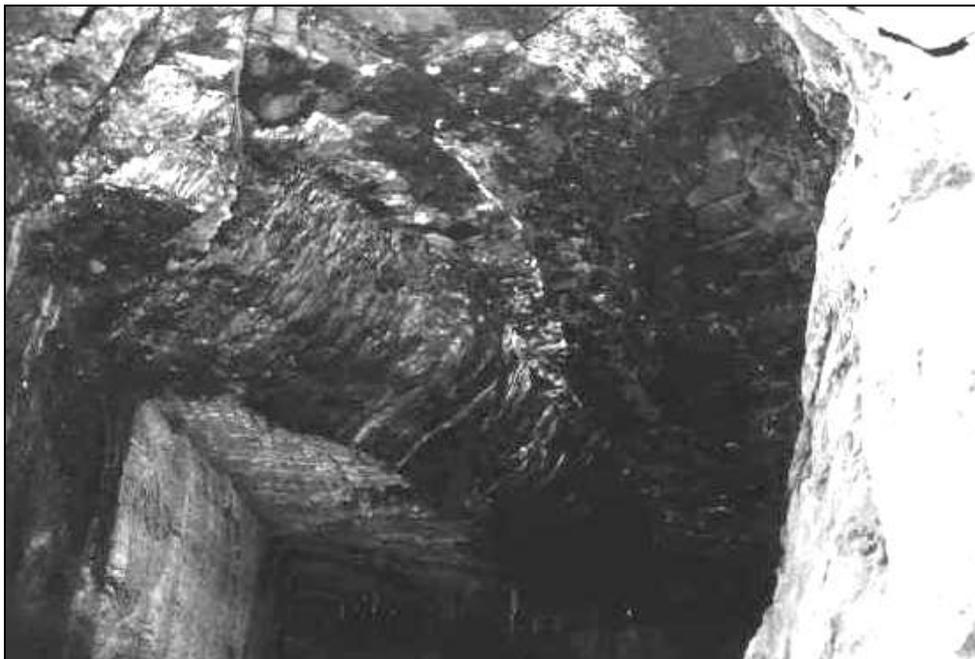
Figure 34. Unsupported joint that resulted in a major fall.

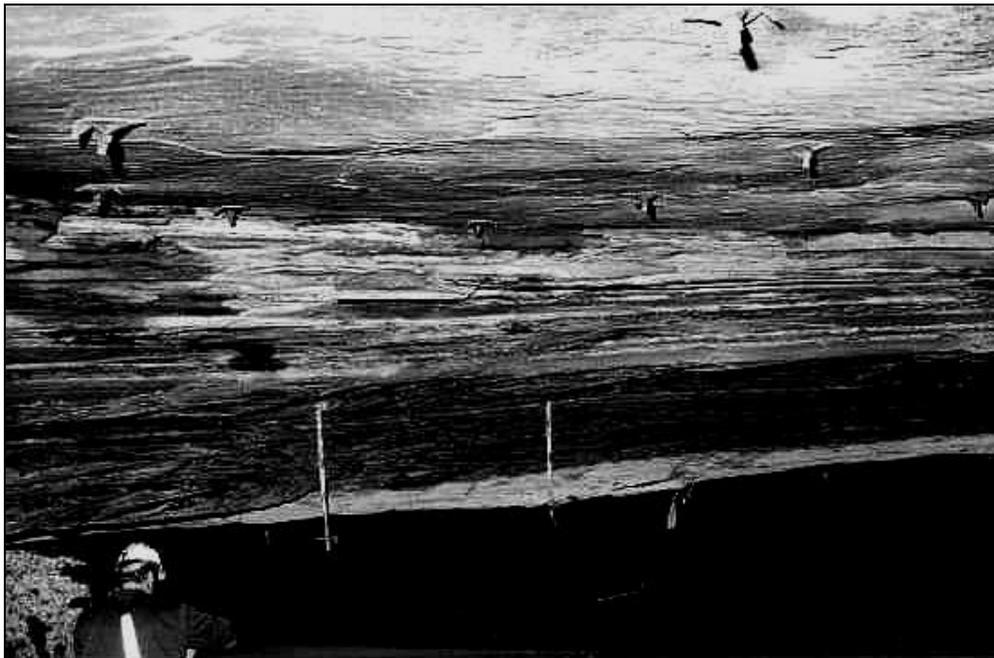
General description of roof: Sandstone beds (0,28 and 0,15 m thick) separated by laminated shale. Shale content of fall 82%. In general, beds varied in thickness from 4 to 30 cm – see Figure 1.

Figure 1. Illustration of the laminated nature of the roof. Note the variation in thickness of the light sandstone layer at the bottom of the roof.

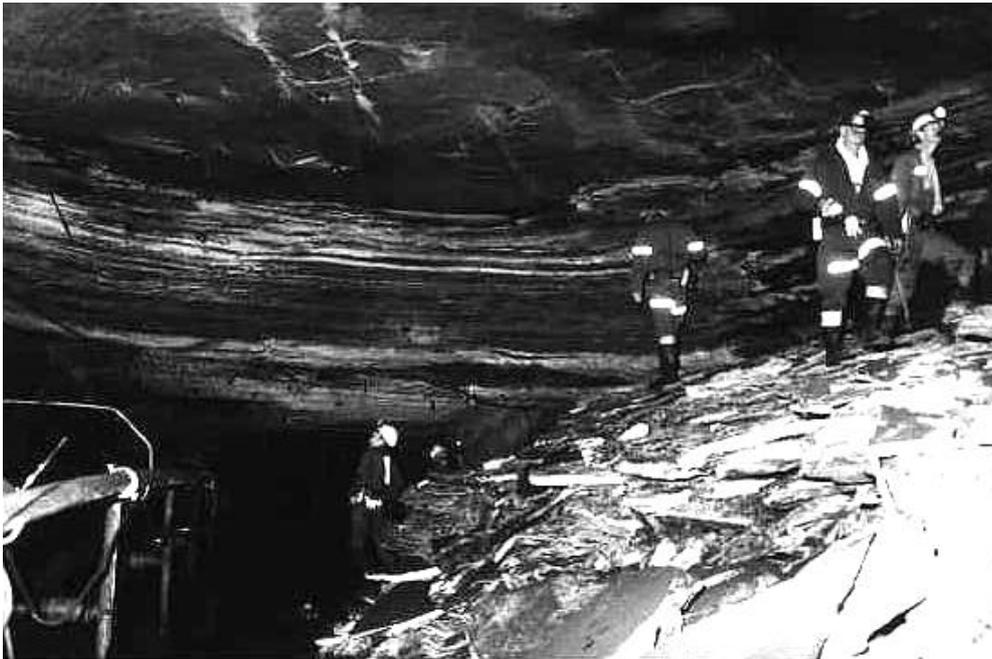
General description of fall: Intersection fell to height of 1,6 m, lateral dimensions 14,8 m by 13,6 m. Area of fall 155 m² – see Figures 2 and 3.

Figure 2. General view of the fall area.

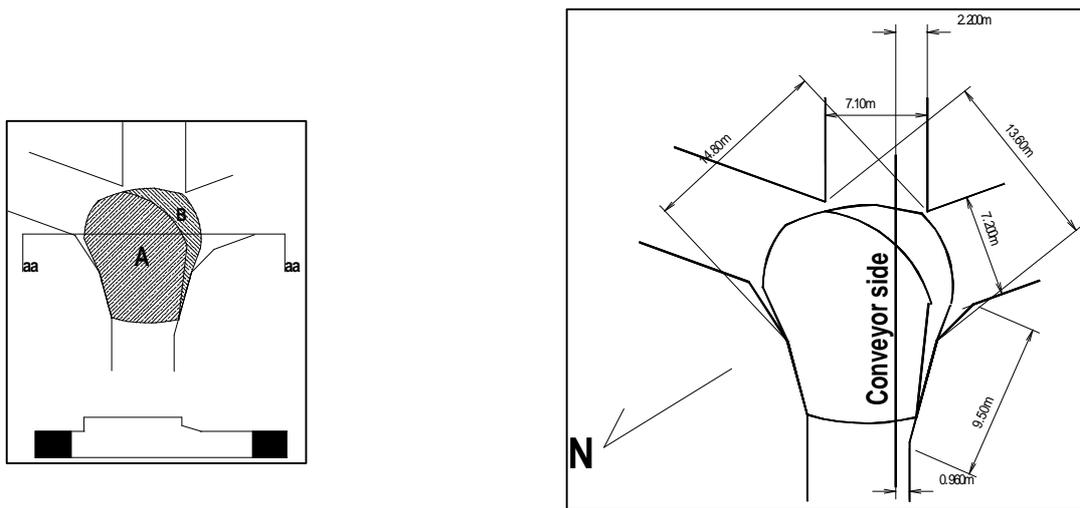
Figure 3 Plan view of the fall

The roof collapsed due to a combination of three adverse factors that were present. Firstly, the intersection was cut to excessive dimensions for the roof composition in this locality. Secondly, the supports were too short – being 1,5 m long in a 1,6 m high fall of roof. Thirdly, there was evidence of the supports only being installed after the roof beds had separated – see Figure 4. It is possible that the fall could have been prevented had any one of the three factors not been present.

Longer bolts would have been able to suspend the roof, even though the roof material had failed. Assuming a bolt density of 3 m² per bolt and 25 mm hole diameters, bolts of 1,8 m length would have suspended this roof.

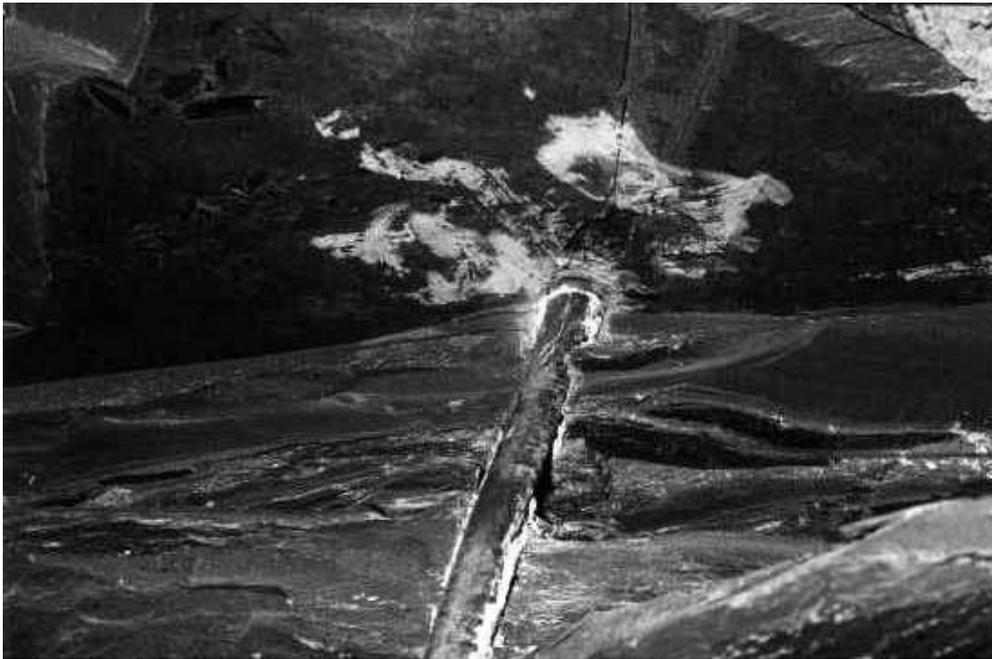
Figure 4. *The white material on the roof next to the top end of the bolt is resin, indicating that the bolts were only installed after the roof layers had separated.*

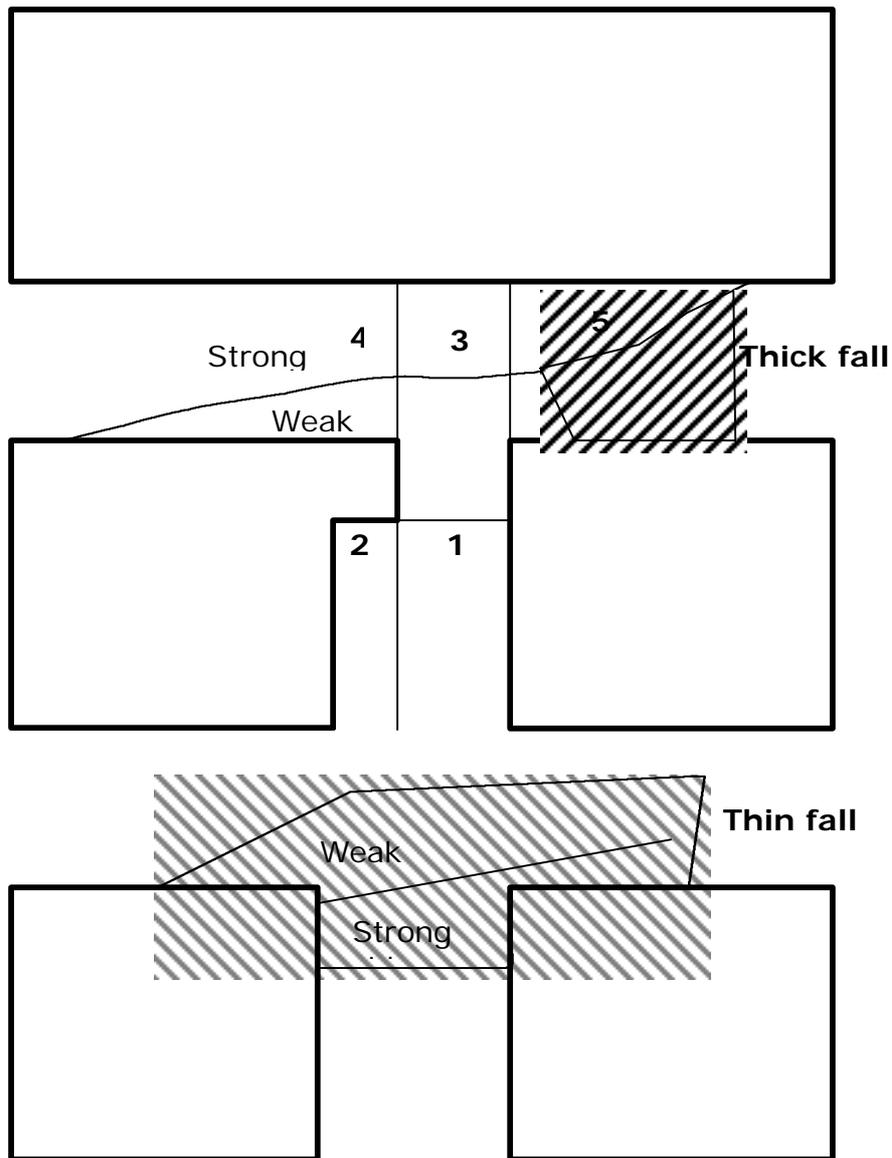
Figure 1 Diagram showing the positions of the two falls and the cutting sequence.

General description of fall: The fall positions and mining sequence are shown in Figure 1. There were two falls. The thin one was approximately 0.1 m to 0.3 m high by 11 m by 7 m (77 m²), either side of a small slip with approximately 0.1 m displacement. The exposed roof above showed signs of dampness but there was no free flowing or dripping water, see Figure 2.

At the far end of the split, where the fall started, the entire road width was on the weak side of the slip. At a beam length of 6.6 m, the generated tensile stress was approximately 6 to 7 MPa which is just greater than the tensile strength. The fall then occurred, the plate breaking back dynamically to where the beam length was about 3 m.

The fall could have been prevented if the slip had been supported at short intervals, i.e. by reducing the cut out distance. On this mine, it was seen that operator awareness of roof hazards was at a high level – yet they were possibly lulled into a false sense of security when the slip did not fall after its initial exposure.

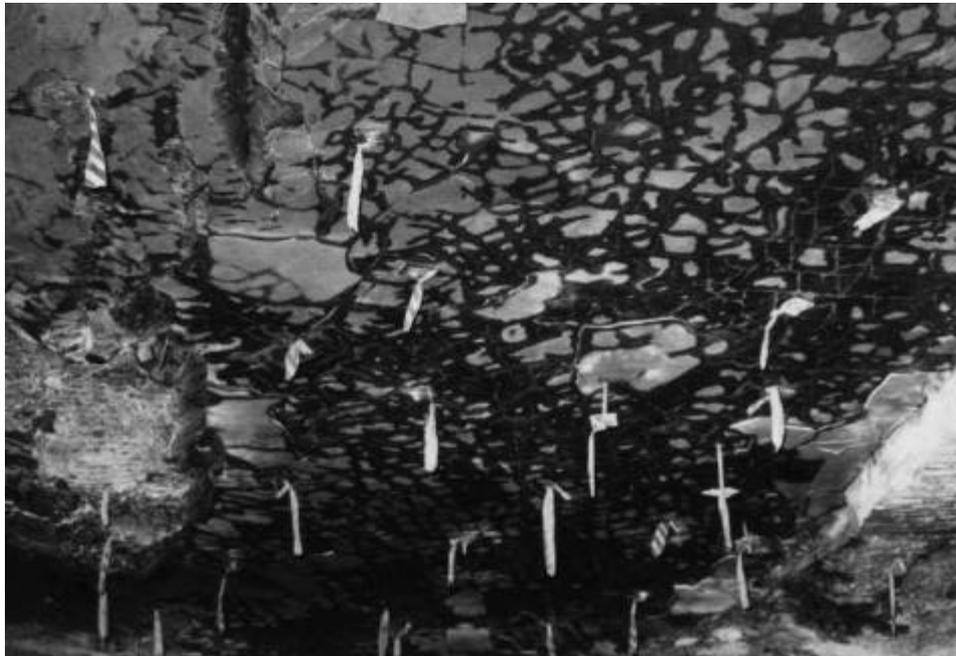
Figure 2 *Detail of the roof of the thin fall.*

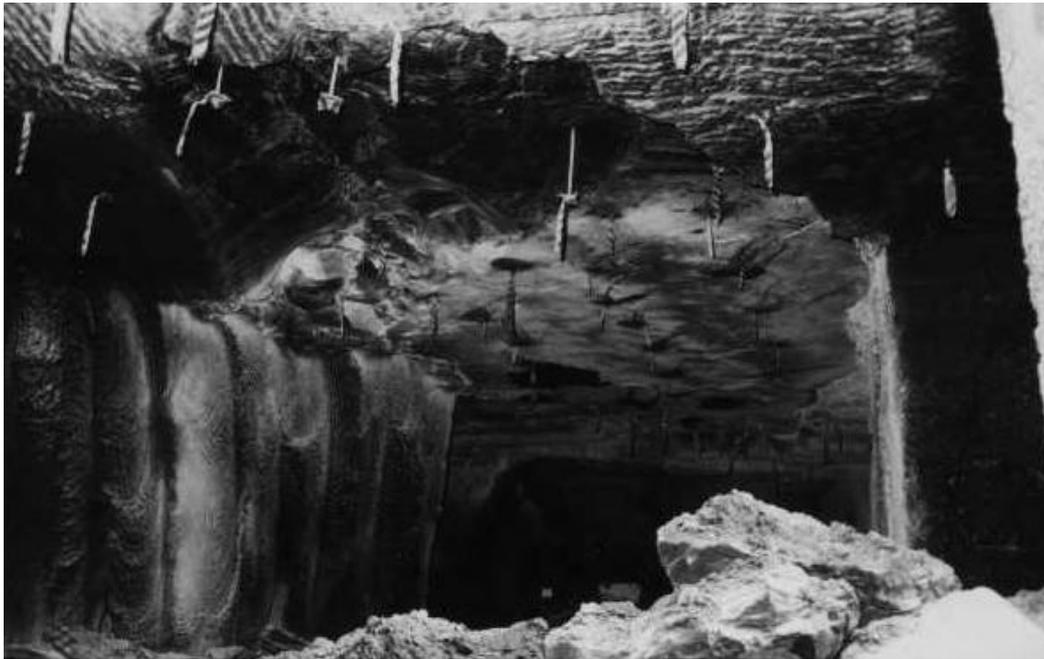
Figure 3 Overall view of the thick fall

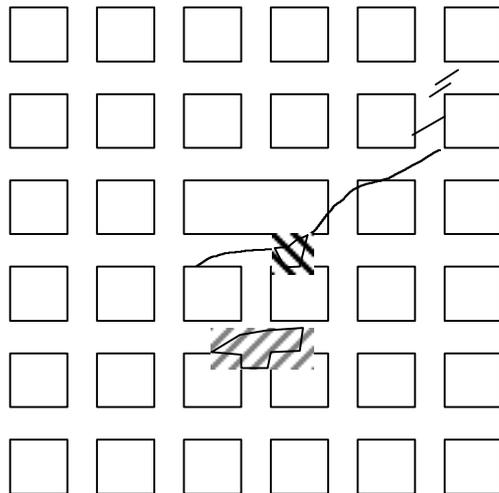
The split was followed in other roadways across the section, where it had not resulted in a fall, see Figure 4. In all the other positions, it either daylighted in a roadway (in other words, crossing the excavation as opposed to running along it) or had a short exposed weak side. It was also well supported, indicating that personnel had become wary of it.

Figure 4 Sketch plan showing the continuation of the slips through the section.

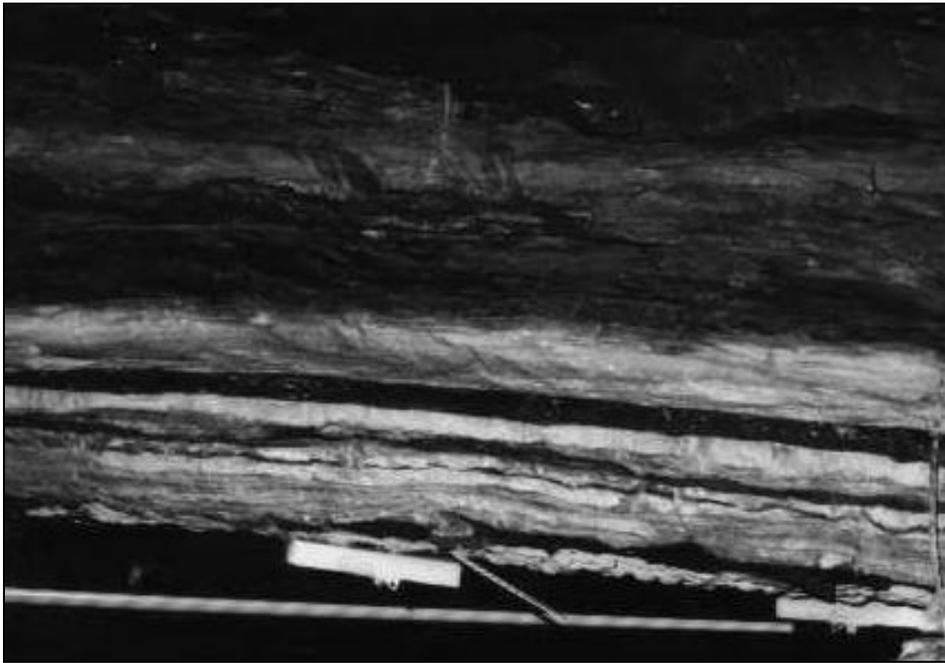
Figure 1 *Laminated nature of the roof.*

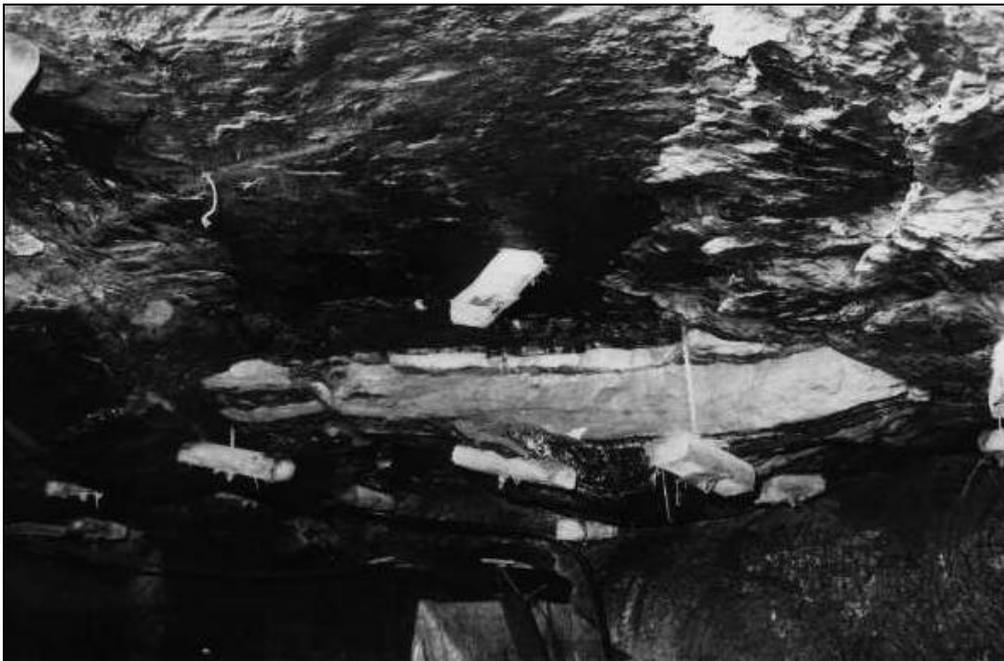
Figure 2. *Discontinuous sandstone remnant in the roof, arguably the result of differential settlement of the floor of the seam.*

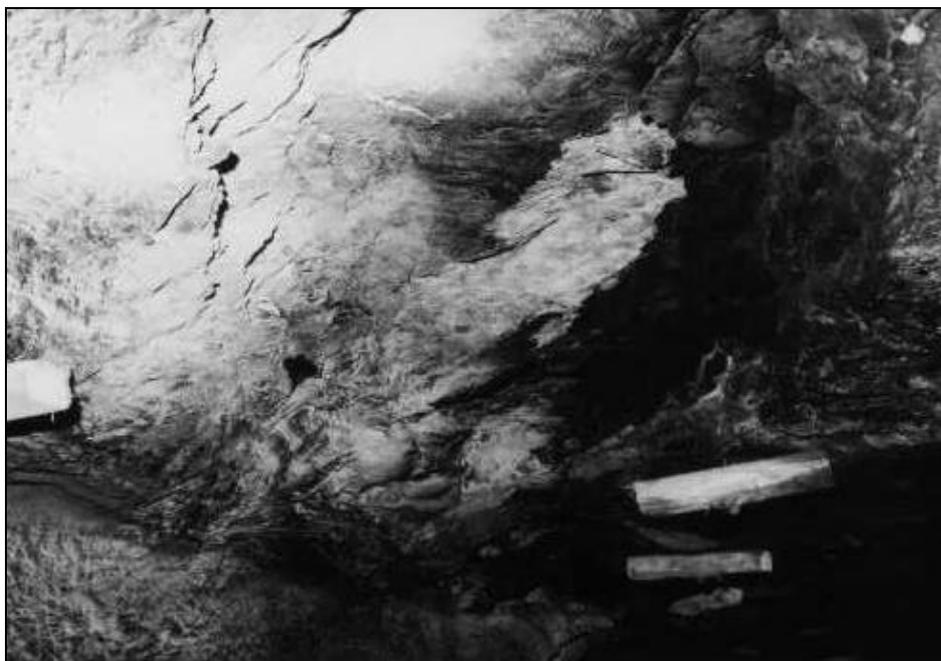
Horizontal stress indicators: Sporadic horizontal stress indicators evident, see Figure 5, sufficient to determine direction of maximum to be NW-SE. No stress indications within two pillars of fall (20 m) and no over thrusting or other horizontal stress indicators seen in sides of fall.

Figure 5. One of the sporadic occurrences of guttering.

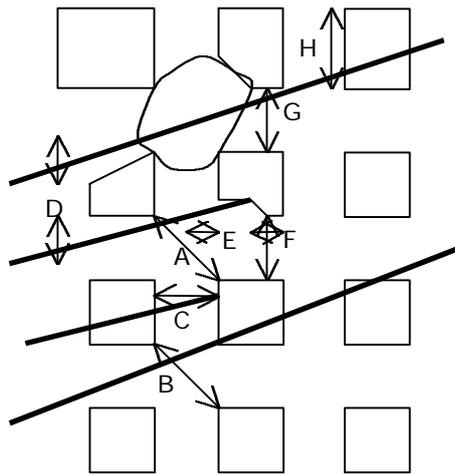
General description of fall: The fall was approximately 1.4 m high in an intersection that was oversized (8.5 m x 10.5 m) due to a corner of a pillar being cut out, see Figure 6. Figure 7 is a general view of the fall. Two slips intersected in the central region of the fall.

Figure 6. Sketch of the fall. The following dimensions were measured at the fall:

$A = 10.5\text{ m}$, $B = 8.4\text{ m}$, $C = 5.9\text{ m}$, $D = 3.0\text{ m}$, $E = 2.7\text{ m}$, $F = 6.1\text{ m}$, $G = 6.1\text{ m}$.

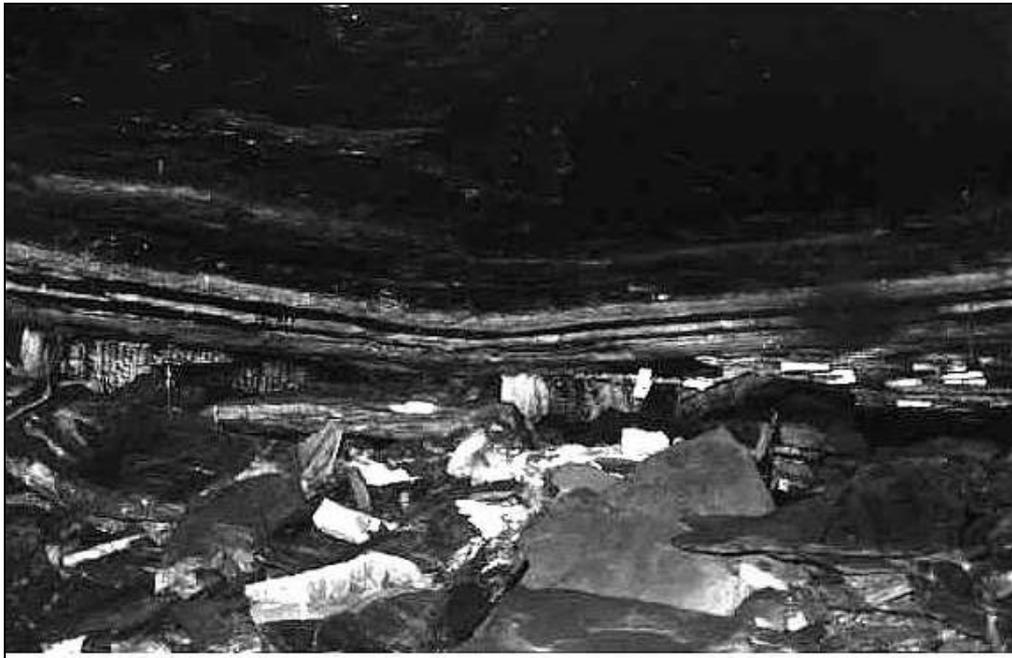
Figure 7. General view of the fall

This roof was at the lower extreme of South African roof conditions, comparable with “poor” roof in the USA. Under the circumstances, a dense, stiff support system would have been more appropriate, coupled with strict control over mining directions and dimensions.

It is concluded that this fall was due to poor support, poor directional control and possibly sub standard support materials under the conditions of a weak, flatly jointed roof with the added complication of horizontal stress.

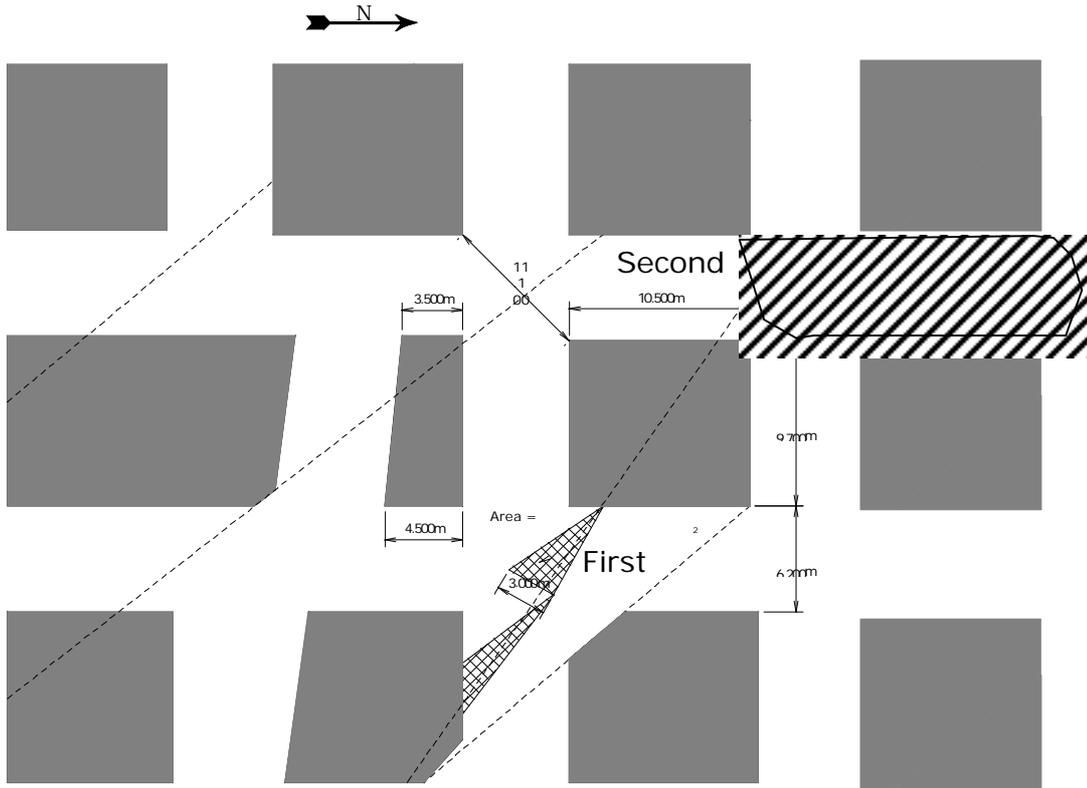
Figure 1 Plan view of the two falls.

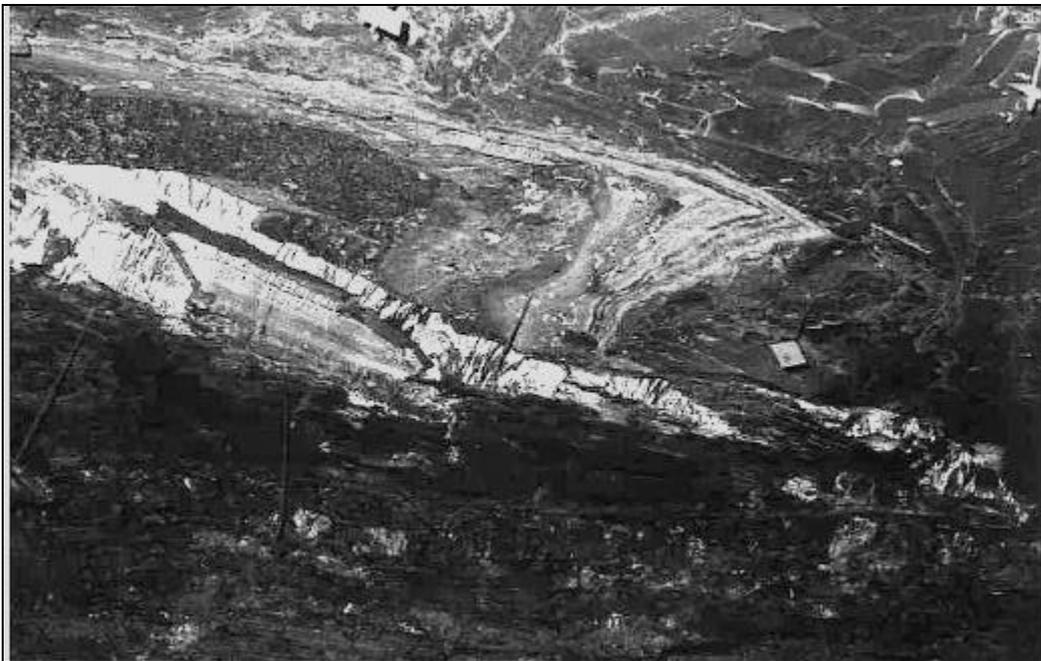
Fall 1: Wedge shaped at intersection against slickensided joint, see Figure 2. Fall height appeared to be 0.5 m. It could have been more than a metre on one side, although the higher area on the southern side was where the top coaling stopped. The extra height may have been top-coaled and not fallen.

Figure 2. View of the slip that bounded Fall 1 on the northern side.

Fall 1 was caused by the slip resulting in a cantilever. It was possibly triggered by blasting during the top coaling operation. It had the appearance of being aided by horizontal stress, but no other indications of horizontal stress could be found. In the soft roof, such signs should have been visible if the horizontal stress had been higher than normal.

Fall 1 could have been prevented by supporting the slip and Fall 2 by using resin instead of mechanical anchors.

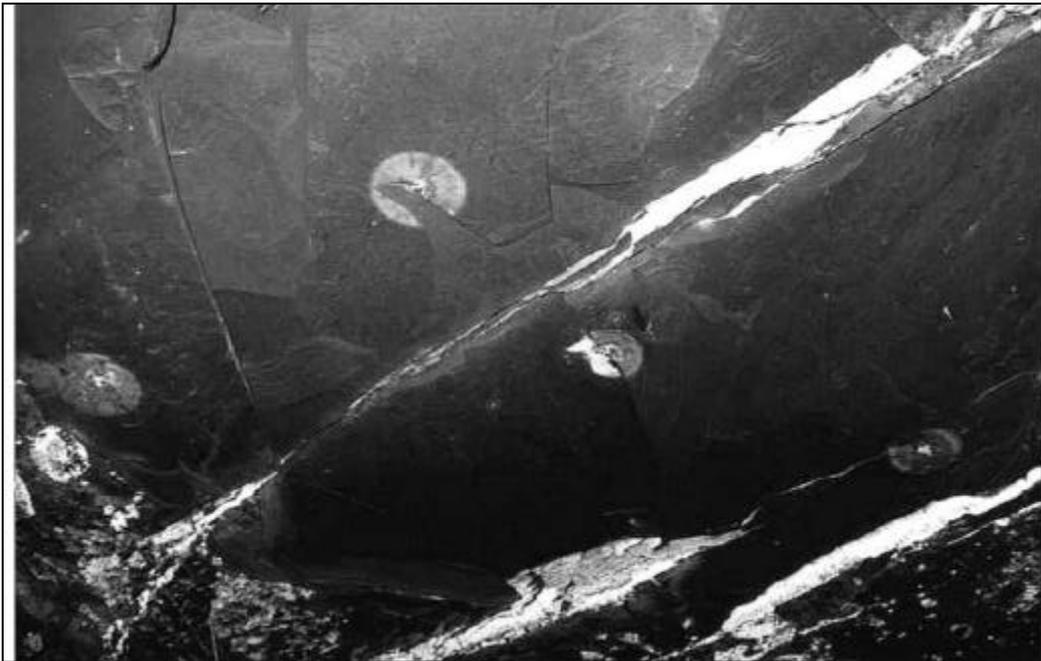
Fall 2: Fall 2 covered a wide area, interspaced with top coaling. The fall height was exactly 1.5 m, the length of the bolts. Each bolt position could be seen, indicated by brown circular discoloration, see Figure 3. The bolts appeared to have been well tensioned, indicated by the rock columns on top of washers, shown in Figure 4.

Fall 2 appeared to have been caused by the bolts. It is postulated that the mechanical anchors caused stress fracturing at the ends of the holes when they were expanded. The bolt density was seen to have been dense (less than a metre spacing in places) and over time resulted in a plane of fracturing at the anchor horizon. Rust marks on the roof indicate that water was also present, or at least that moisture accumulated in the minute openings caused by the stress fracturing. Eventually a loose layer was formed with the upper boundary at the anchor horizon and the collapse occurred.

Figure 3. *View of the discoloration at the anchor positions of the bolts, also showing the high density of slips.*

Fall 2 was caused (or aided) by the wrong choice of support for the existing conditions. Resin anchors would have afforded better anchorage without inducing the radial stress in the surrounding rock. From all appearances, the bolts were well tensioned and installed at a dense spacing. While this is normally sound mining practice, and commendable in the light of the observed jointing, it aggravated the situation in this case.

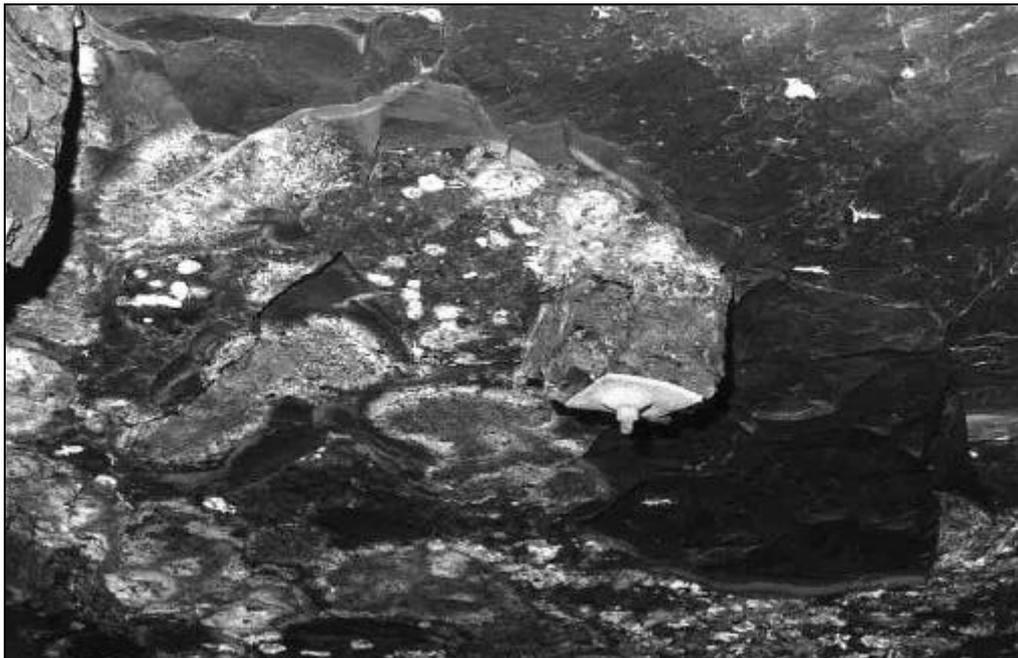
Figure 4. *View of a rock column on top of the washer, indicating sufficient pretension on the bolt.*

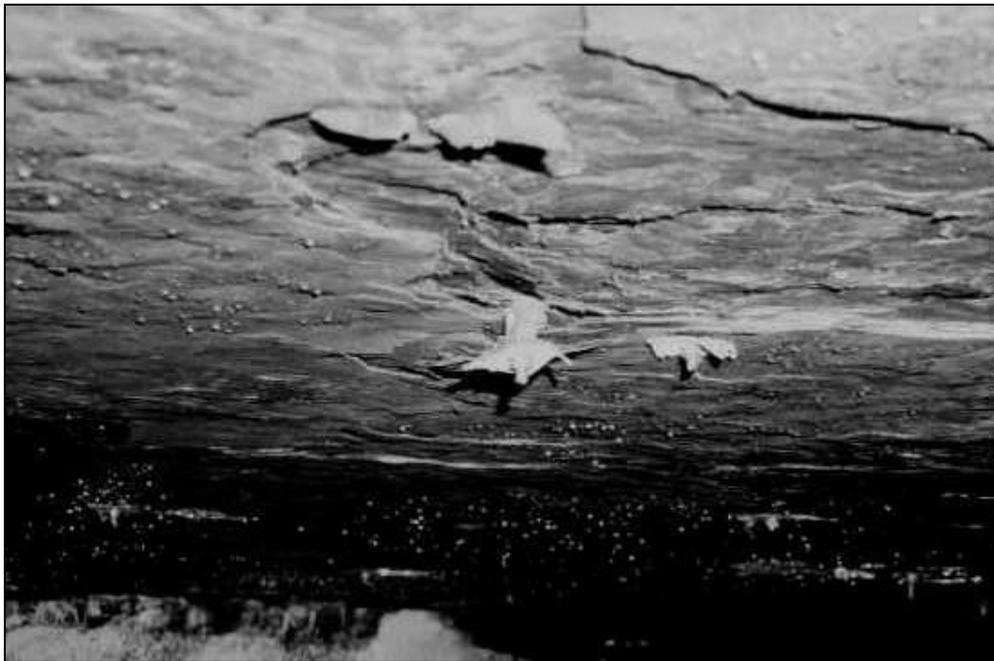
General description of roof: Silty sandstone (0.36 m), followed by laminated sandstone (0.2 m), then laminated silty sandstone (0.24 m), then shale (0.15 m) and finally sandstone with shale bands (0.1 m). Roof slightly weathered, susceptible to weathering. Dripping water was evident, see Figure 1.

Figure 1. *Water dripping from the roof.*

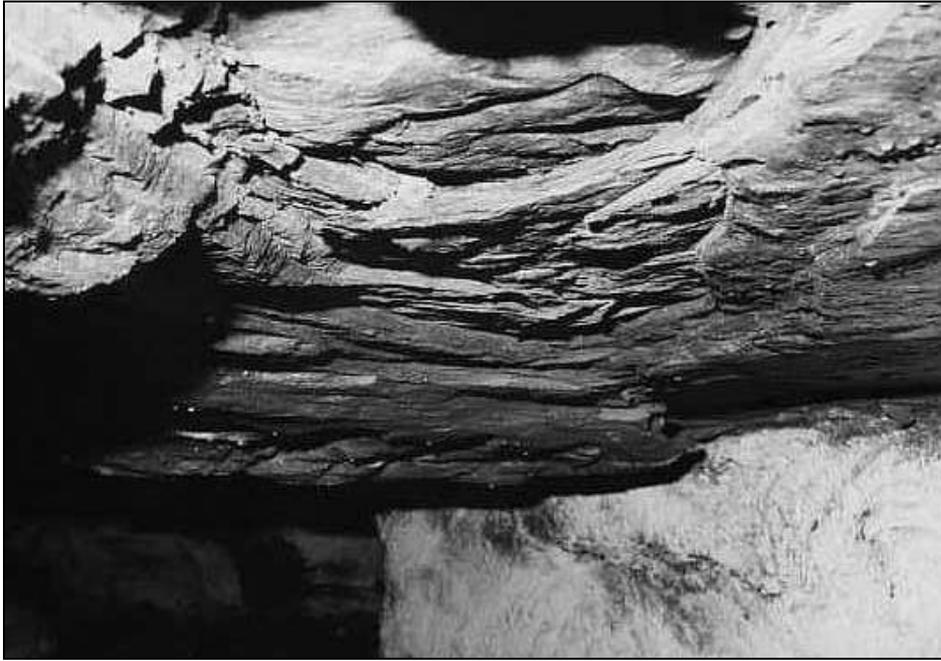
Figure 3. *Over thrusting of roof layers.*

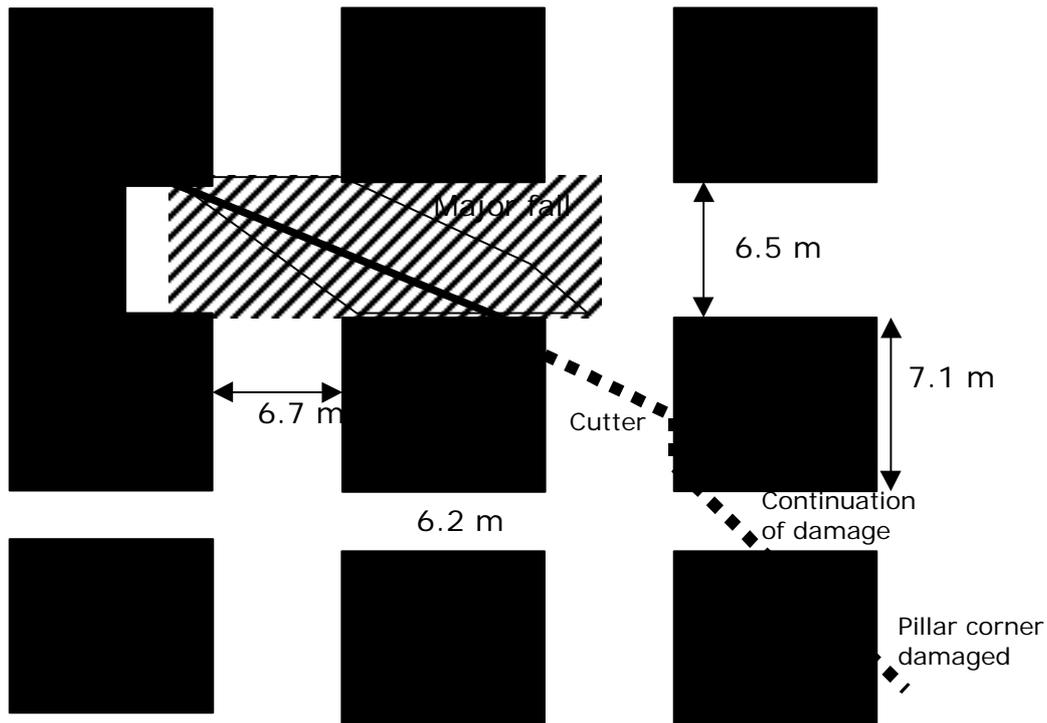
General description of fall: A plan view of the fall is shown in Figure 4 and a general view in Figure 5. The fall originated in the intersection and migrated into the split to the right. From there it crossed the next roadway and caused a cutter on the opposite ribside. The cutter/overthrusting continued for at least another roadway where it caused damage to a pillar corner. The fall height was 0.7 m at the intersection. The continuation fall was confined to the nether 0.3m skin of the roof.

Figure 4. *Sketch plan of the fall.*

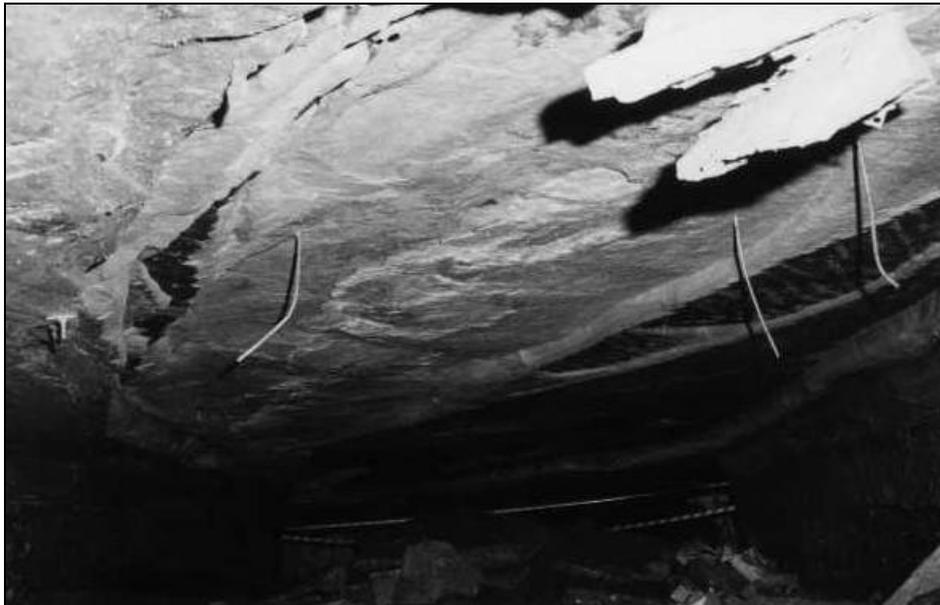
This fall was caused by high horizontal stress. The joint was the weak spot where it originated. Once mobilised, the roof strata continued to deform, driven by the high horizontal stress. The difference between the magnitudes of the maximum and minimum horizontal stresses are estimated to be small, as there was evidence of minor over thrusting in a direction perpendicular to the axis of the main damage, see Figure 6.

Figure 5. *General view of the major fall.*

It is possible that the fall may have been prevented by installing a stiffer support system, i.e. thicker bolts at a denser pattern and with higher quality of bolt installation. The time lapse between exposure and support of the roof is not known, but it should be a minimum in a case where high horizontal stress exists.

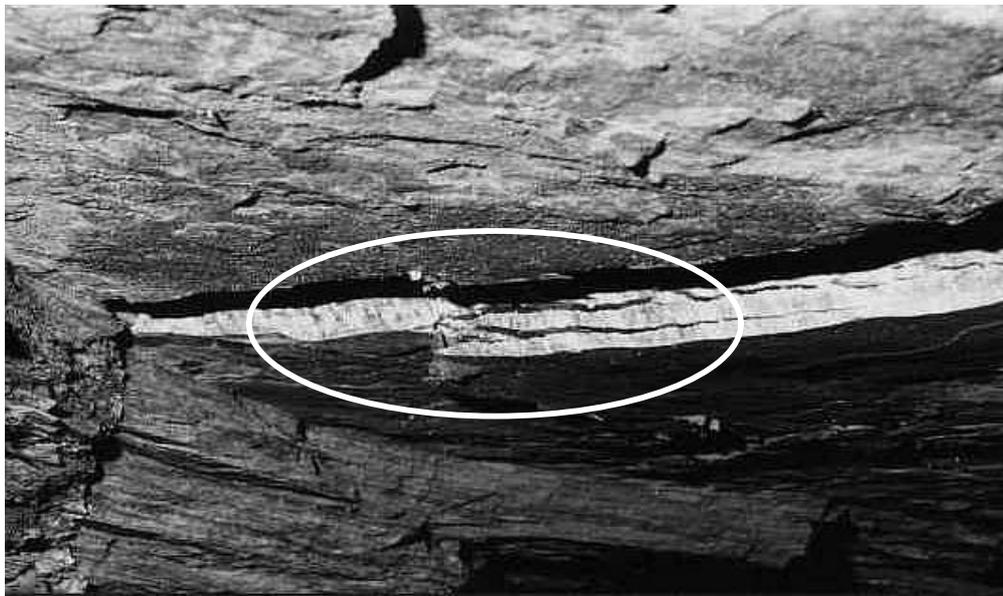
Figure 6. *Minor over thrusting in a direction perpendicular to the main guttering.*

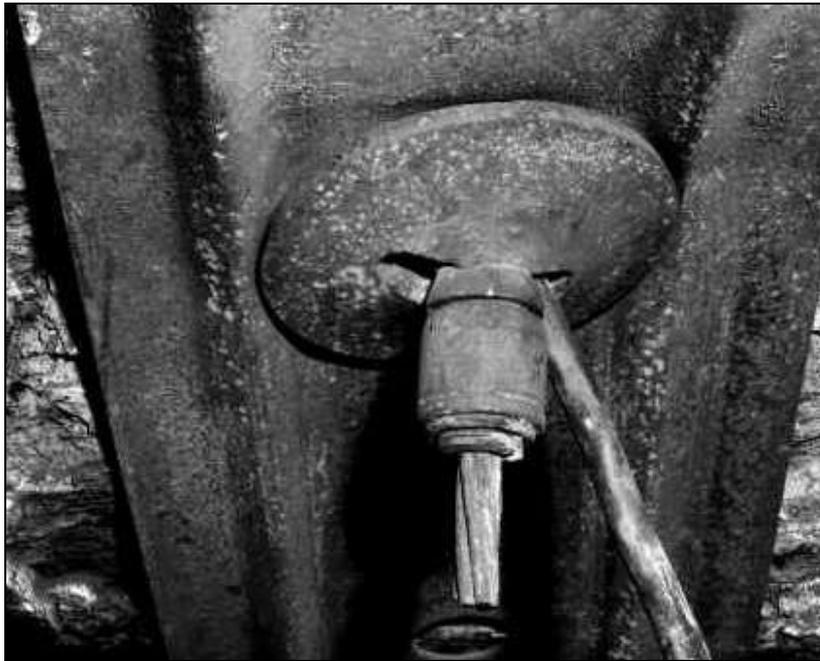
Support quality: The bolts were well installed, but there was some doubt regarding the quality of the cable anchors. This did not contribute to the fall, as they were installed on the other side of the dyke as where the fall occurred. The tension indicator rings were not exposed – see Figure, implying that either the pretension was insufficient or that the wrong indicator rings were installed. A 2 m long cut-off was found, see Figure 2, which is always cause for concern as it may mean that some of the cables were cut shorter prior to installation.

Figure 1. *Detail of the tensioning assembly of the cable anchor, showing that the load indicator had not come out. Note also that there is only one grouting tube instead of two.*
