Safety In Mines Research Advisory Committee

Causes of Falls of Roof in South African Collieries

**J.N. van der Merwe
J.J. van Vuuren
R. Butcher
I. Canbulat**

**March 2001
Revised August 2001**

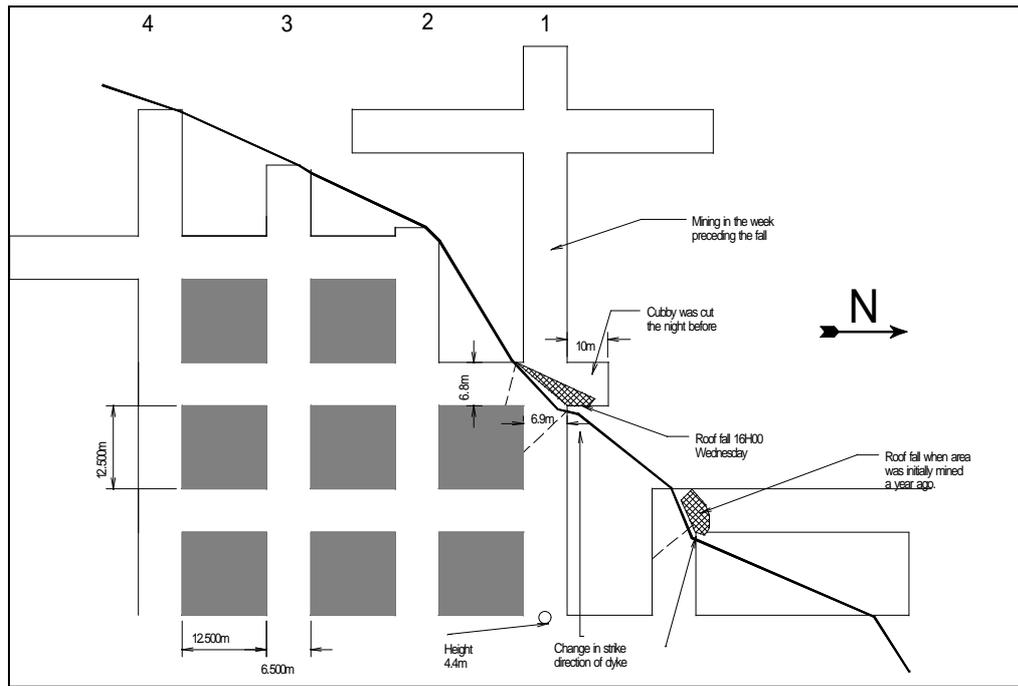
General description of fall: The fall was wedge shaped, +/- 1.5 m high by 12 m long and 2 m wide at the wide end. The top was flat. A plan view of the fall area is shown in Figure 3 and a view of the slickensided edge of the fall in Figure 4. As the roof had not yet been re-supported, a detailed inspection could not be done. The roadway through the dyke had been mined a few days prior to the fall. On the night before the fall, a cubby was cut at the dyke/roadway intersection. No additional support appeared to have been installed in the newly exposed roof.

Figure 3. Plan view of the fall.

This fall was caused by an insufficiently supported wedge that was formed by joints associated with the dyke. As the dyke had been mined before, and appeared to be stable, consideration was possibly not given to the effects of enlarging the area that was mined at the dyke.

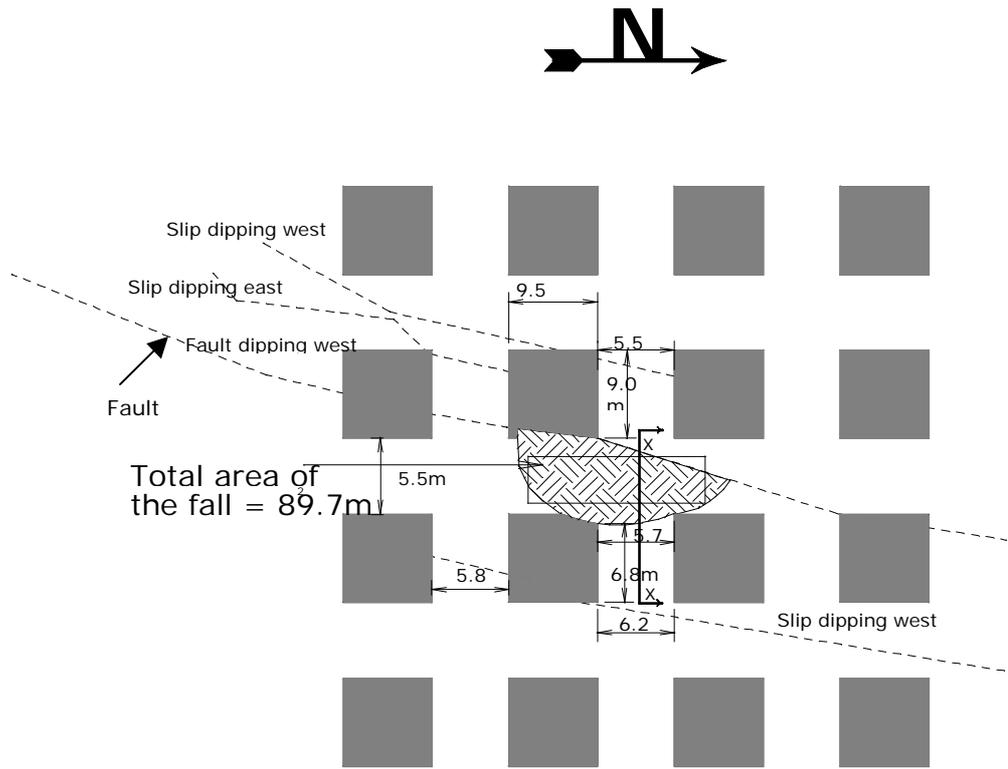
Figure 1. Plan view of the fall.

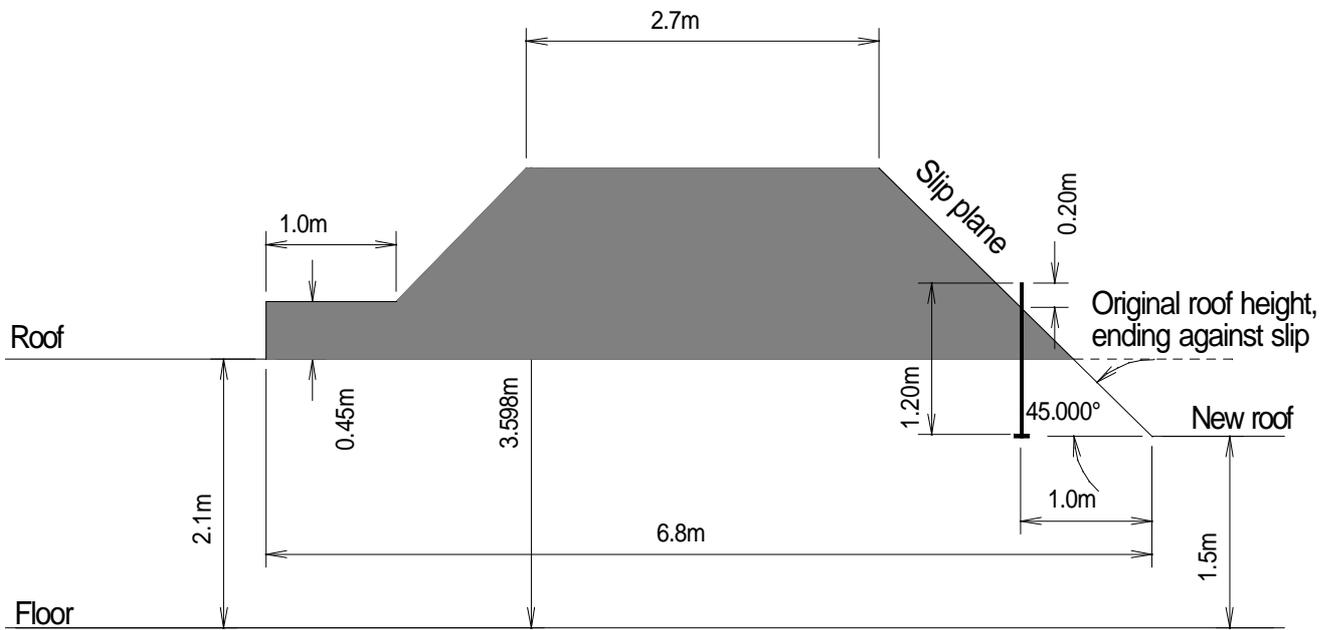
Figure 2. Cross-section through the fall.

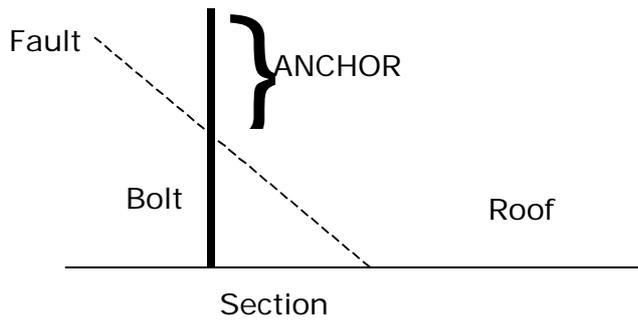
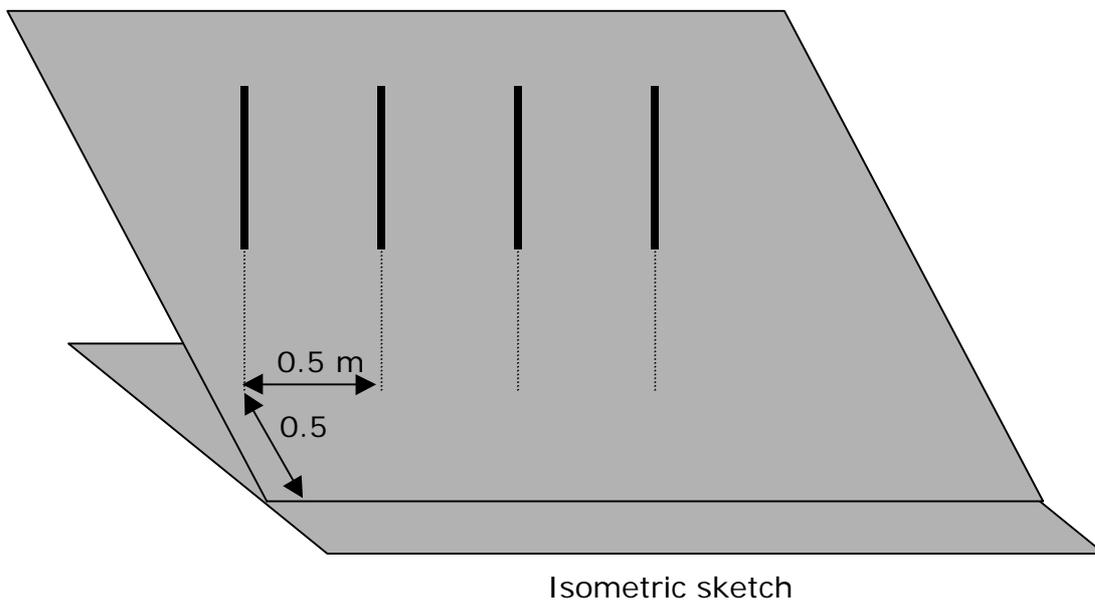
Figure 3. Section and isometric view to explain bolting configuration through fault plane.

If the spacing had been reduced to 0.5m, the anchor length would have had to be 0.5m, see Figure 3. This would have been possible if the bolts were installed 0.5 m from the fault plane. To summarise, a support configuration consisting of the 1.2m bolts spaced at 0.5m apart and installed 0.5m from the fault, would have been sufficient to contain the fall. Note that this presupposes a suitable support tendon. If V-bar had been used, with failure occurring on the steel/resin interface, the spacing would have had to be reduced to 0.37m.

The other alternative, which is preferable because it is independent of the dip of the fault, is to install bolts on either side of the fault and to join them with short lengths of W-strap.

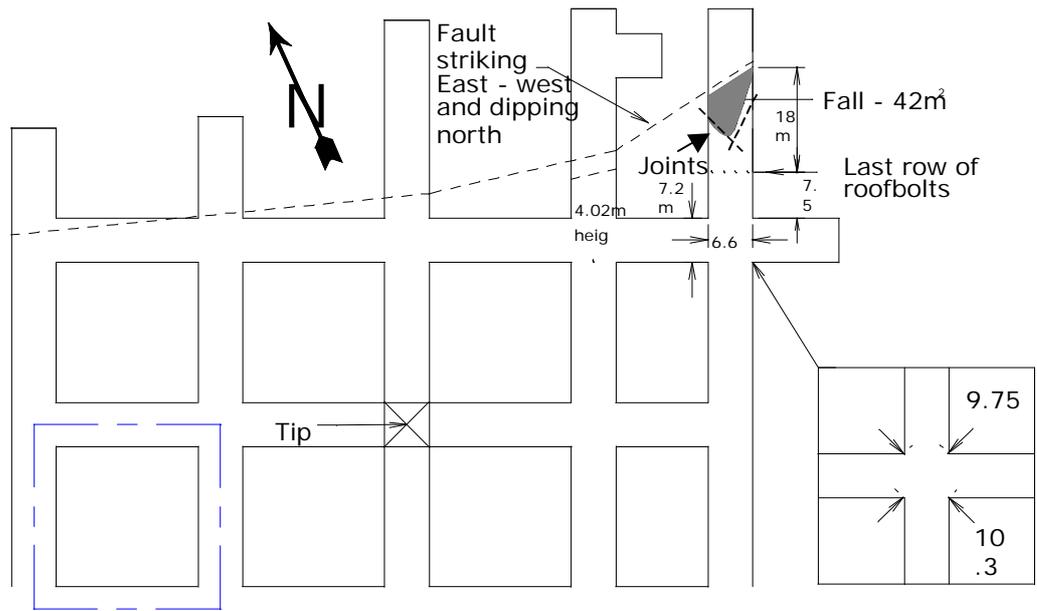
The fall was caused by the excessive cut out distance resulting in mining underneath an unfavourable jointing configuration in the roof without support. The underground crew's reaction in the next roadway, i.e. to project the position of the fault and then to reduce the cut out distance accordingly, is laudable.

Figure 1. Plan view of the roof fall.

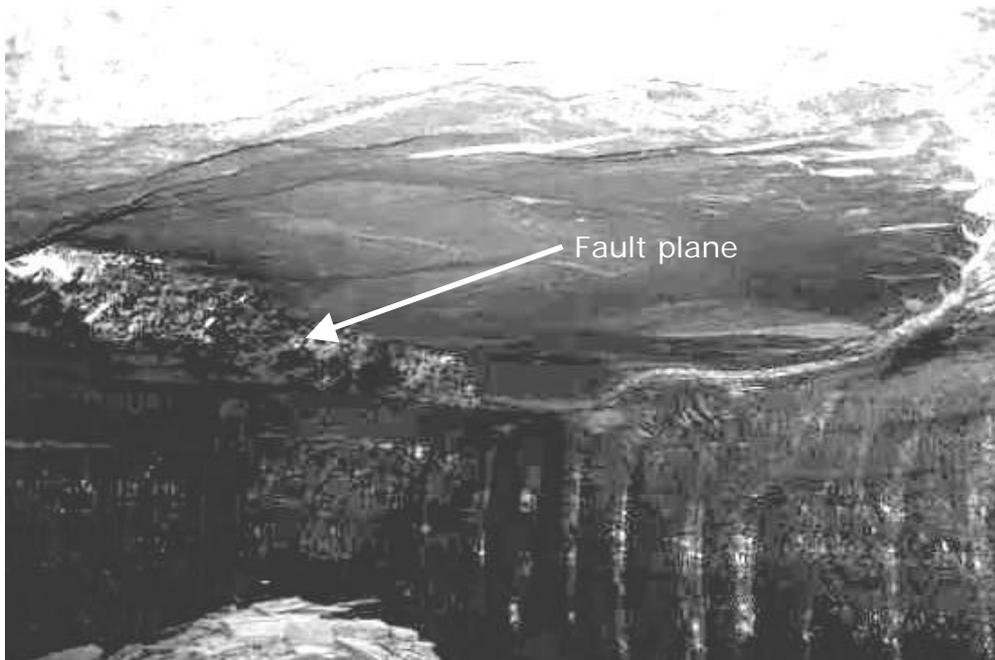
Figure 2. General view of the roof fall, showing the fault at the far end.

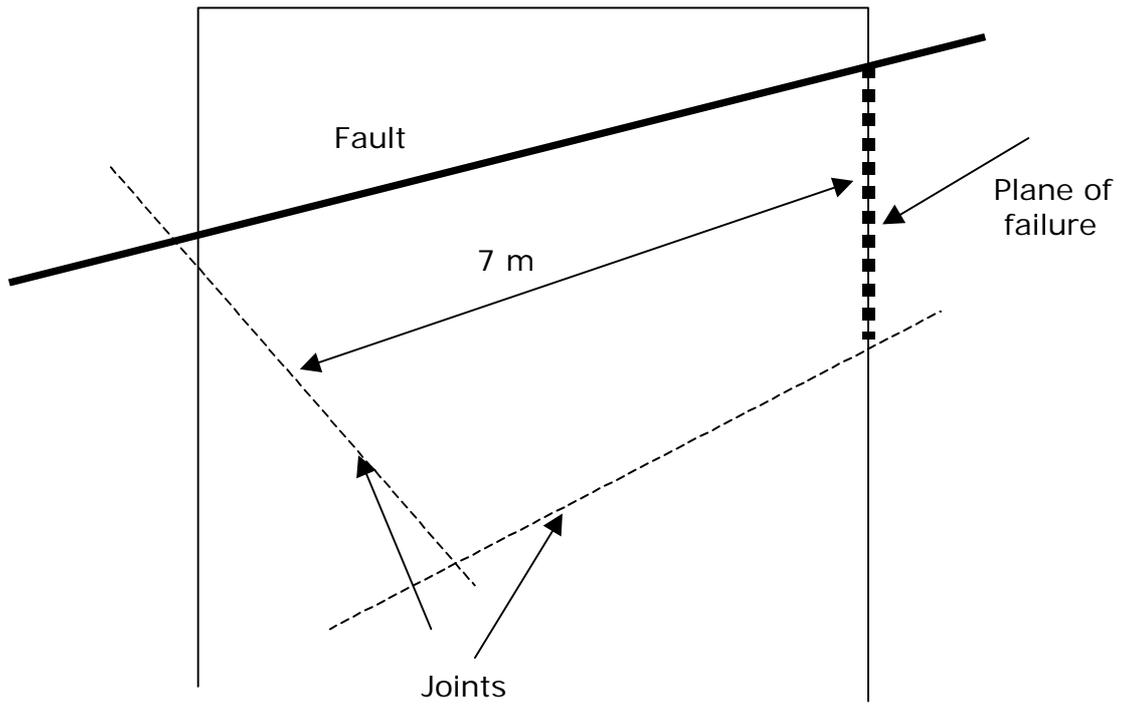
Figure 3. *Simplified diagram of the beam formed by the configuration of the fault and the minor joints.*

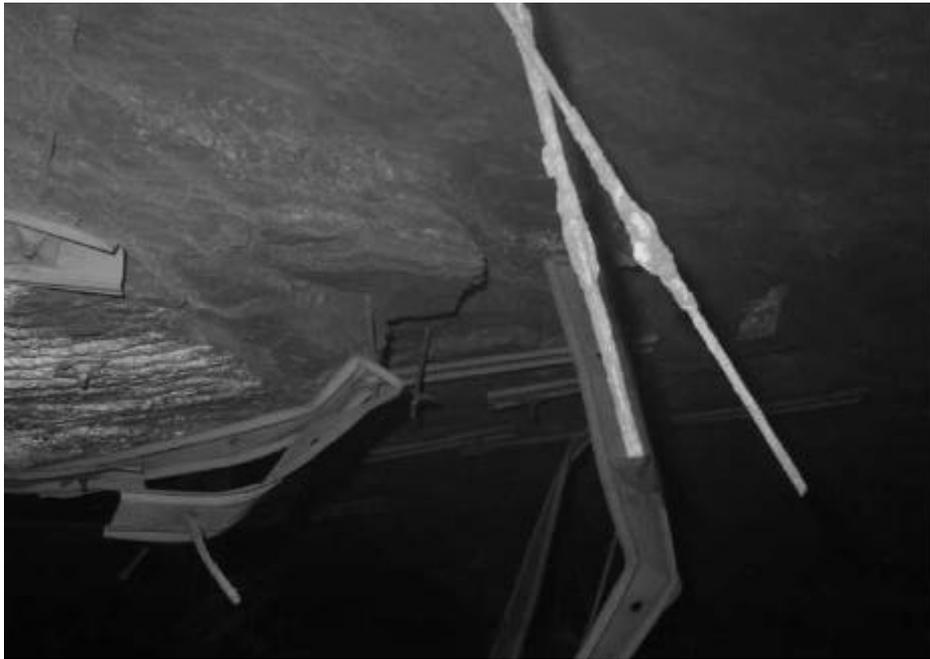
Support quality: Medium to poor, bolts not fully tensioned. Indications that roof had separated prior to support installation, see Figure 1.1 showing resin bulbs on bolts.

Figure 1.1. *The resin bulbs on the exposed bolts indicate that bed separation had already taken place by the time the bolts were installed.*

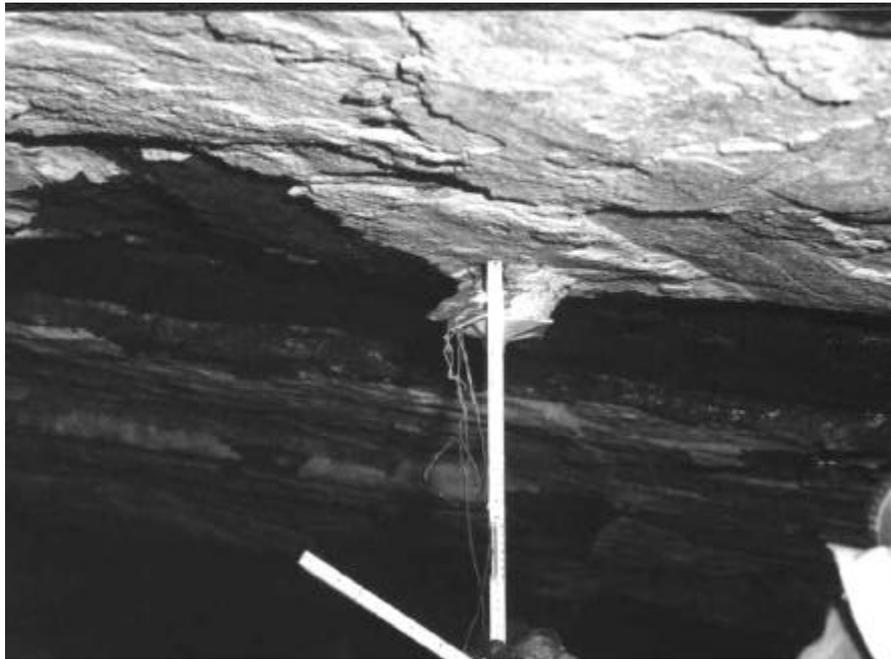
Horizontal stress indicators: None at fall, potting some distance away. Direction of maximum horizontal stress estimated at 120° . Open joints in approximate direction of major horizontal stress indicate lack of compression, or even tensile minor horizontal stress. At a small (unmapped) fall approximately 200 m west of this area, a roofbolt showing post installation horizontal movement was seen, see Figure 1.2.

Figure 1.2. Post installation horizontal displacement of bolt or bending beam?

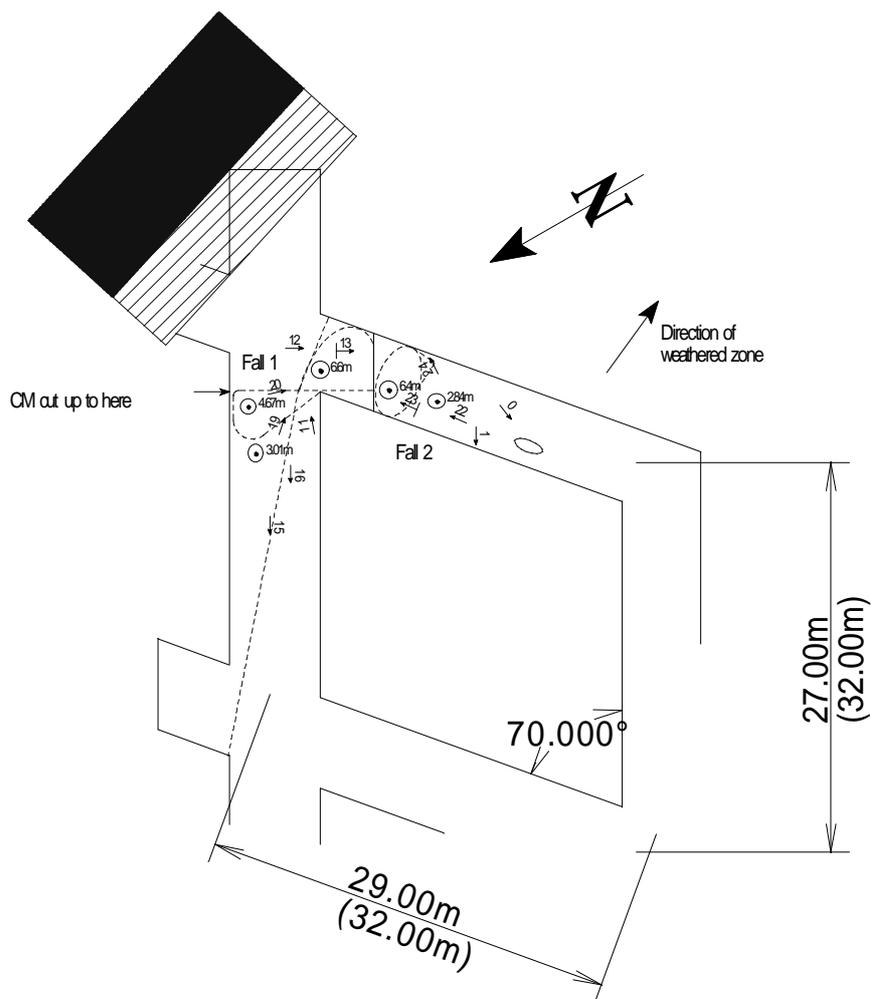
General description of fall: See Figure 1.3 for plan view. Fall height estimated 1.5m for Fall 1 and 6.5 m for Fall 2. Figure 1.4 shows dome shape of Fall 2 and Figure 1.5 the small fragmented rubble, indicative of the weak nature of the roof.

Poor rock quality, weathering, joints. Falls do not align with direction of maximum horizontal stress, which is probably incidental due to the proximity of the dyke. Appears that the contribution of horizontal stress may have been to open some joints, increasing instability.

Figure 1.3. Plan view of Falls 1 and 2.

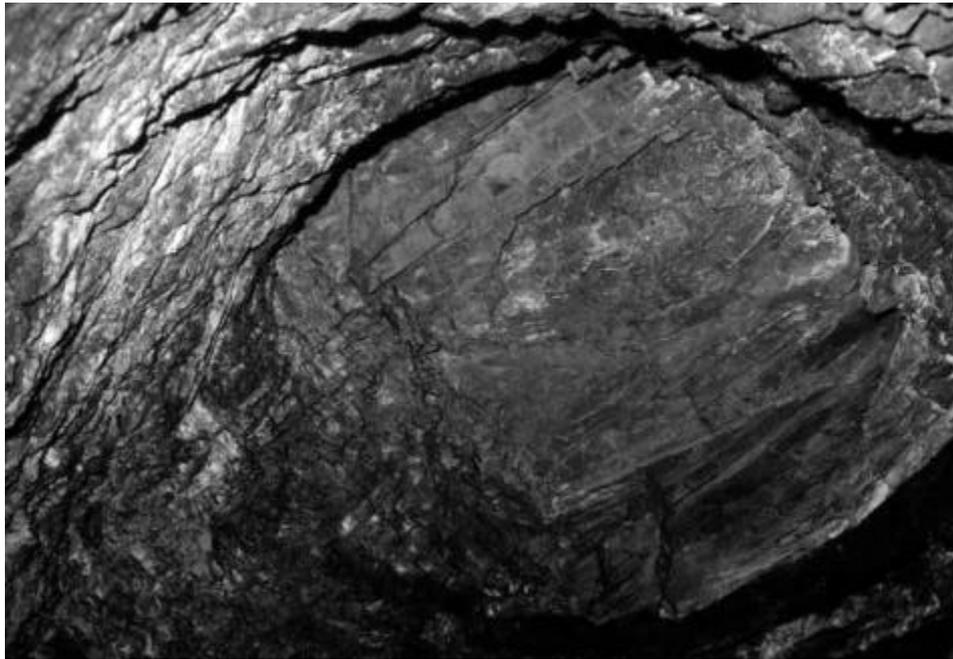
Figure 1.4. *Dome shape of Fall 2. Note the density of the joints.*

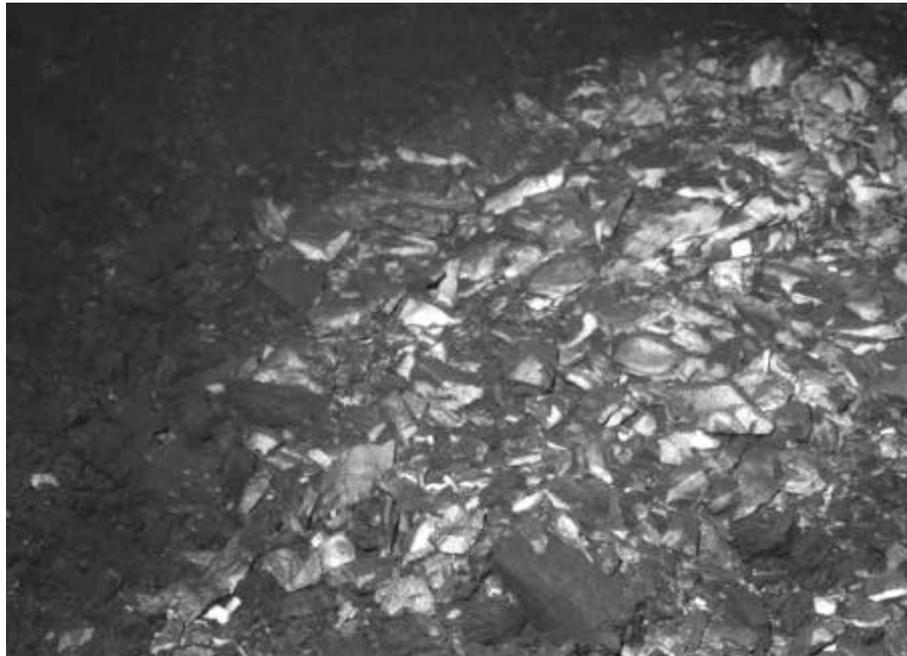
Figure 1.5. *Note the small fragments of the fall rubble.*

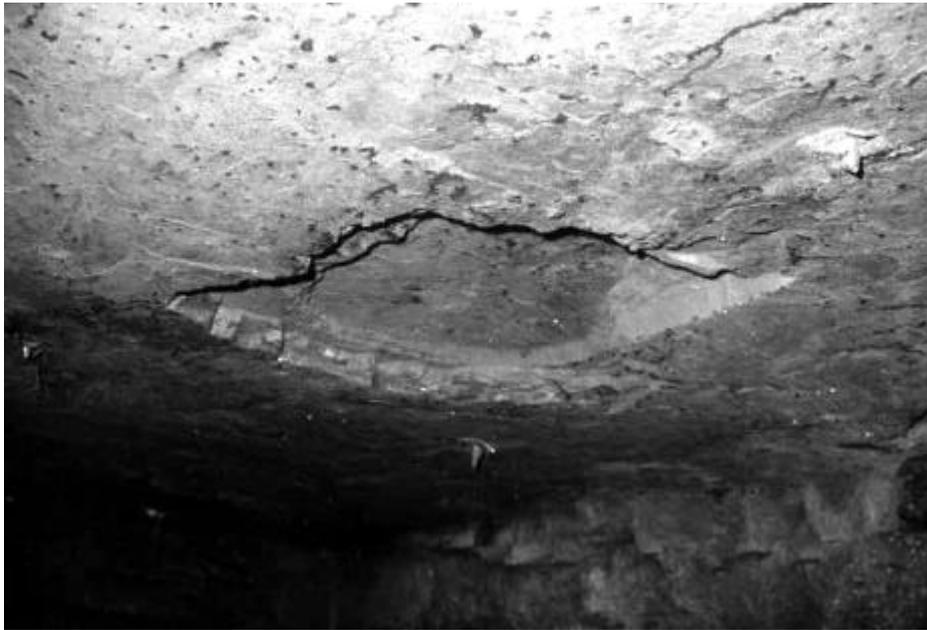
Horizontal stress indicators: Deep cutters and one severe roof potting, see Figure 2.1. The SDR was estimated at 4 – 6 and the direction of the maximum horizontal stress was 179° .

Figure 2.1. Roof potting in the vicinity of Fall 3/4

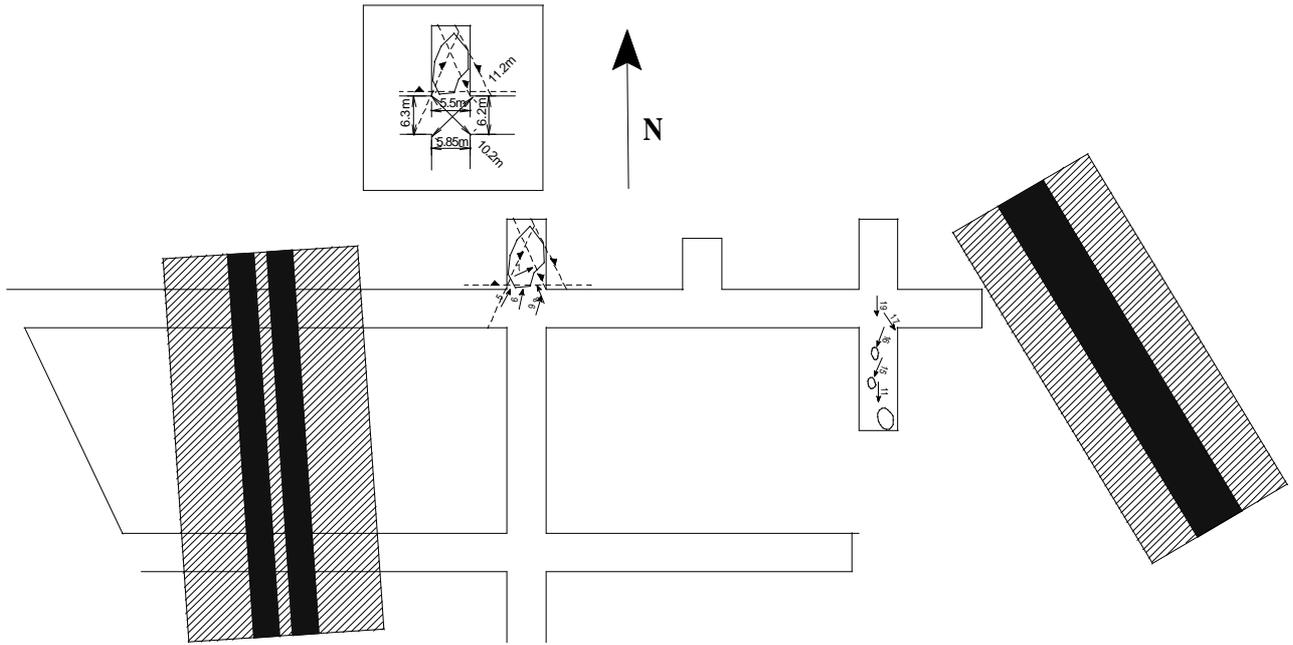
General description of fall: Figure 2.2 is a plan view of Falls 3 and 4. Figures 2.3 and 2.4 are general views of Falls 3 and 4 respectively. Water came out of the roof. At fall 4 there was a borehole.

The falls were caused by weak, jointed roof in the vicinity of a dyke, aggravated by water and horizontal stress.

Figure 2.2. *Plan view of fall 3 and 4.*

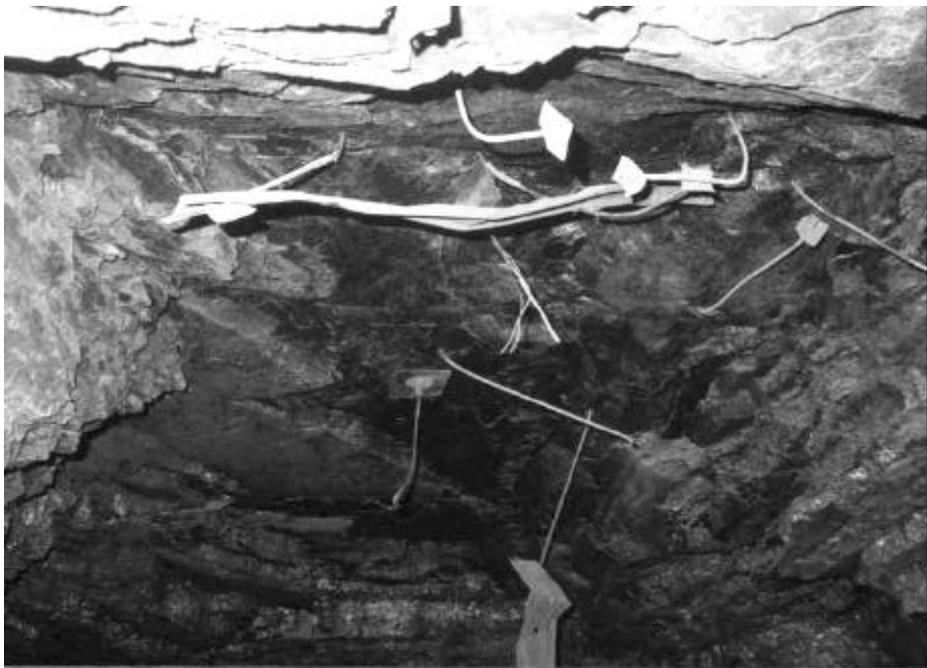
Figure 2.3 *General view of Fall 3, showing the blocky nature of the roof.*

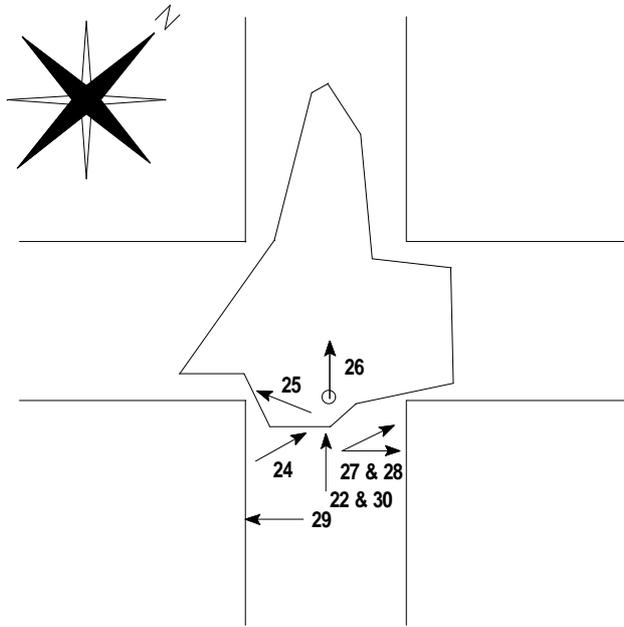
General description of falls: Figures 3.1 and 3.2 are plan views of two of the falls. The fall heights ranged from 1.5 m to over 4 m. Figures 3.3 and 3.4 show typical damage to the roof. Note the column of rock on top of the W-strap in the background of Figure 3.4, indicating the weakness of the roof and its inability to support itself even over very short distances. Figure 3.5 shows the intensity of the jointing in the area. Figure 3.6 is a general view of the fall shown in plan in Figure 3.2.

Figure 3.1. Plan view of one of the falls in the area, indicating the aerial extent of the fall. The fall had an estimated height of 1.5 m.

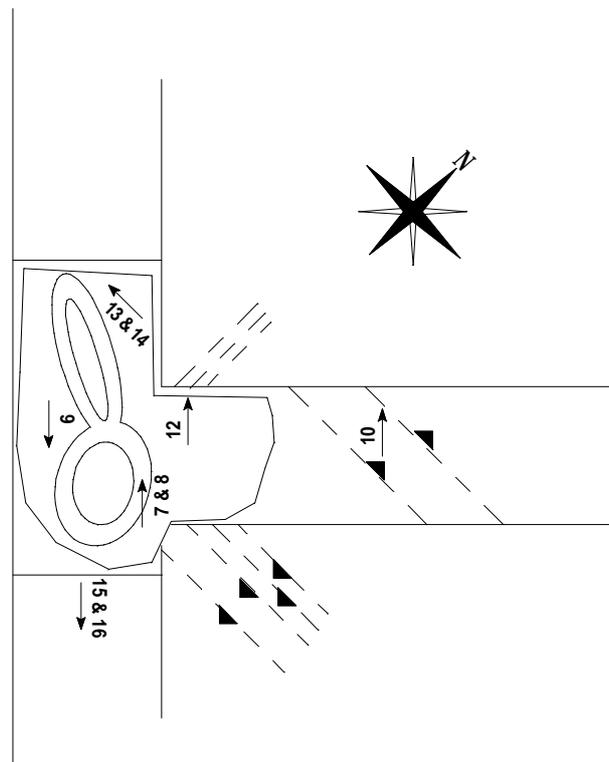
Figure 3.2. Plan view of the fall that was more than 4 m high.

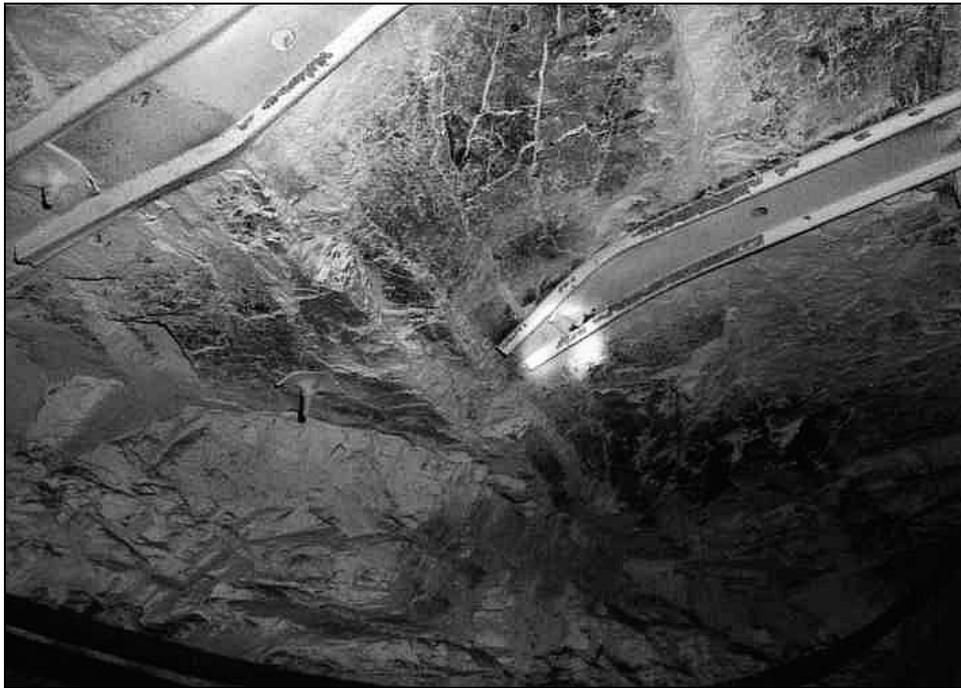
Figure 3.5. *Note the intensity of jointing in the roof.*

These falls were caused by the high intensity of jointing and weak roof that is typical of heat induced damage in the vicinity of some dykes.

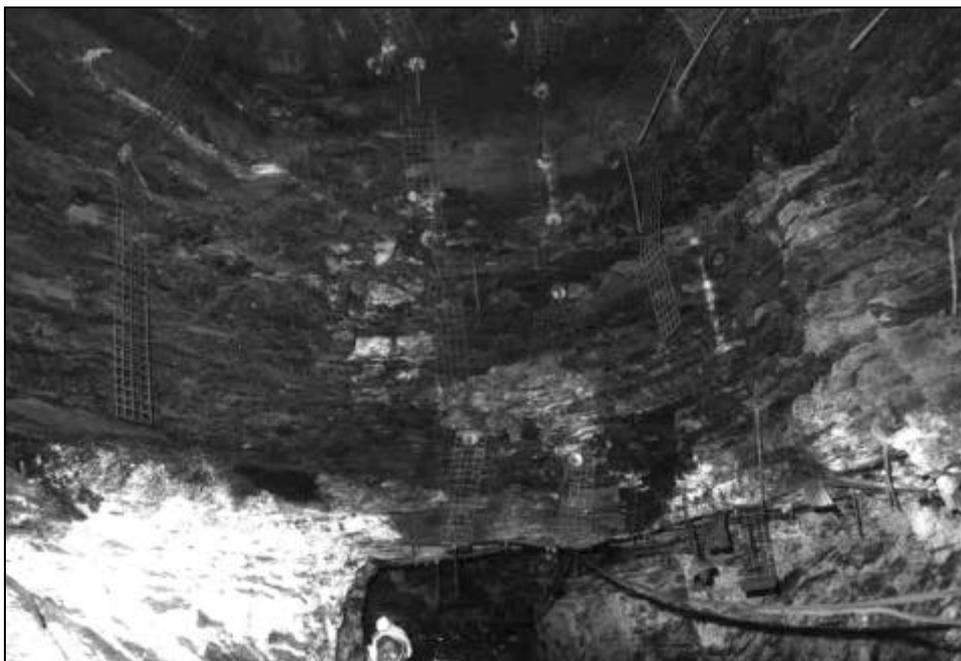
Figure 3.6. *General view of the 4 m high fall, shown in plan in Figure 3.2.*

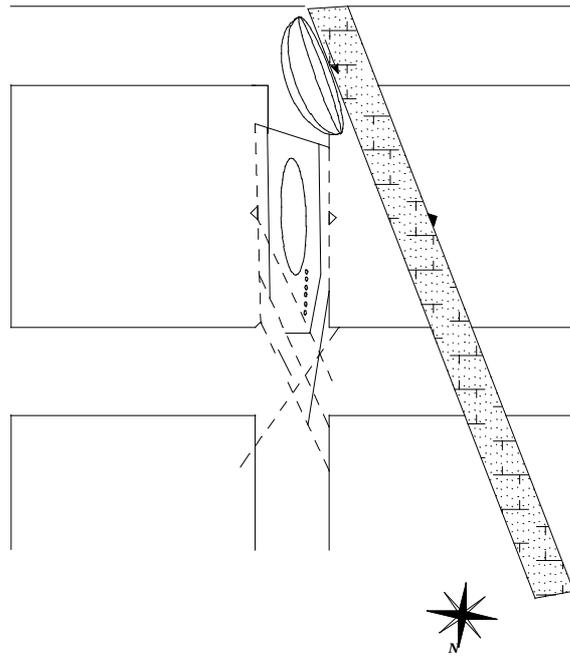
General description of fall: Figure 4.1 is a plan view of the fall , which consisted of two parts. It was not known which occurred first. The fall in the intersection was in the burnt coal, and was approximately 4m high. The fall in the split was between joints that formed a 3m high wedge that fell out. Figure 4.2 shows one of the joints that formed the wedge.

Figure 4.1 *Plan view of the two parts of the fall.*

The fall was caused by intersecting joints forming a wedge and by the weakened roof due to the heating effects of the dyke.

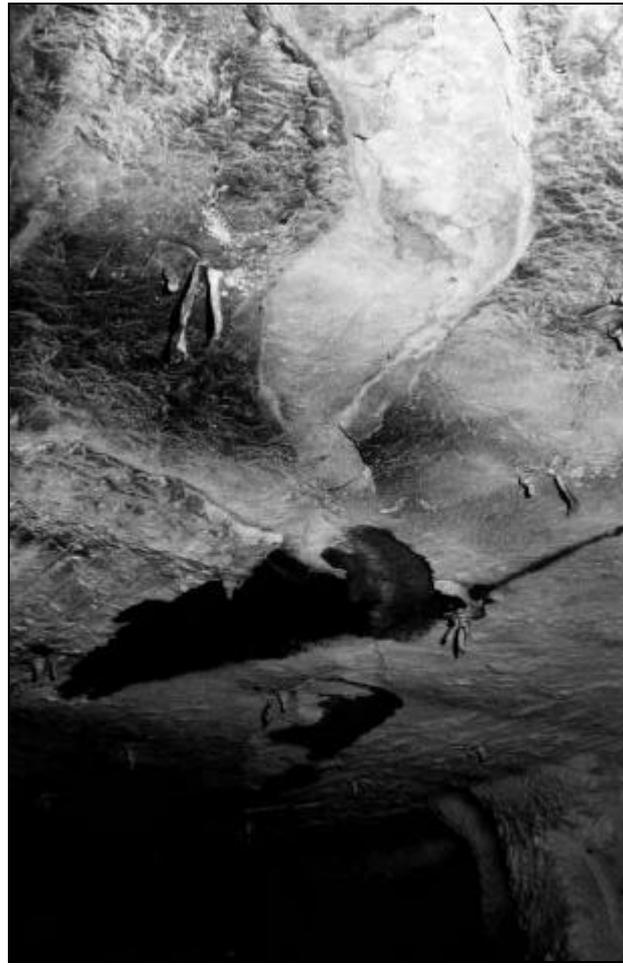
Figure 1 **Minor potting.**

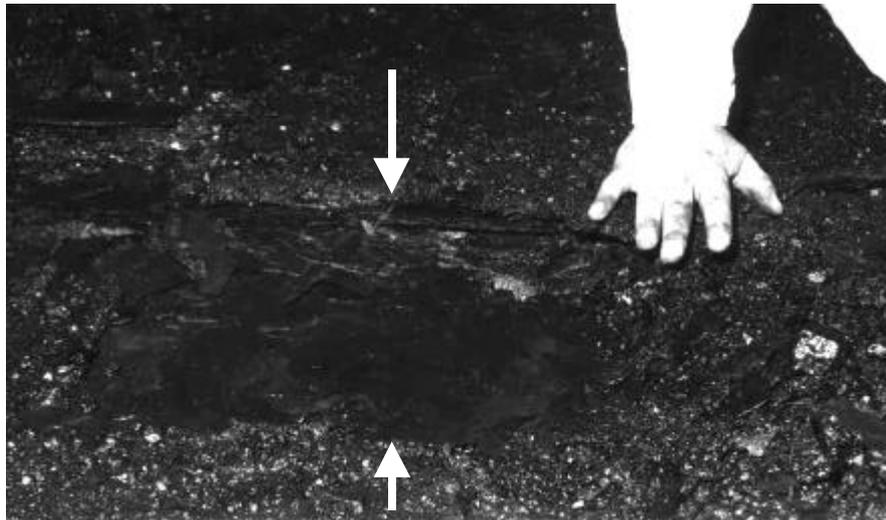
Figure 2. **Floor heave**

In split 80, road no. 4, floor heave was observed. The floor heave was $\pm 100 - 150\text{mm}$ high and ran in two lines more or less diagonally across the intersection. The lines were not parallel with the strike direction being $\pm 320^\circ$ and 340° respectively. The intersection that was formed, was larger than the other intersections throughout the section due to the splits being started of in this roadway. Thus the pillar corners were cut away to enable the CM to turn. The corresponding intersection, one split back was also inspected and no floor heave was observed. The position of the floor heave corresponds to the channel of weakness.

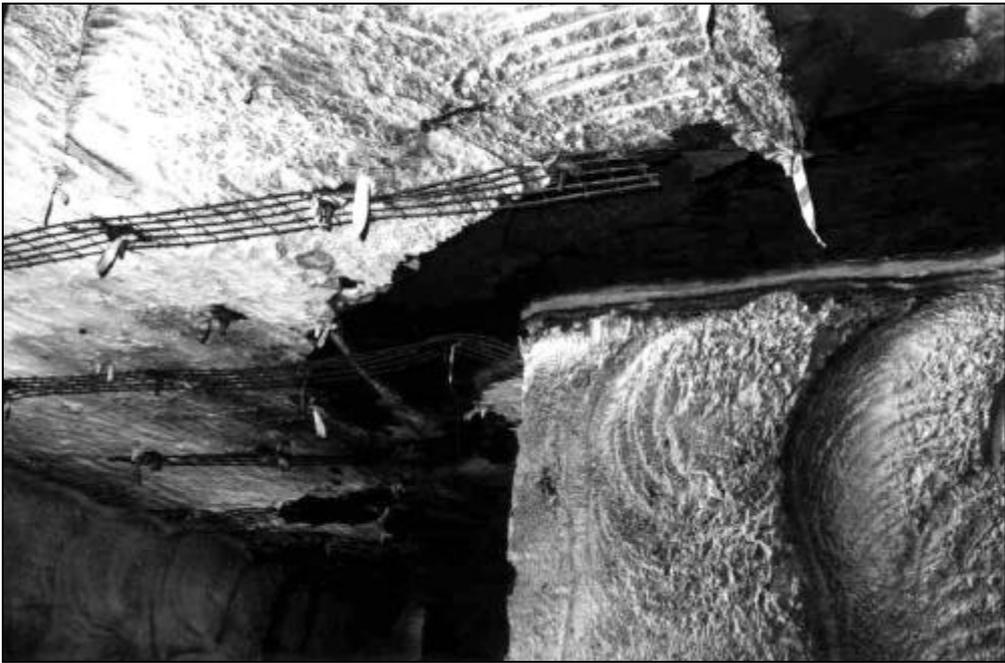
Horizontal stress indicators: The excavations where the fall occurred showed signs of damage that could be attributed to horizontal stress. The near-by workings showed signs of horizontal stress damage. The horizontal stress damaged (roof) was confined to the southwest side of the panel. This damaged zone was defined by a line bearing 302/122° (magnetic). To the north east of this line, the roof was not damaged. In the southwest section, horizontal stress damage took the form of potting and cutter roof, see Figure 1. The cutter damage to the roof varied from slight to deep. Minor floor lifting was seen in the undamaged areas, see Figure 2. Minimal pillar stress induced damage was observed. Where this occurred it normally took the form of scaling of the pillar corners, with shear failure of the top pillar/roof contact being also seen. The falls were seen to migrate around corners, see Figure 3. One of the roofbolt holes was seen to be deformed as shown in Figure 4.

Figure 3. *Fall progressing around a corner in the form of a cutter.*

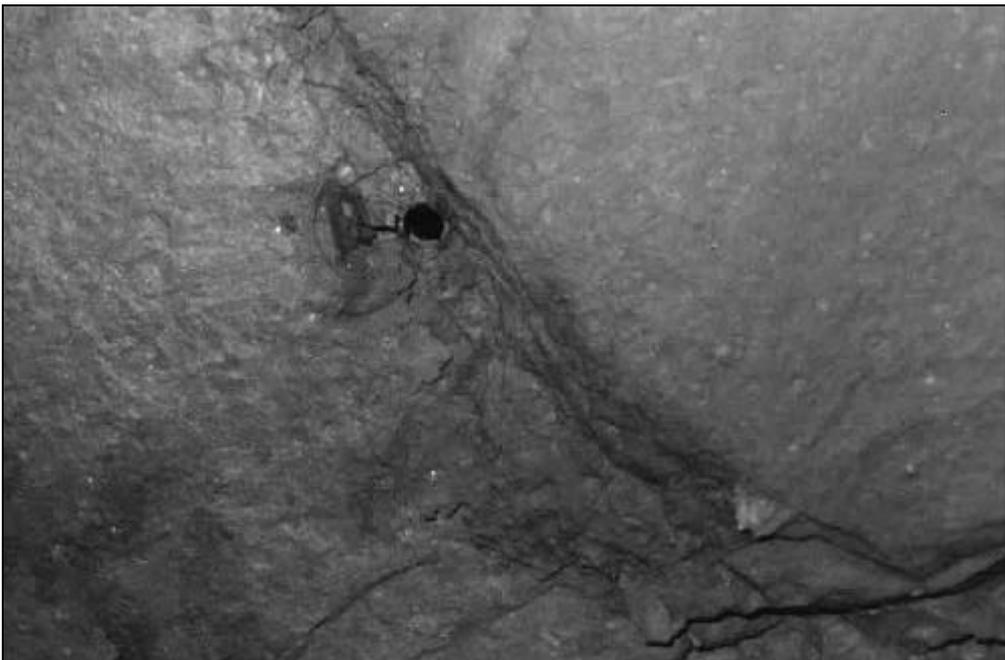
Figure 4. *Deformed roof bolt hole.*

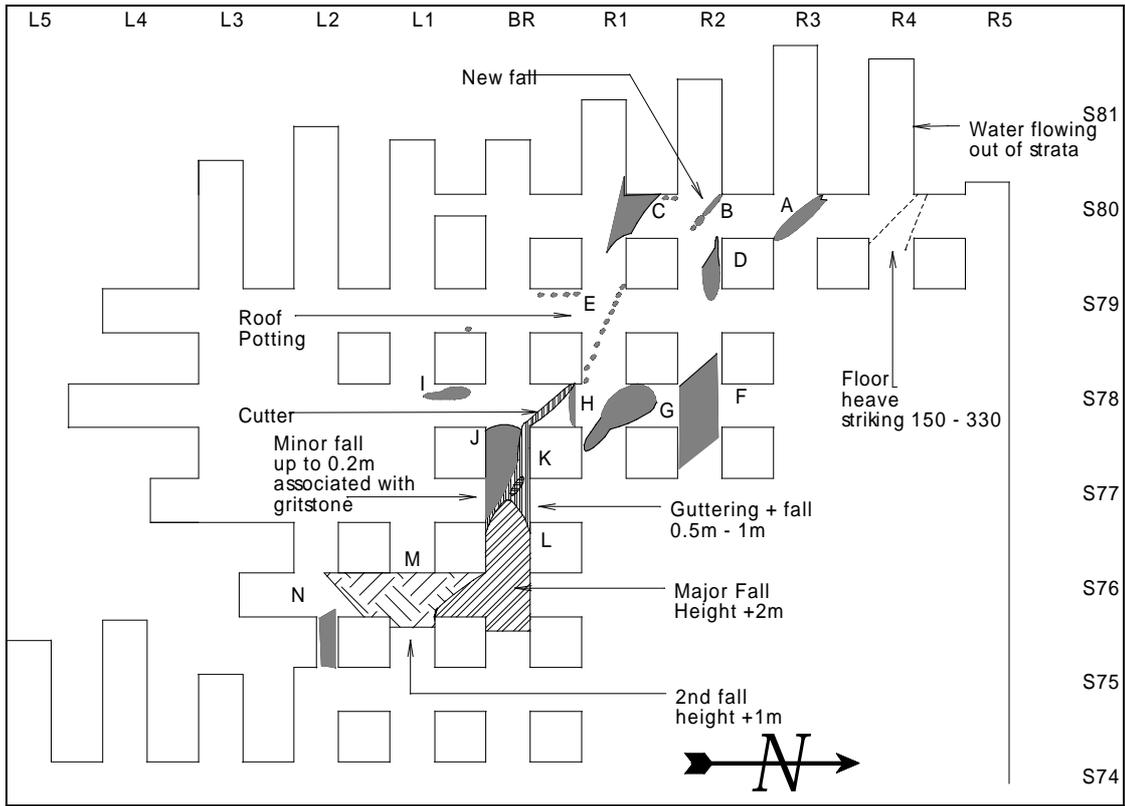
General description of fall: Figure 5 shows a layout plan of the section with most of the falls, potting, cutters, floor heave and guttering indicated on it. A distinct channel, in which the roof falls occur, can be plotted from this. The direction of this channel is ± 300° to 320°. The Mine overseer stated that this channel has been following them from some distance back and slowly crept across the panel as they advanced.

Figure 5. General key plan of the falls.

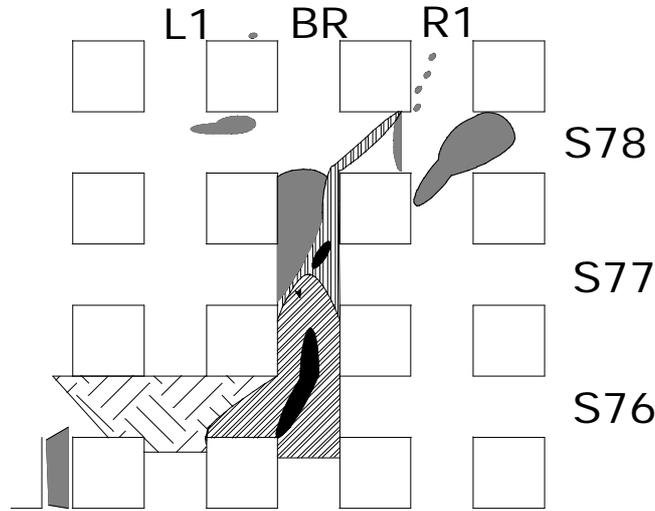
Figure 6. Detail of the major fall, Fall L in Figure 5.

L was the major fall with a domed shaped top as indicated in Figure 6 by the black shaded area in Fall L. It extended around the corner and was $\pm 2\text{m}$ high. A general view of the fall is shown in Figure 10.

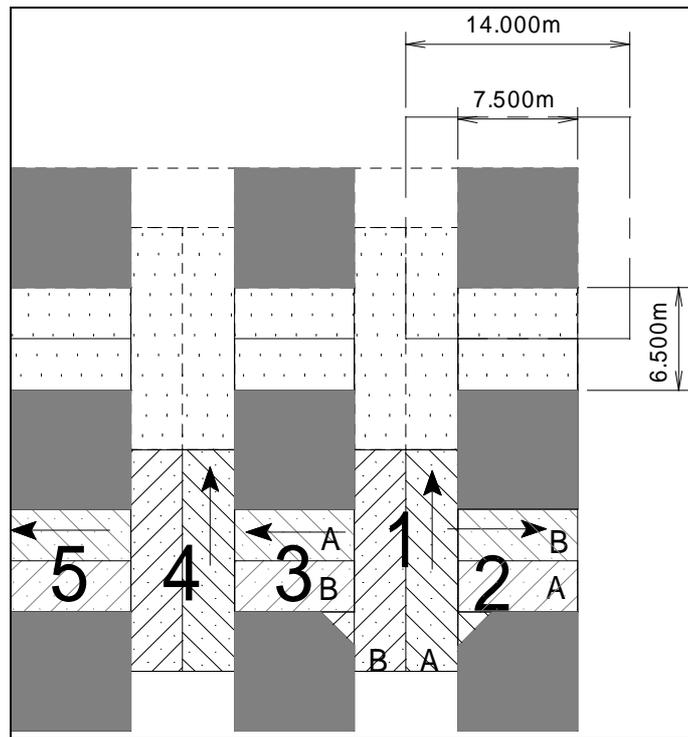
Figure 7. The cutting sequence.

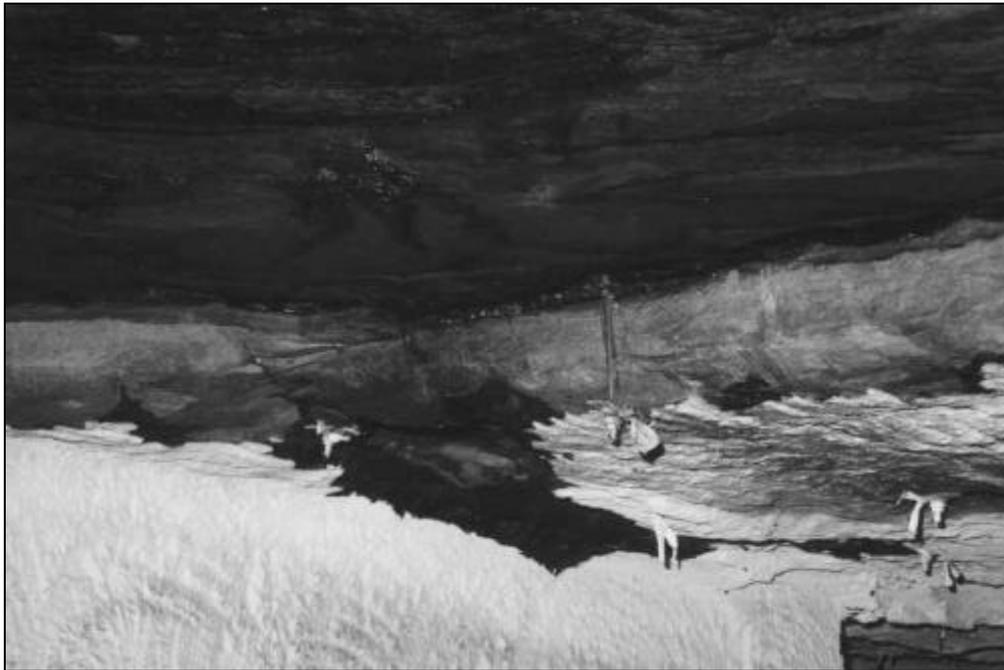
Fall H was a minor fall in the shape of a half circle across the roadway but it was out of or up to this that a cutter in the roof led, see Figure 9.

Figure 9. Cutter linking up with a roof fall.

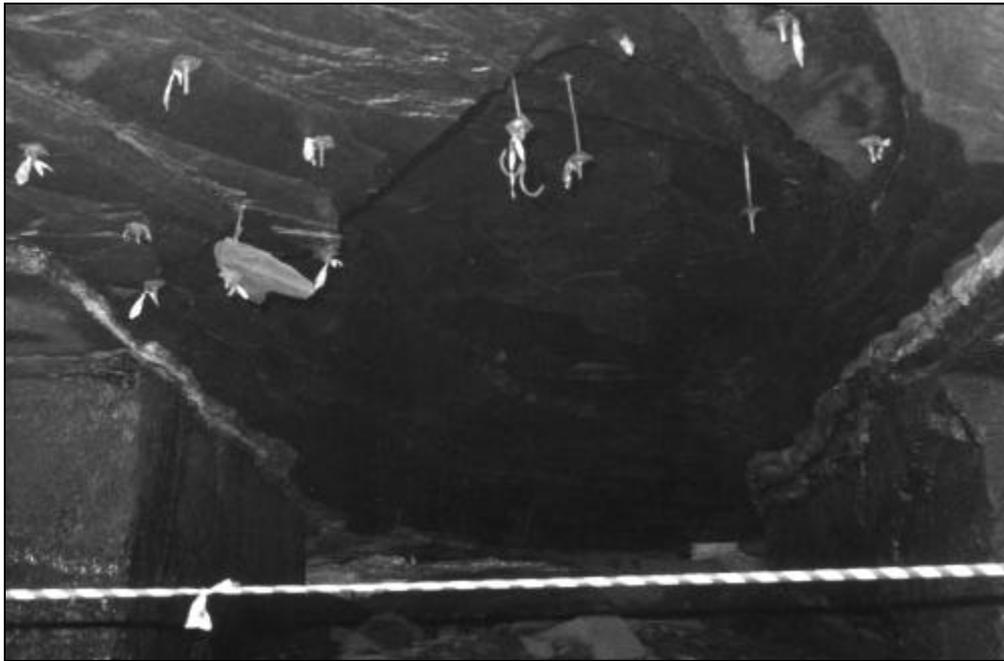
Figure 10. General view of the major fall, Fall L.

The fall was caused by a localised zone of weakness stretching diagonally across the panel. The driving force behind the fall was the horizontal stress. Once the roof rock was mobilised at the major fall, the effects continued in a direction perpendicular to the direction of the maximum horizontal stress. In the rest of the section, there are no visual indications of horizontal stress like guttering or floor heave. The effects are confined to the relatively narrow area of local weakness. The presence of water is a further indication of weaknesses in the rock mass in that area.

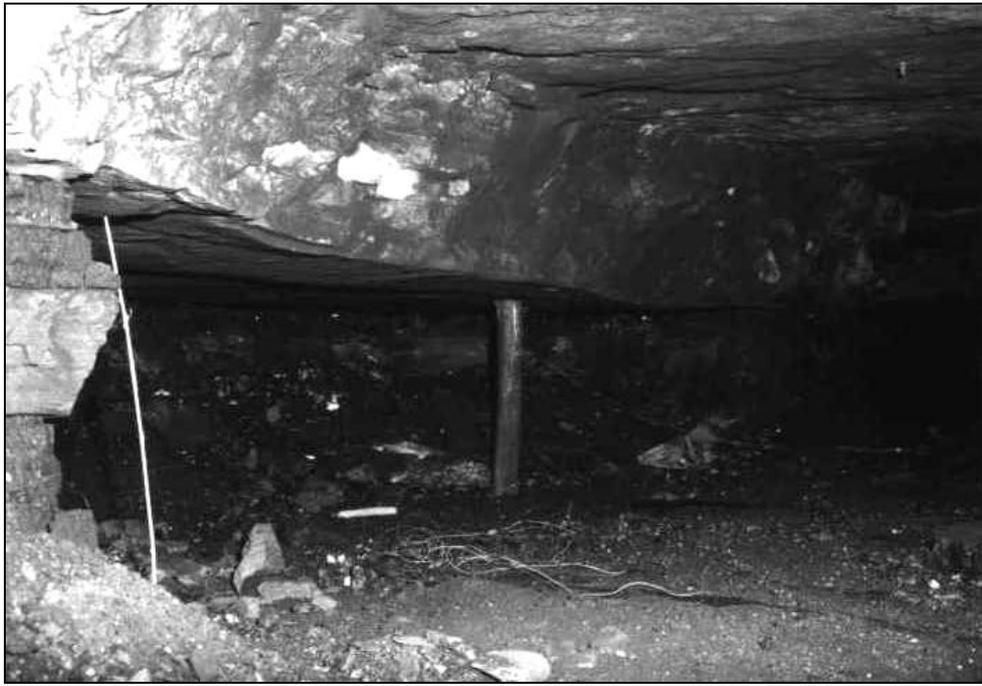
Figure 1. *View of the brushed roadway and the undercut into the pillar during stooping.*

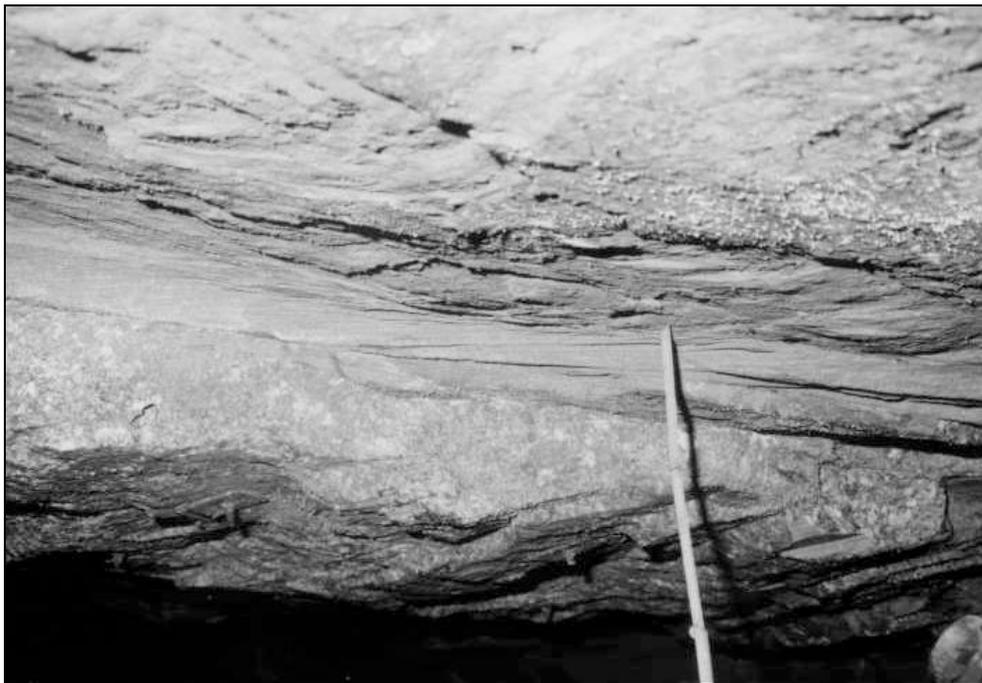
Figure 2. *Bedding and cross bedding of the nether sandstone and the weathered, uncemented contact between the bottom and top sandstones.*
