Safety In Mines Research Advisory Committee

Causes of Falls of Roof in South African Collieries

**J.N. van der Merwe
J.J. van Vuuren
R. Butcher
I. Canbulat**

**March 2001
Revised August 2001**

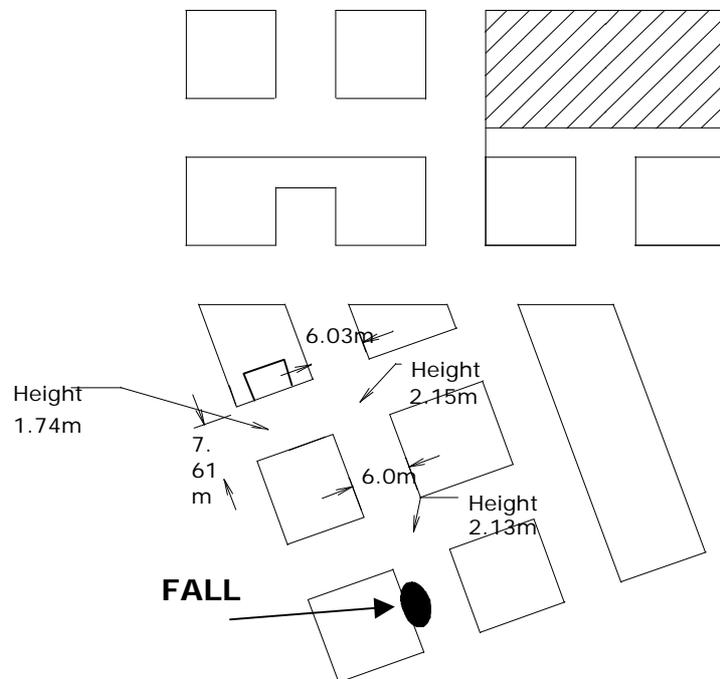
The roadway was brushed during development several decades ago. During pillar extraction now, the coal only is extracted, undercutting the sandstone roof. The undercut roof fell, the dimensions being 3 m long by 1 m wide and 0.7 m high. Figure 5 shows the locality of the fall and Figure 6 is a view of it.

Figure 5. Plan view of the fall area.

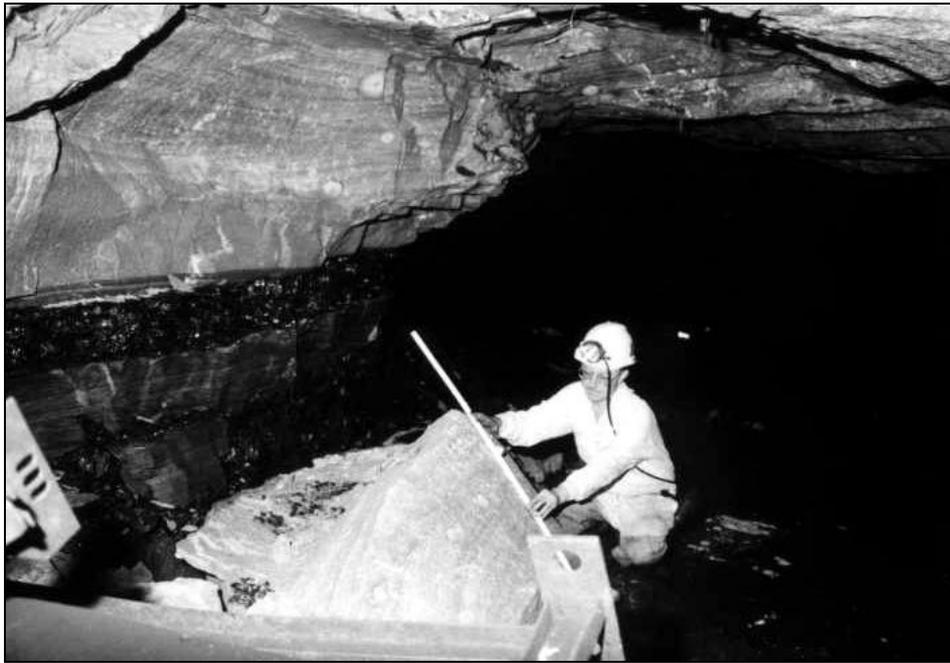
Figure 6. View of the fall.

The high vertical loading caused by stooping and the presence of the overlying goaf edge, results in differential compression of the pillars, the pillar in the process of being mined compressing more than the others. This result in bending of the roof beam, which is a cantilever due to the one end having been removed by the brushing. This beam then fails. Failure is aided by the cross bedding of the sandstone beam and by the lateral movement of the coal as the pillar gets compressed.

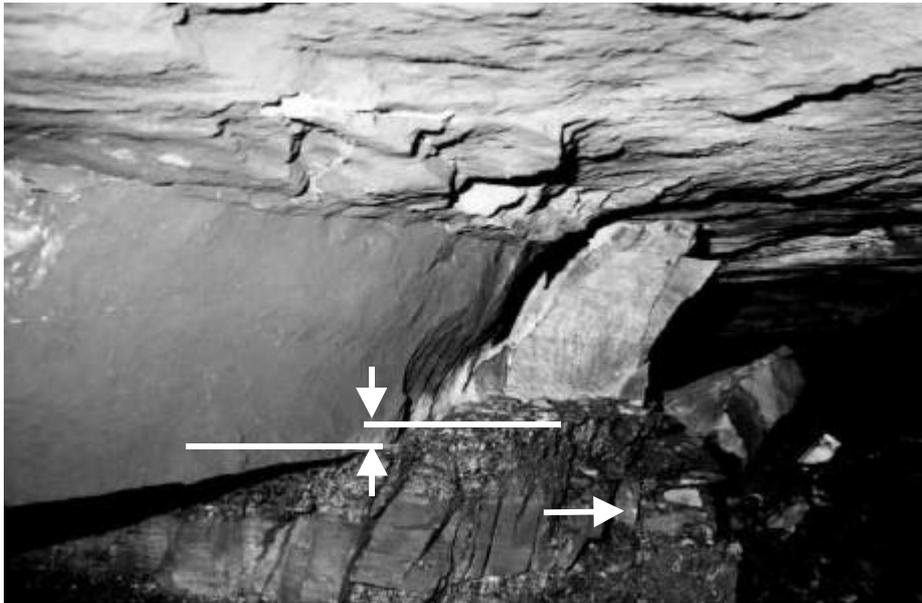
There was high vertical loading in the area, indicated by cracking noises in the pillars, bent roofbolt washers, ribside spitting, pillar compression - shown in Figure 7 - and even roofbolt washers flying off.

Figure 7. *Vertical compression and lateral expansion of the pillar during extraction.*

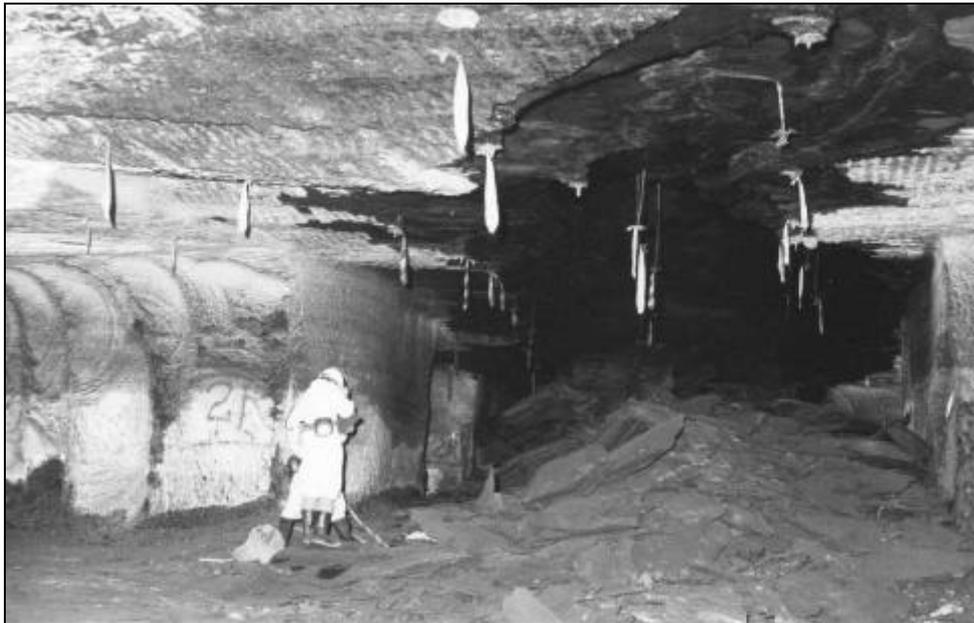
General description of fall: A general view of the fall is shown in Figure 1. The fall height was 4,1 m to 4,5 m. In width it spanned across the roadway (planned width 6,5m – actual could not be measured) and had a length of more than 20 m. It appeared to have started at an intersection where pillar corners were cut away (according to the u/g manager).

Figure 1. General view of the fall.
