THE INFLUENCE OF BALLAST FOULING ON TRACK SETTLEMENT

A RAMPERSAD, T B GEORGE, R MOKOENA, M B MGANGIRA, P J GRÄBE*

This paper discusses the effect of coal contaminated ballast on track settlement by use of a large scale “box test” apparatus. A series of tests was conducted on ballast aggregate, typically used on heavy haul railway lines in South Africa, with varying percentages of coal dust material (0, 8.4, 16.9, 25.3 and 33.8 % by weight of aggregate). Testing was conducted at 10 Hz for 100 000 cycles with a moisture content of 5.0 %. Results indicated an increase in settlement of between 11.7 and 40.2 % per 10 % increase in coal dust contamination.

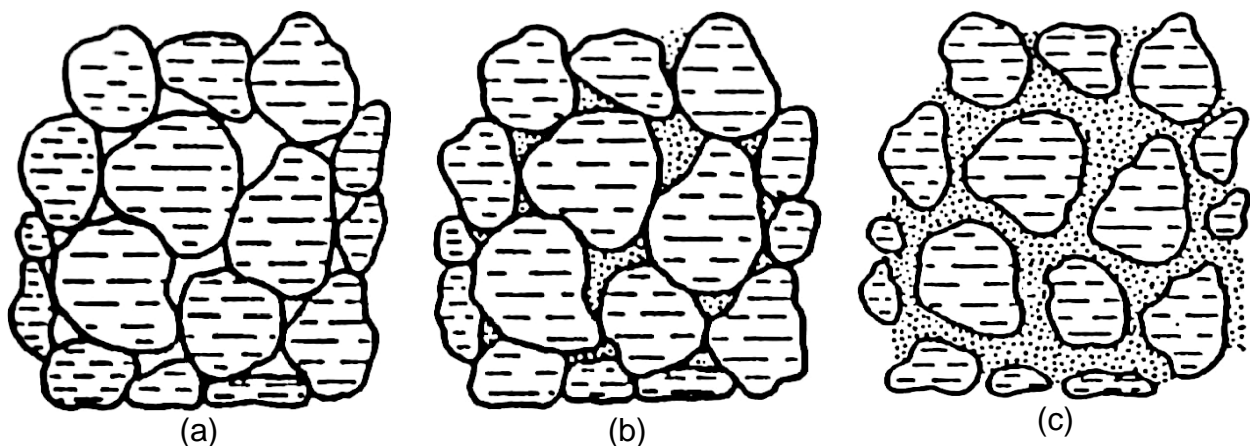
Figure 1: Critical ballast fouling phases: (a) clean ballast (Phase I), (b) partially fouled ballast (Phase II), and (c) heavily fouled ballast (Phase III) (Huang et al., 2009)

Huang et al. (2009) identified three critical phases of ballast fouling (Figure 1). The fine material occupies the void spaces between the ballast aggregates which may ultimately result in the loss of contact between the large ballast particles and subsequently contribute towards ballast settlement due to unstable track support conditions. Figure 1 illustrates three phases with varying degrees of ballast fouling occupying the void spaces. Phase 1 (Figure 1a) indicates the ballast sample almost free of any fouling materials, and the ballast particles establishing good contact with each other for effective load carrying ability. Although contact between the aggregate particles are still maintained in Phase 2 (Figure 1b), the presence of fouling material in the void spaces between the ballast aggregate is enough to significantly reduce the strength of the ballast aggregate skeleton. Phase 3 (Figure 1c) indicates a heavily fouled ballast condition, resulting in the loss of contact between the ballast particles which will undoubtedly affect ballast strength and hence compromise track stability.

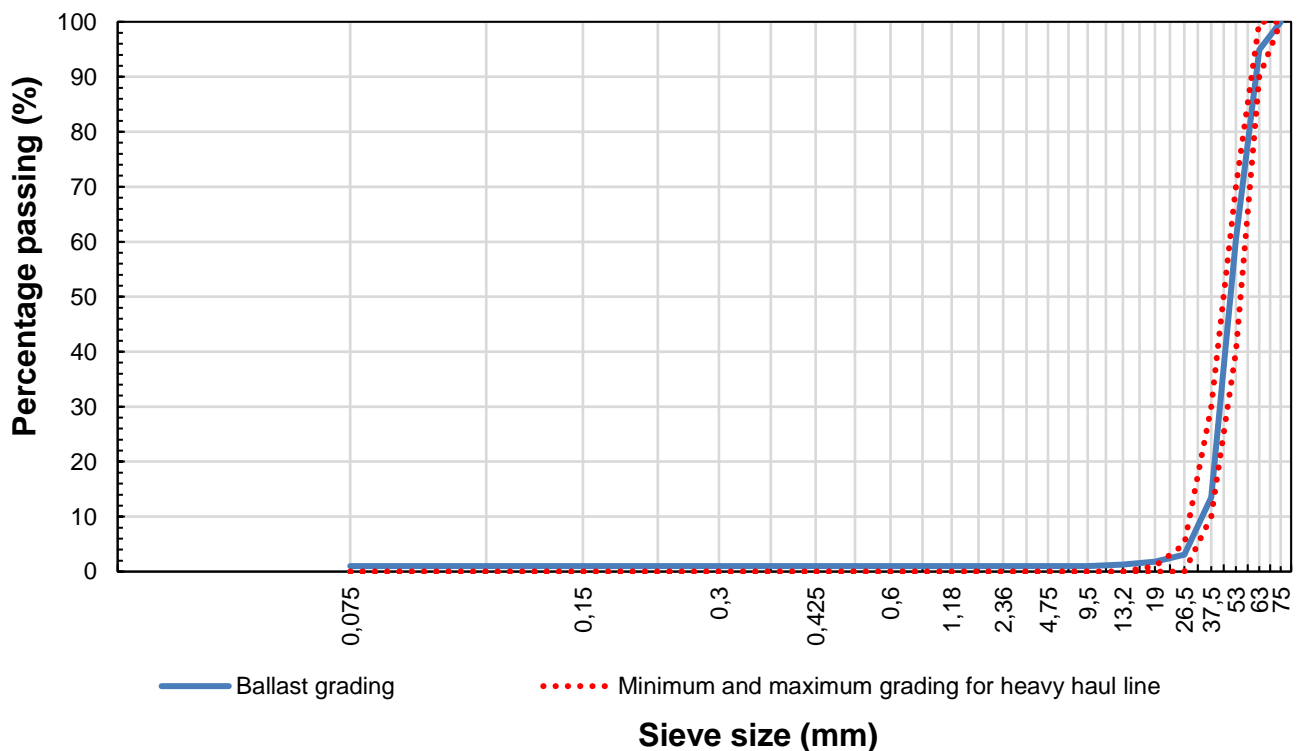
Figure 2: Ballast grading compared to Transnet specifications (1998) for heavy haul lines

The grading of the ballast was done according to TMH 1 Method B4 (1986) and compared to the Transnet specification for heavy haul lines. It can be seen from Figure 2 that the ballast met the specifications for heavy haul lines with a slight deviation from the maximum grading specification for the ballast aggregate passing the 19.0 mm sieve.
