# The development and implementation of a Bridge Management System for the Provincial Government of the Western Cape, South Africa

## ABSTRACT

This paper describes the development and implementation of a bridge management system for the Provincial Government Western Cape (PGWC). During the first phase of the project, the inventory and inspection modules were customised to meet the needs of the Department, which included integration of the BMS with the PGWC Road Network Information System. The second phase of the project involved the appointment of structural engineers to carry out the visual assessments, which is based on a defect rating system in order to determine a priority ranking of all inspected structures. The third phase of the project involved the validation of assessments and prioritisation of structures in terms of maintenance needs and the selection of suitable rehabilitation projects.

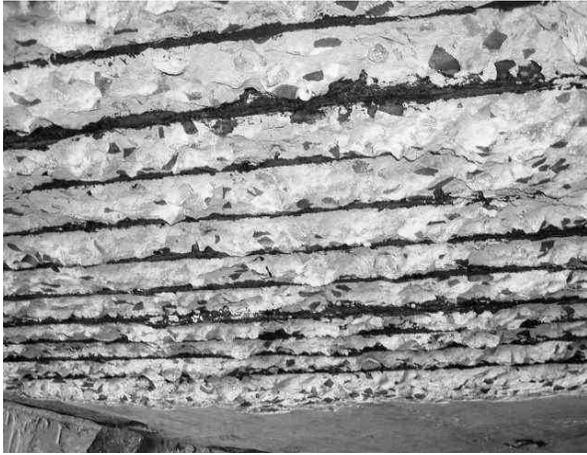
Fig. 1. Delamination of large areas of concrete at soffit of culvert top slab (C10447).

Typical defects identified on these structures are shown in Figures 1 to 4.

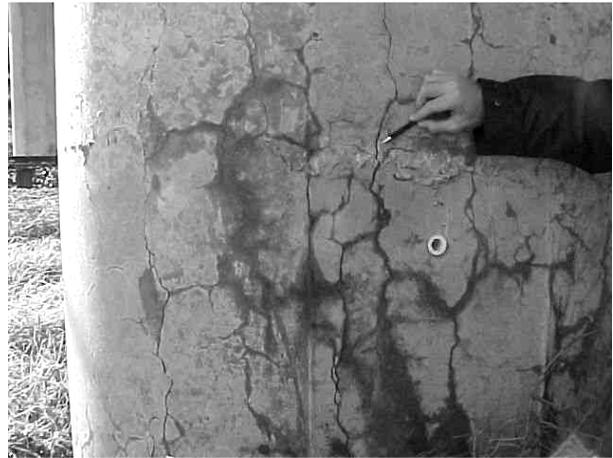
Fig. 2. Severe AAR cracking on abutment breast wall (B2960).

The most common deterioration mechanisms to reinforced concrete in the Western Cape Province (especially in the coastal regions) are alkali aggregate reaction (AAR) and carbonation- and chloride-induced corrosion. Apart from the typical AAR crack patterns observed on several structures (Figure 2), the existence of carbonation and chlorides in the concrete and their effect on the reinforcement, could not be assessed during the visual inspections. The maintenance actions as indicated in the inspection reports were based purely on observed physical defects, and the early stages of concrete deterioration (and subsequent corrosion of reinforcement) are seldom visually evident. It is therefore considered essential to perform detailed diagnostic testing and forensic investigation on a representative sample of structures in this area [2]. As far as the other defects in the area are concerned, the following are the most common:

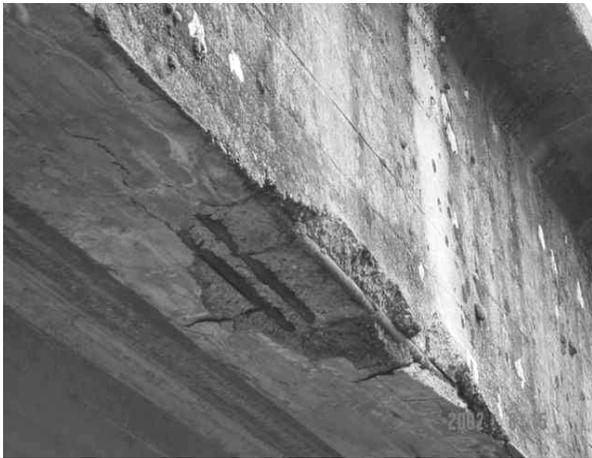
Fig. 3. Spalling of concrete at deck beam soffit (B2983).

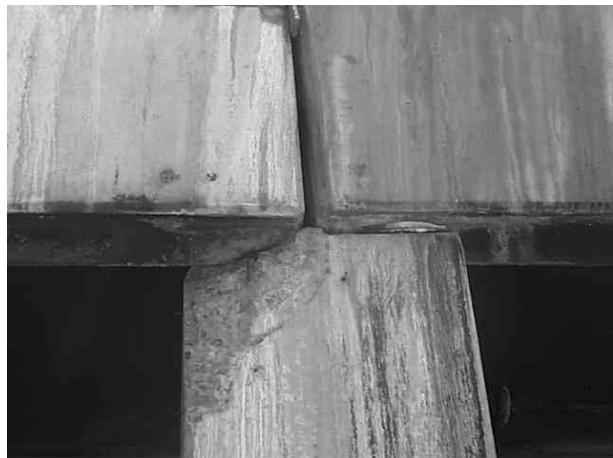
Fig. 4. Spalling of deck beam seating on top of pier trestle beam (B2167).
