DETECTING DEFECTS DURING POWDER DEPOSITION IN ADDITIVE MANUFACTURING

ABSTRACT

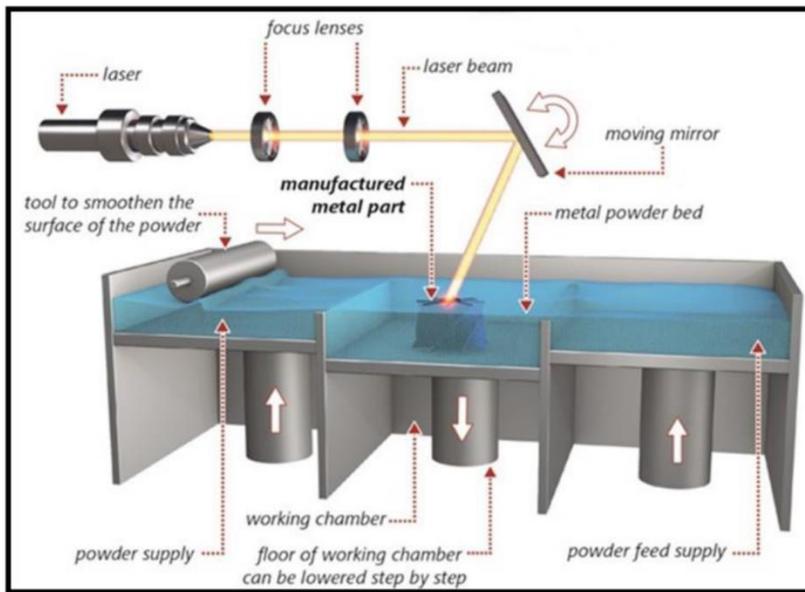
Figure 1: An example of a typical AM machine making use of a powder bed system (Source: empa.ch).

In additive manufacturing (AM) parts are fabricated by consolidating material layer-by-layer using an energy source and a three-dimensional computer aided design (CAD) of the part. In the work presented we make use of an AM technique called Selective Laser Melting (SLM) to create parts utilizing a powder bed system. A recoater is used to spread a thin layer of metal powder across the build area to smoothen the surface of the powder across the bed. A laser source then selectively scans over the bed according to the layer data, generated from the CAD file, melting the powder and consolidating it into a homogeneous part. The material not forming part of the design model is left untouched and acts as a support structure for the part. The build platform is now lowered by a layer thickness typically 20-100 μm . This procedure is repeated for each powder layer until part completion is achieved. A schematic overview of a typical SLM machine using a powder bed system is shown in fig. 1.

The technique we consider to detect powder layer defects is dependent on the formation of shadows on the powder bed (denoted working chamber in fig. 1) as a result of a light source positioned on one end of the bed and illuminating a powder layer across the powder bed. We implemented a strip LED as the light source where the initial location of the strip was parallel to the powder bed and was positioned 300 mm above and 500 mm right from the centre of the bed.

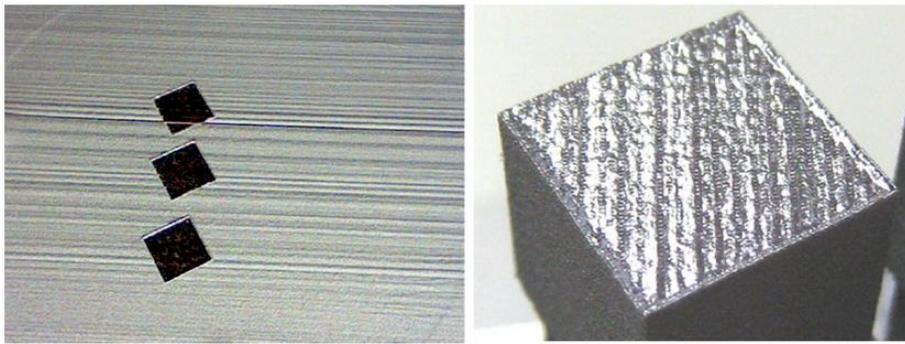
Figure 2: Recoating defects leading to high surface roughness after material consolidation (Source: [2]). (a) Part is still on the powder bed surrounded by powder. (b) Part removed revealing a high surface roughness.

Each of these can lead to different types of metal powder consolidation defects [1]. Recoater damage and recoater hopping lead to high surface roughness. Part extrusions leads to more powder deposited at the extrusion than the rest of the powder bed which in turn allows the extrusion to grow in size each layer added. Powder deficit cause the solid part to re-melt leading to rising temperature gradients and high stress levels on the metal surface which ultimately lead to cracking. An example of recoater damage leading to high surface roughness can be seen in fig. 2.

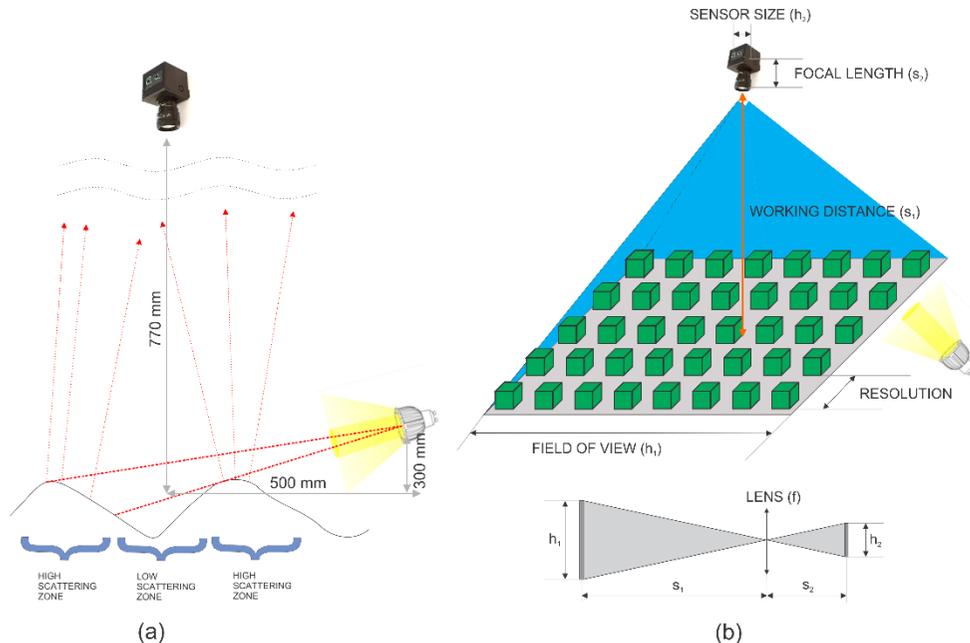
Figure 3 (a) Illustration of shadow casting due to a light source illuminating a powder bed from the right. Regions of high scattering is observed for higher powder levels where low levels of powder result in low levels of scattering. (b) Is the setup used to image the powder bed.

A single layer of powder is illustrated as an oscillating wave of peaks and troughs as shown in fig. 3(a). If the light source is positioned on the right with a camera above the bed, the light impinges on the positive slope of the powder and illuminates extrusions with shadow regions formed over the troughs. This is also true of the light source positioned on the left; however, the opposite of the case above occurs. Hence, the light intensity captured by a camera (represented as a grayscale intensity measurement) can provide information regarding the surface roughness of new powder layers deposited on the powder bed. Fig. 3 (b) shows the optical setup used during image collection. Visual detection of the powder bed was achieved with a CMOS camera (Mightex, SME-B050-U) mounted 770 mm above the powder bed (working distance, s_1).

A 12 mm lens (f) was used to image the powder bed (h_1) onto the CMOS chip (h_2) leading to an object to image transformation of roughly $150 \mu\text{m}/\text{pixel}$ and a field-of-view of 28.5×38 mm. To resolve a feature on the powder bed the required resolution is at least twice the object to image transformation. This implies at best we can only resolve defects the size of $300 \mu\text{m}$ and larger with the current system in place. To simplify mathematical computations during image processing, a square section of the image is selected leading to a field-of-view 20.8×20.8 mm (1400×1400 pixels). Experimentally, it was necessary to induce powder bed defects based on the recoater to ensure their adequate detection and sampling. This was achieved by using an old recoater which exhibited several defects on the powder bed after powder deposition as shown in fig.4 (a). The defects include (1) Recoater damage, (2) Super-elevated part, (3) Powder deficit and (4) Recoater hopping due to momentary mechanical failure of the recoater. Such defects can lead to the fabrication of a poor quality part or even part failure.

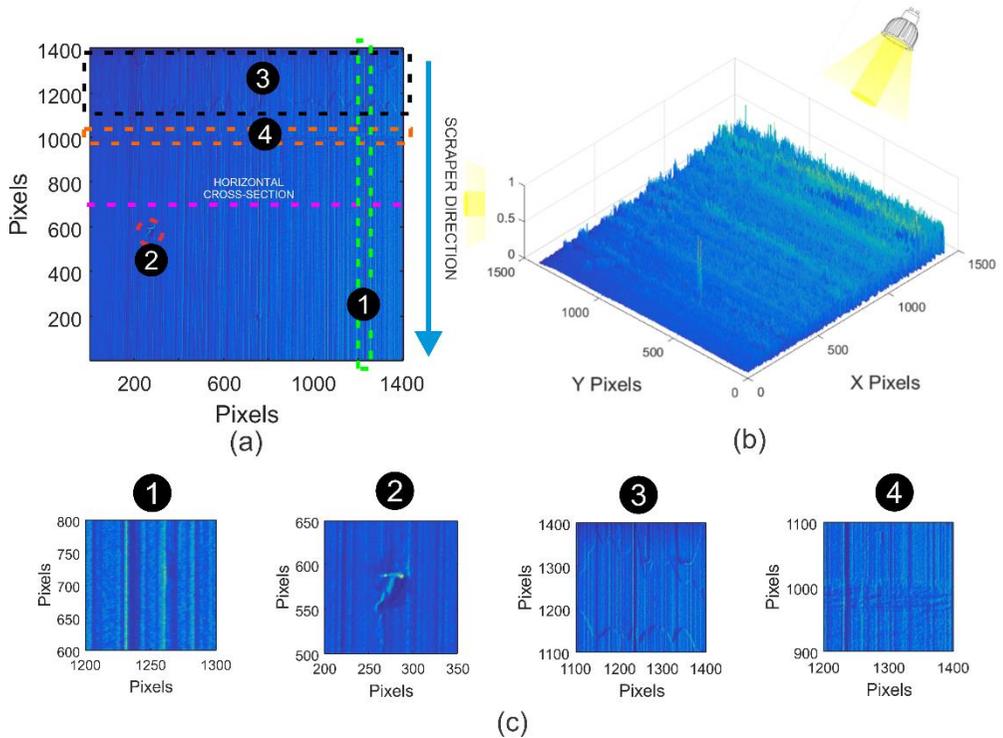
Figure 4: (a) 2D representation of powder bed defects artificially created on the powder bed. (c) Defects include: (1) Recoater damage, (2) Super-elevated part, (3) Powder deficit and (4) Recoater hopping due to momentary mechanical failure of the recoater. (b) Shows the 3D representation of imaged object.

As previously stated, the defects shown in fig. 4(a) are typically identified through a visual inspection of the powder bed which necessitates the presence of an operator at all times. In future this will be circumvented using an in-situ imaging system with complimentary software to identify the defects.

Within the 2D representation (fig. 4(a)) of the powder bed image, the broken boundaries for the various defects are not easily differentiated. If we consider a 3D representation, however, it is possible to observe the noisy information landscape but not the powder deficit defect. Therefore, standard procedures of identifying the outlines of defects using edge detection algorithms are not possible and more comprehensive software analysis is required.

The analysis of the defects induced on the powder bed was achieved through the development of software to automatically identify the defects as shown in fig. 4. Images of the powder bed were captured in a standard laboratory environment where the powder bed was exposed to several ambient light sources. The light source used to illuminate the powder bed was also not a point source, but consist of an array of LEDs. These all lead to increased background layer noise which needed to be suppressed as far as possible before locating the powder layer defects.

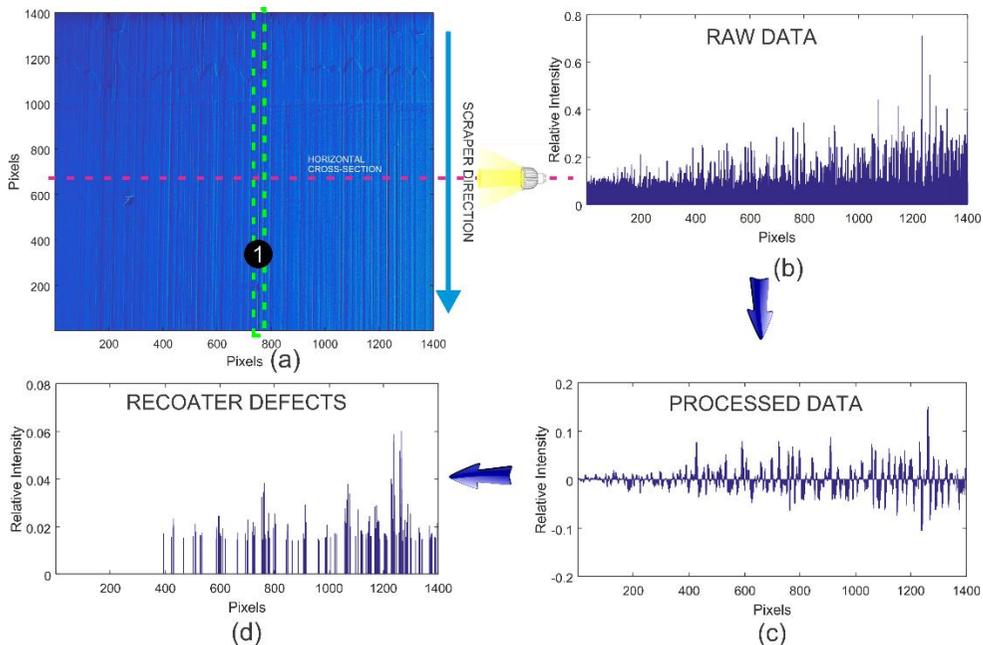
Figure 5: (a) Unfiltered images taken of the powder bed exhibit vertical lines which is associated with recoater related defects. (b) A cross-sectional cut ((a), pink line) perpendicular to the recoater coater direction is selected for processing to search for recoater damage. The data from (b) undergoes several filtering processes (c) to clean-up the information before finally being subjected to intensity filtering to isolate the location of recoater damage (d).

Recoater related defects appear as lines parallel to the recoater coating direction across the powder bed. In our case, this is seen as bright and dark vertical lines in fig. 5(a).

Recoater related defects can be identified by selecting a horizontal cross-section (as illustrated in fig. 5(a), the pink line) of the 2D camera data as shown in fig 5(b). Fig. 5(c) is the processed data after background subtraction showing the greyscale values below and above the averaged greyscale value. Not all the lines in fig. 5(a) are due to recoater damage as there is a tolerance in the acceptable layer flatness (or surface roughness) related to the particle size being coated as well as the surface roughness of the recoater. The roughness of the recoater is typically in the nanometer range for a new recoater which implies that the surface roughness will typically be of the order of the particle sizes which in general range between 40-100 μm .

To identify recoater related damage, we determined the steepness between neighboring pixels where 2 standard deviations from the average greyscale value (fig. 5(d)) is considered as recoater damage. Recoater damage was primarily observed on the right side of the powder bed due to the close proximity of the light source where the light intensity is

with poor contrast leading to poor resolvability of the edges. Furthermore, in certain cases the image at the edge comprise of defects from both the recoater and powder deficit as shown in fig. 7 (a), orange dashed circle. In this section the edge is broken by a distance of roughly 15 pixels which extends beyond the thickness of the edge itself and therefore cannot properly be reconnected using edge connection algorithms without connecting other unrelated sections to the edge. The location of the light source on the right side of the powder bed also lead to good resolvability for edges facing the light source (fig. 5(a), red dashed line) vs. edges facing away from the light source (fig. 5(a), yellow dashed line).

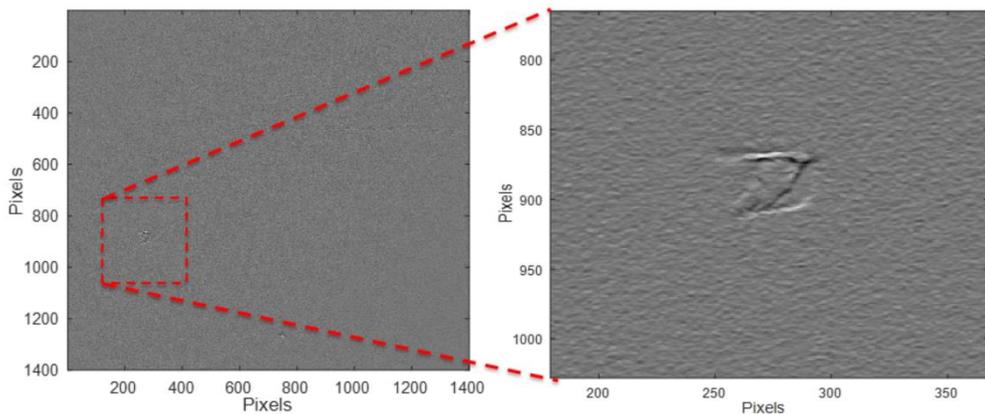
Figure 6: (left) Defect number two in fig. 2 which is an extrusion of the part beyond the powder bed powder layer. (right) Zoomed into the area where the extrusion is observed.

Super elevated parts are sections of the built part which extends beyond the newly recoated powder layer. These can be identified by comparing the build outline (from the computer generated slice files) with the powder bed images taken after powder deposition. Extrusions, however, not related to the actual part (for instance large sputtered particles); require the complete powder bed to be evaluated and not only the areas where a build is in progress. From fig. 4 it is clear that the vertical lines created by the recoater dominates and will influence most procedures used to identify other powder layer defects. To prevent this we sampled over the horizontal axis with a gradient based algorithm while searching for local centre of mass locations within the image. This allowed us to identify a super-elevated part as shown in fig. 6 (left). Fig. 6 (right) is zoomed in on the location where the super-elevated part was detected.

In this particular case we were searching for the defect with the largest gradient differences in relation to its neighborhood. In general, detecting extrusions are not only based on gradient detection methods, but also incorporate algorithms searching for the physical transverse size (number of pixels) of the defect. Due to the low camera resolution it is possible for a single pixel to represent part of an extrusion as well as part of the background if the defects are small. In this case our current approach may not be used due to the poor contrast of the elevated section in comparison to its neighborhood. This may be overcome by implementing higher resolution cameras which will aid in detecting smaller defects on the powder bed.

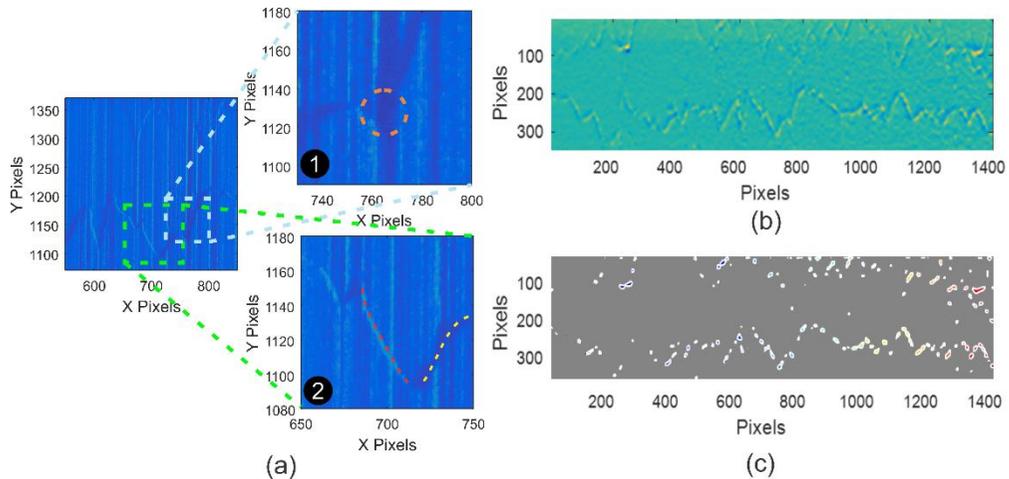
Figure 7: (a) Powder deficit observed due to scraper defects. The orange dashed circle show overlap between defects from scraper damage and the edge created between the low and high powder levels. The red dashed line show an edge facing the light source which can be resolved while the yellow dashed line faces away from the light source and is poorly resolved. (b) Low intensity filtering combined with gradient based algorithms to identify the edge between low and high powder layer levels. (c) Powder deficit located after thresholding.

Converting the grayscale images to binary white (1) and black (0) allowed us to partially resolve the edges by suppressing data below a preselected threshold value. Unfortunately this also removes in part information related to the edge between high and low powder layer levels. Fig. 7(c) shows the part of the edge identified. The edges on the left of the powder bed weren't identified due to too low signal to noise ratios.

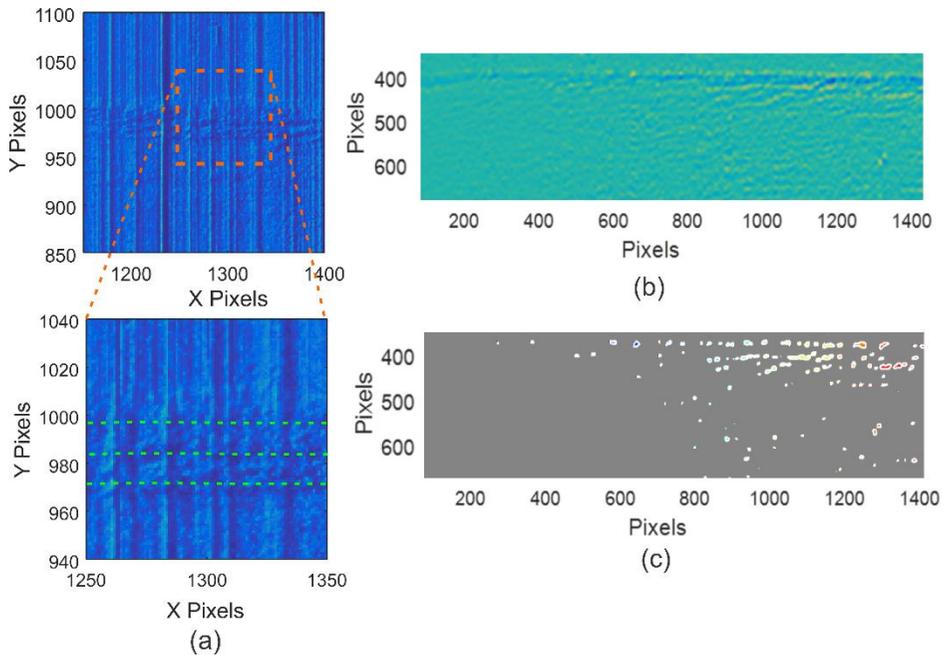
Figure 8: Recoater hopping observed as intermittent sections of too much powder deposited as well as sections of the recoater pressing into the new layer deposited. (b) Filtered data before thresholding. (c) Filtered data after thresholding.

Recoater hopping does not necessarily lead to a single horizontal line, but can lead to several closely located lines as shown in fig. 8(a) as it consist of intermittent areas of dumping to much powder or pressing into the new created powder layer forming a powder deficit section. Similar to the case for detecting powder deficit one finds the signal to noise ratios very low related to image sections exhibiting recoater hopping defects. Furthermore, the defect lines face the light source causing low light scattering henceforth small shadows with low contrast. A similar approach was taken as in the case of detecting powder deficit. Similar to the defect of powder deficit only part of the hopping could be identified as shown in fig. 8(c).

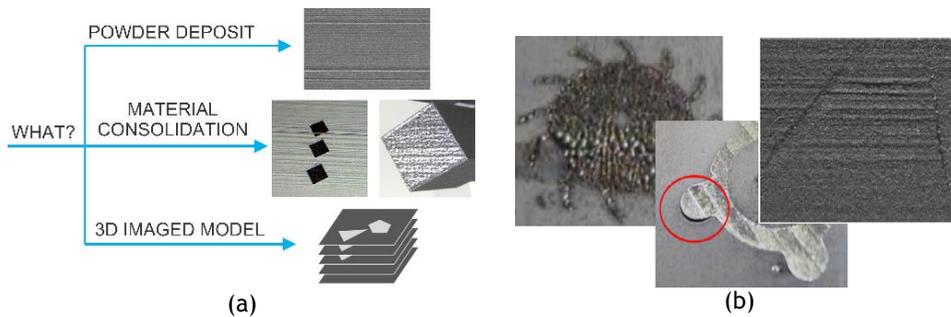
Figure 9: (a) Different areas considered for future work. This includes imaging the powder bed after metal powder consolidation as well as constructing an imaged 3D model of the built to investigate dimensional mismatches between the parts built and the CAD of the build. (b) Powder consolidation defects one would like to identify. (1) Balling effect of particles, (2) part extrusion, (3) delamination of the part.

This new system will be extended to also monitor the part after metal powder consolidation to quantify how powder layer defects influence consolidation (fig. 9(a)). Fig. 9(b) shows 3 different features one could detect using the same setup as that for the powder bed monitoring. Future work also includes the construction of an imaged 3D model of the build to investigate dimensionality mismatches between the built part and the CAD of the build.
