INVESTIGATION INTO LASER REFINISHMENT AND TRANSFORMATION HARDENING OF CAST IRON FORMING DIES FOR THE AUTOMOTIVE INDUSTRY

Paper #258

Maritha Theron¹, Corney van Rooyen¹, Khoro Malabi¹

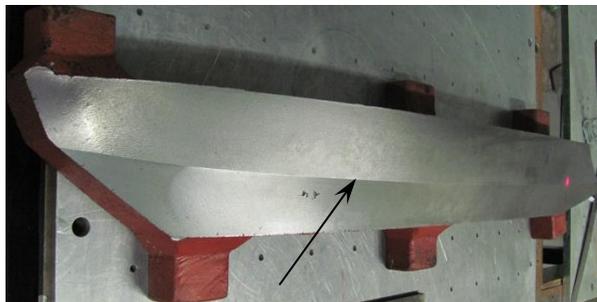
Figure 1 Small casting replica of the forming die that was supplied for laser hardening tests. The angled profile is indicated by the arrow
(Courtesy of Volkswagen Group South Africa)

A small casting replica of the forming die, with the correct angled profile, was supplied for laser hardening trials, together with a smaller casting sample. The as-received material hardness averaged 22 HRC and the aim was to increase the designated area hardness (Figure 1) to a maximum, with a case depth as high as possible.

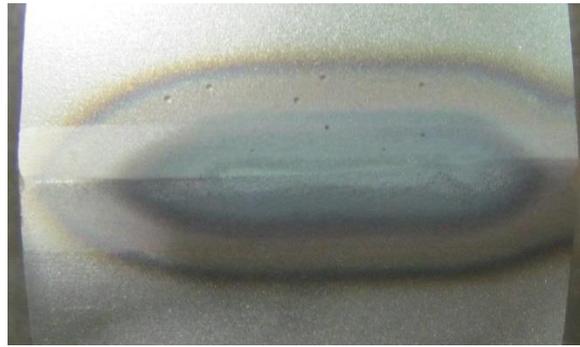
Figure 2 Typical appearance of the machined casting sample with the optimal hardening parameter track

The optimal hardening parameter track done on the machined cast sample, is shown in Figure 2. The transverse micrograph of this hardened track is shown in Figure 3 and the measured hardness traverses for it are shown in Figure 4.

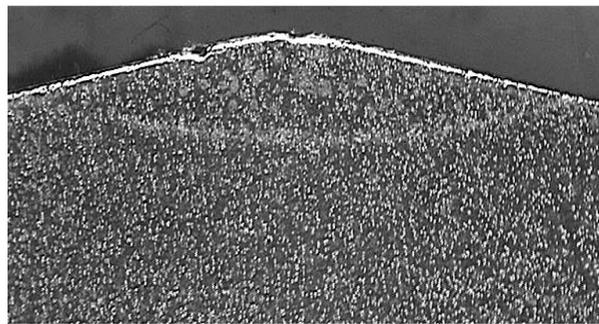
Figure 3 Transverse micrograph of the laser hardened track, showing the case depth as well as the track width

From Figure 4(a) it can be seen that the case depth obtained on the cast sample when laser hardened with the optimum parameters, was in the order of 2.3mm, when the minimum required hardness is taken as 500 HV (49 HRC). Attention should however be brought to the fact that the case depth decreases with increasing distance from the centre of the angled profile, due to the geometry of the case (Figure 3).

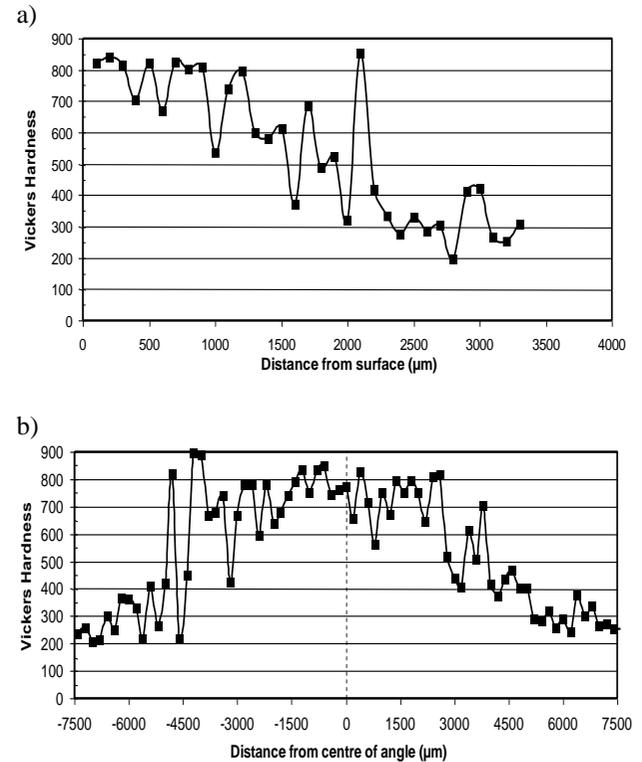
Figure 4 Vickers hardness traverse of the optimally hardened cast sample track from the surface into the base material (a) and sub-surface (200 μ m below surface) (b)

Figure 4(b) shows that the effective hardened track width (taken with 500 HV as minimum required hardness) is typically 10 mm (5 mm each side from the centre of the angle). This width also increases as the minimum required hardness decreases. The visible hardened width measured on the surface was therefore 14 mm, but the total hardening track width was about 28 mm (heat affected zone (HAZ) included).

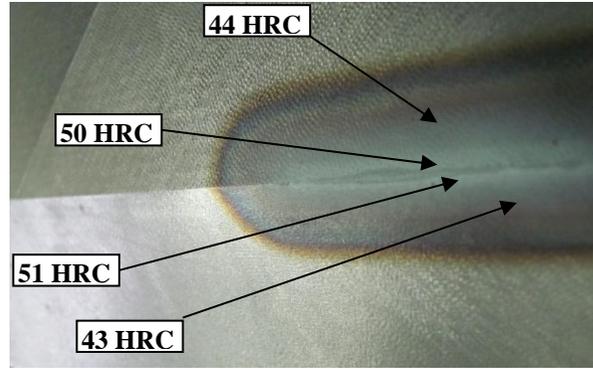
Figure 5 Laser hardening track obtained on the punch die replica, with the average measured Rockwell C hardness indicated on the different areas

These laser hardening parameters were then applied to the punch die replica which had a coarser surface finish than the cast sample. The obtained hardened track is shown in Figure 5, together with the average Rockwell C hardness measured with the portable, handheld hardness tester in different positions. The case depth obtained on this replica could not be determined since it could not be cut for analysis. The effectively hardened track width on the surface was again measured as 14mm (7mm on each side from the centre of the angled profile), if 40.8 HRC (400 HV) is taken as the minimum required hardness.

The maximum hardness measured with the handheld hardness tester (equivalent to 530 HV) is much lower than that measured with the micro-hardness tester. This was probably because it was not possible to measure very close to the angle, which is the area of highest hardness, and the surface finish was much coarser than that of the polished sample. The accuracy of the measurement is also reliant on the perpendicular positioning of the tester onto the surface being tested.

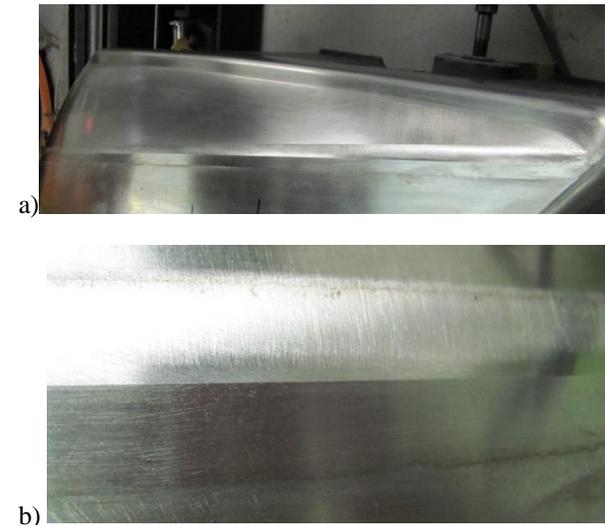
Figure 6 Part of the as-received forming die (a) with a close-up of the angled profile (b) (Courtesy of Volkswagen Group South Africa)

The as-received angled profile of the forming die is shown in Figure 6 while the hardened profile is shown in Figure 7. From the close-up pictures it can clearly be seen that the forming line was hardened effectively and no damage was caused to it during the hardening process. The complete hardened track width again measured 30 mm and the effective hardened track width 14 mm. The hardness at the centre of the track was measured at the end of the hardening track (off the forming line) and registered 53 HRC.

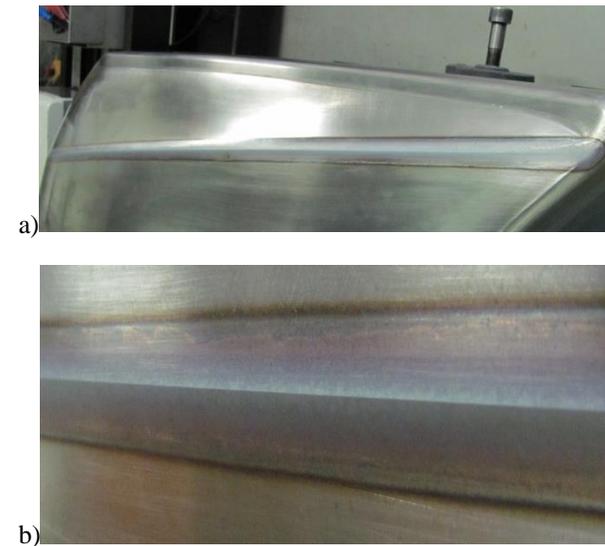
Figure 7 Part of the hardened forming die (a) with a close-up of the hardened angled profile (b)

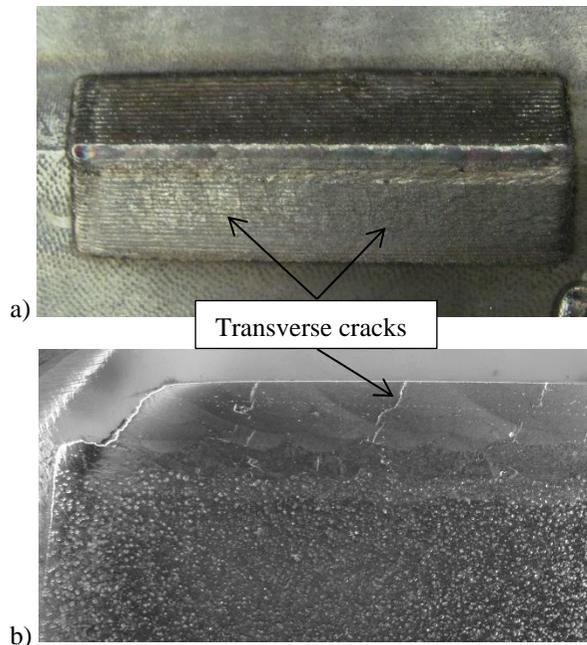
Figure 8 (a) H11 tool steel clad onto GGG70 cast iron with the angled profile, (b) Transverse micrograph of the clad

The trials were started with the cladding of only H11 tool steel directly onto the GGG70 cast iron (Figure 8(a)). A transverse sample was cut from the area, mounted and polished for microstructural analysis. The result is shown in Figure 8(b). The average hardness of the H11 clad was measured to be 56 HRC and solidification cracking could clearly be detected both visually and microscopically.

was the case with the H11 tool steel clad. The cracks were also visible on the surface (Figure 8), which is another characteristic of solidification cracking [7].

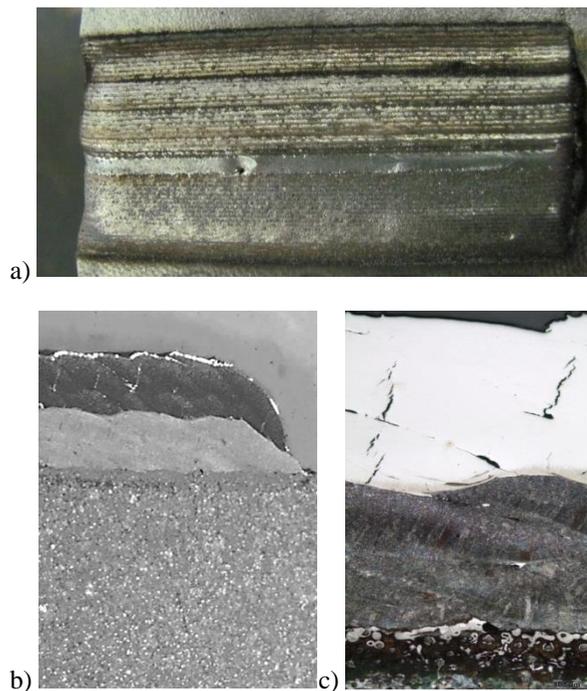
Figure 9 (a) Clad patch of the stainless steel buffer layer and H11 overlay on the GGG70 cast iron, (b) transverse section thereof and (c) microstructure of the three different material layers

The cracking was thought to be attributed to the dilution of impurities into the clad material, and a buffer layer between the cast iron and H11 was introduced. The low-C martensitic steel was used and the clad repair patch is shown in Figure 9, together with the cross section and microstructure.

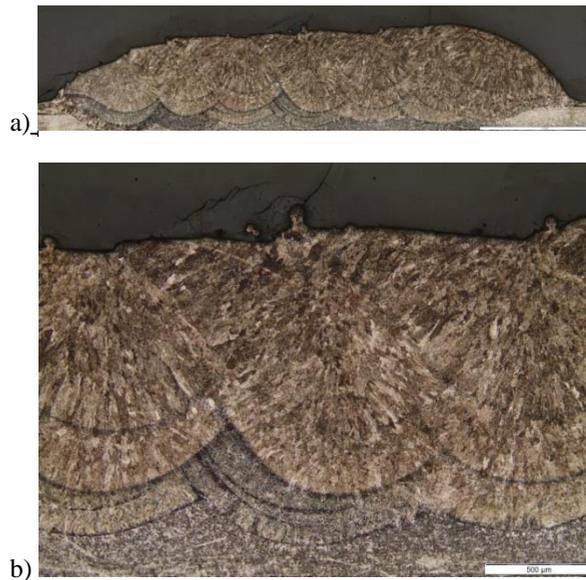
Figure 10 Three-layer H11 tool steel clad processed with the optimum parameters: (a) Stitched micrograph showing the full clad build-up and (b) Detail microstructure highlighting the crack-free, 0.4 mm thick layers

The process parameters found to be successful in producing crack-free H11 clads are listed in Table 4 and the build-up is shown in Figure 10 Three-layer H11 tool steel clad processed with the optimum parameters: (a) Stitched micrograph showing the full clad build-up and (b) Detail microstructure highlighting the crack-free, 0.4 mm thick layers. The complete repair build-up with the low martensitic stainless steel buffer layer (2 layers) as well as the H11 overlay (2 layers) is shown in Figure 11. The microhardness of the H11 overlay was measured on this build-up and the average was 673 HV.

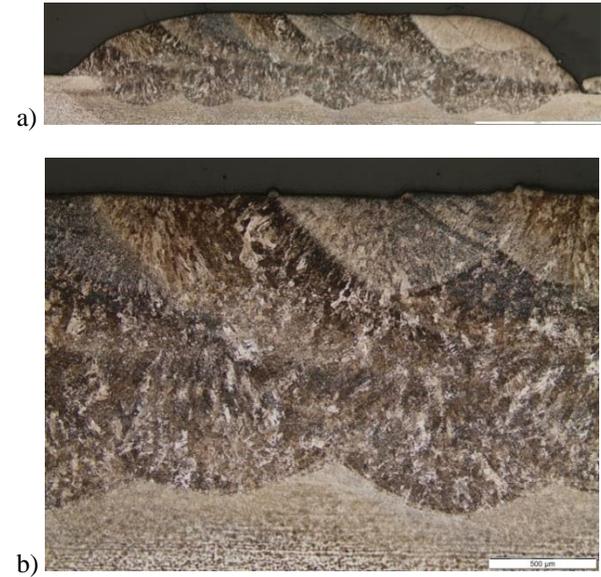
Figure 11 Complete clad repair build-up of the buffer layer together with the H11 overlay: (a) Stitched micrograph and (b) Detail microstructure
