Making Africa's Roads More Resilient to Climate Change

Paige-Green, Phil

Verhaeghe, Benoit

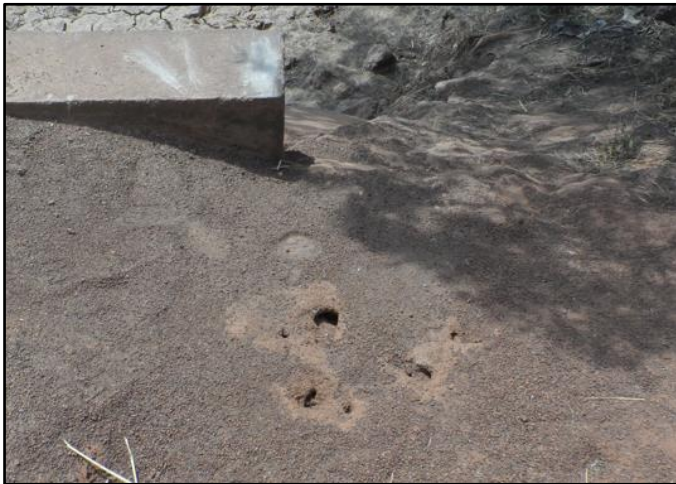
Fig. 2. Example of ant holes undermining the structural integrity of an embankment

in the road area. Fig. 2 shows ant “holes” that will allow water to penetrate into the embankment (there is usually an extensive network of tunnels beneath such an area) and these should be taken care of.

There are many other issues that may need taking note of and these will usually be identified as the assessment takes place. A typical example of one of these is the presence of ants
